DEFECT INSPECTION FOR HOUSE CONSTRUCTION

BACHELOR OF BUILDING SURVEYING (HONS)

PRACTICAL TRAINING REPORT

The project is located in Lorong Sri Saga, 36600 Chenderong Balai, Perak, this project is a single-story bungalow house, and the size of this project is 1370 sq. ft. This house project is owned by Mr. Muhammad Ferdaus bin Selamat.

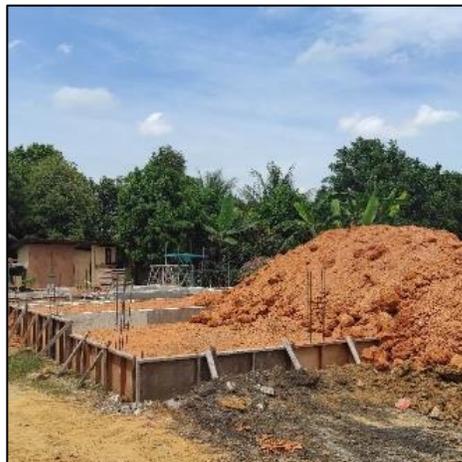
Photo 3.3: Land Filling

If there are inaccurate measurements on-site, the inspector needs to report the issues to the contractor to solve the issues. After the issues have been solved, the inspector needs to do the same inspection procedure until it complies with the proposed drawing. Below is the process carried out on site after the approval of the inspector.

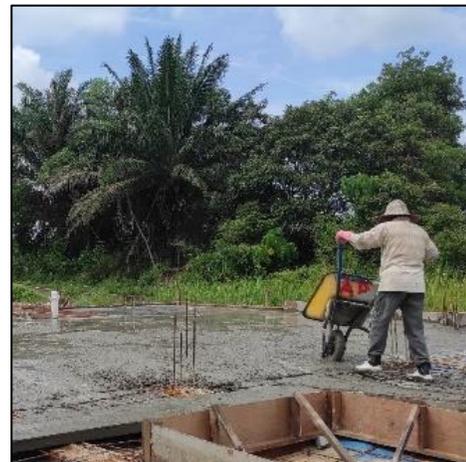
Photo 3.4: Concrete Slab

Besides that, during the measurement process, the inspector also needs to inspect the quality of constructed beam either in good condition or not. The inspector needs to ensure they're no honeycomb or crack on the surface of the beam. By referring to the drawing below, the inspector also needs to ensure the position of beams is aligned and comply with the proposed drawing.

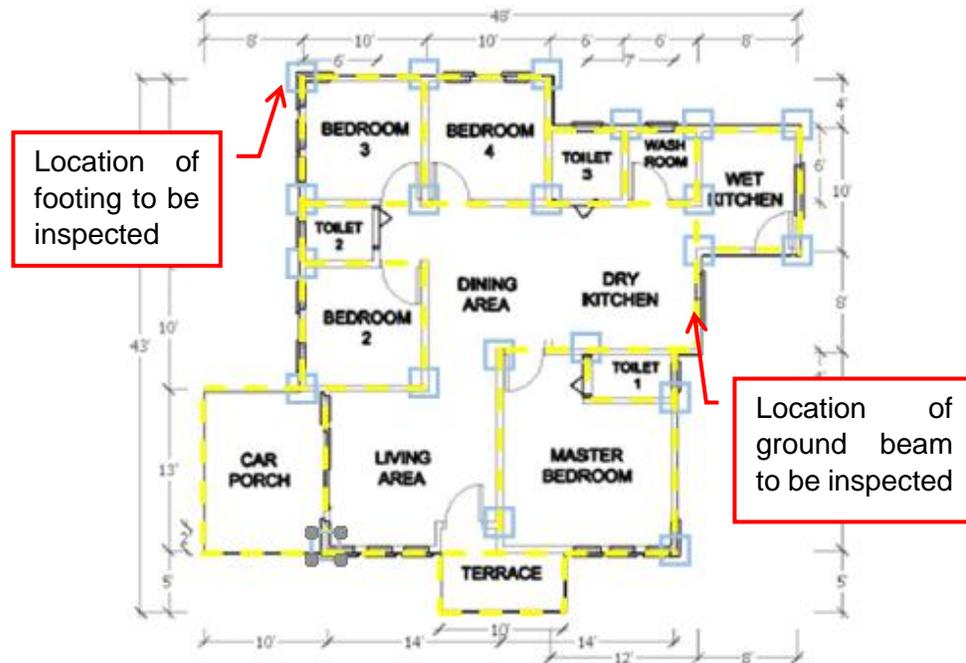
Figure 3.9: Plan for Sub-Structure Work

After the project position has been confirmed, the inspector needs to do a second visit exactly after the floor beam has been constructed. The inspector needs to measure all floor beams on-site and record them into the inspection form. This process has been done to ensure the size of every beam and space area are comply with the drawing plan. The record of size and area of build space will be analysed to identify any inaccurate measurement.

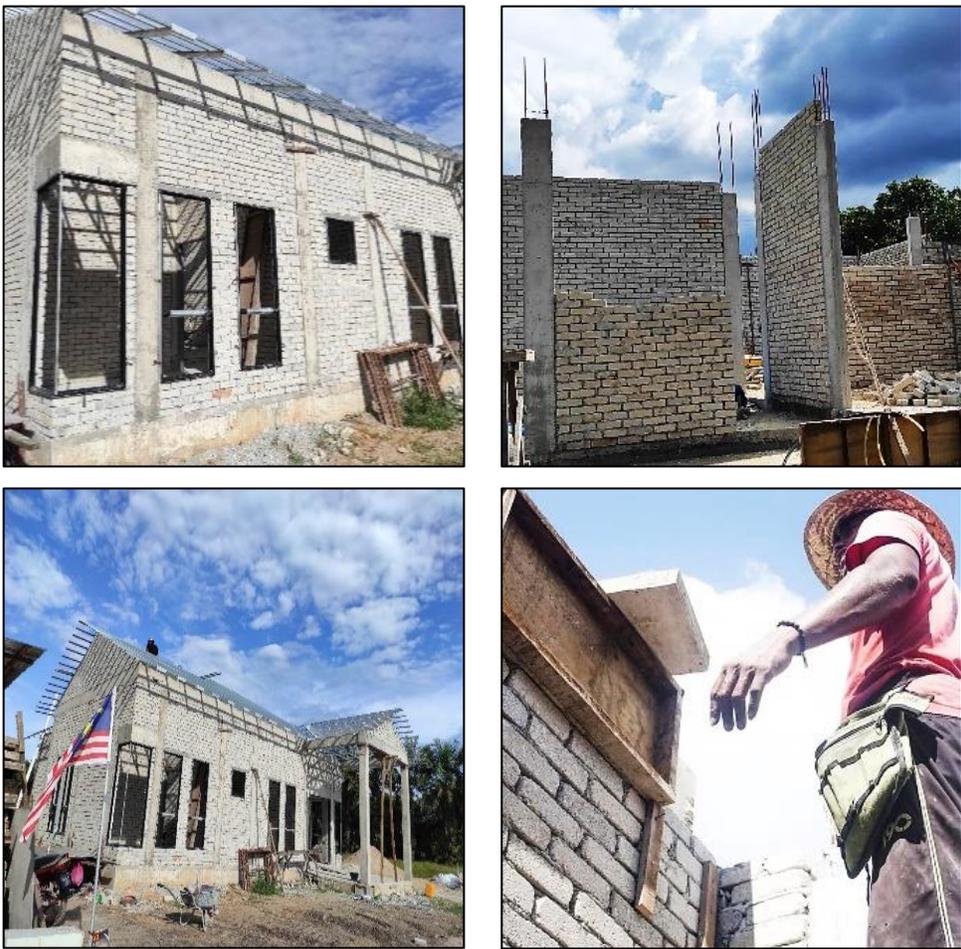
Photo 3.6: Bricklaying Process

For the mortar work, the inspector needs to ensure the thickness of the mortar joint is not exceed 10mm. Besides that, the inspector also needs to do a visual inspection on the wall surface to ensure the brick wall is not leaning

and straight, comply with the requirement. All this inspection work needs to be carried out during the progress of work to avoid the delay of the progress work. Below is the photo of the bricklaying process carried out on-site under the supervision of the site supervisor.

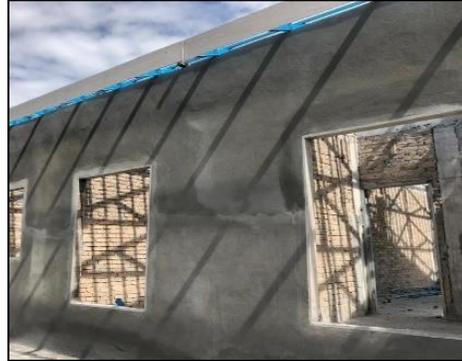
Photo 3.7: Inspection of Plasterwork Process

During the inspection process, the inspector needs to use spirit levels to identify the evenness of the plasterwork in vertical and horizontal directions. The inspector also needs to ensure the plastering thickness is even at all points during the plastering process. If there are defects that have been found, the inspector needs to record the defects and provide the report to the contractor

to repair them. After the repair works have been done, the inspector needs to do the same inspection work until it complies with the requirement.

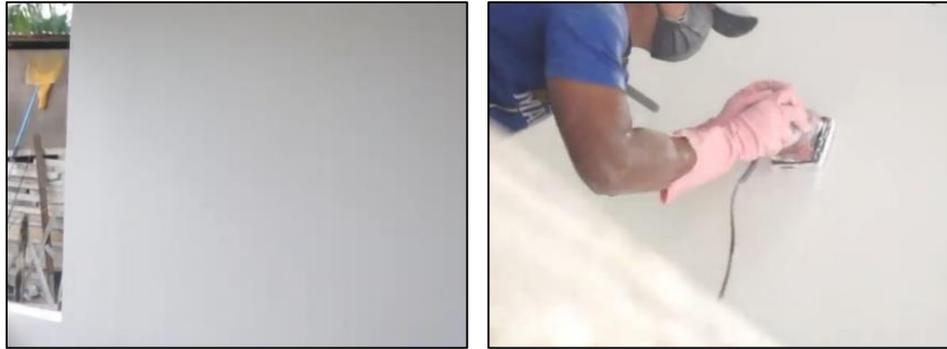
Photo 3.10: Inspection on Skim Coat

To identify the smoothness of the work, the inspector needs to use a flashlight or tube light on the wall to evaluate the quality of work. By using the tube light, it will help the inspector to evaluate the surface of the wall. If there are defects been found such as a crack, hole, uneven surface, and else, the inspector needs to mark the defects and ensure the site worker does the repairing work. After repairing work is complete, the inspector needs to repeat the inspection process until the work quality complies with the client's request.

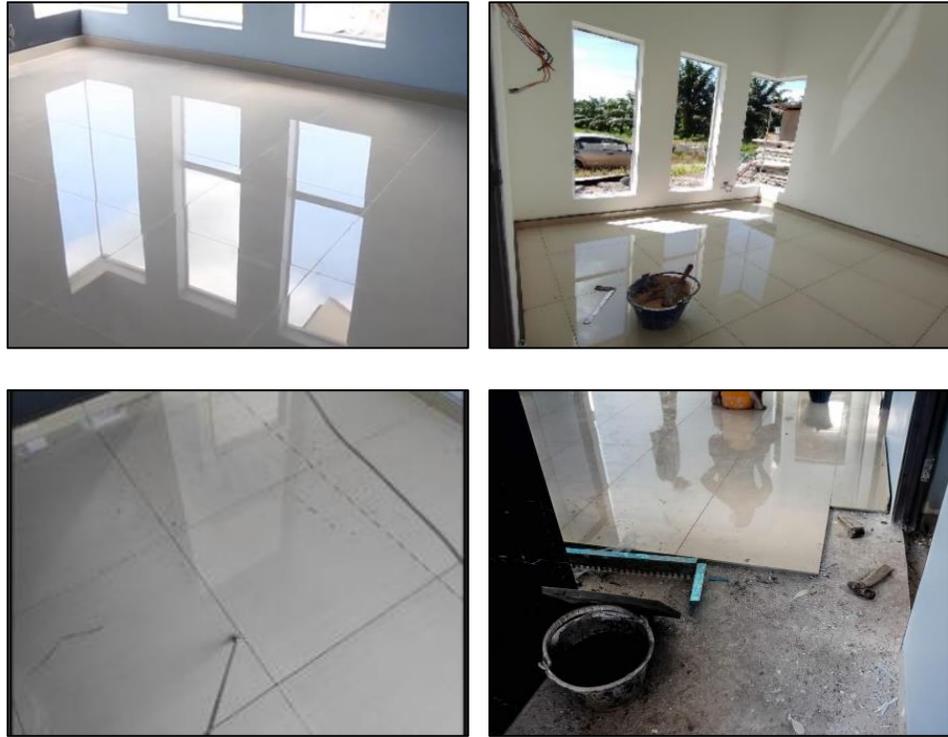
Photo 3.12: Inspection on Tiles

For the tiles in the bathroom, the inspector needs to use the spirit level to measure the slope toward the drainpipe. The slope in the bathroom is very important to avoid other defects occurring such as water stagnant, leakage, seepage, and dampness. The installation of tiles on space need to comply with the tiles plan. The inspector needs to ensure there are no starches marks on the tiles surface and the colour shade of the tiles are comply with the client's requirement.

If there any defects are found during the inspection process, the inspector needs to label the location of the defect on-site and draw the plan for the monitoring process. The defects that have been labelled by the inspector will be repaired by the worker, and the inspector needs to do another inspection work after the repairing work is completed. This inspection progress will be repeated until it complies with the requirement.

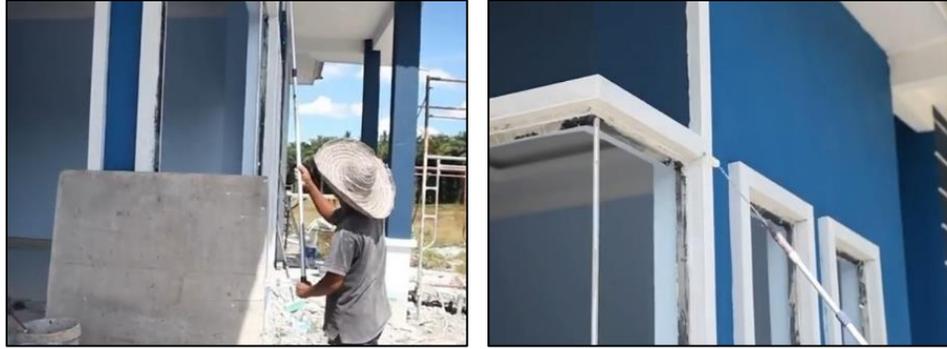
Photo 3.13: Painting Work Process

While for the paint coat work, the inspector needs to do visual inspection work on the element surface to identify if any defects need to be repaired. The inspector needs to identify if the crack or fine crack is appearing on the element surface. Besides that, the inspector also needs to ensure there are no bulging, chipping, white patches, stains, or signs of dampness appearing on the house element process. Other than that, the inspector also needs to carefully evaluate the tone of painting work even or not and ensure the colour code complies with the client's request.

The inspector also needs to ensure the surface of the inspected element is in good condition without any sign of defect, if there any defects appear, the inspector needs to identify the causes of the defects and suggest the repairing method for workers to repair the defects. This process will be repeated until the quality of work comply with the requirement.

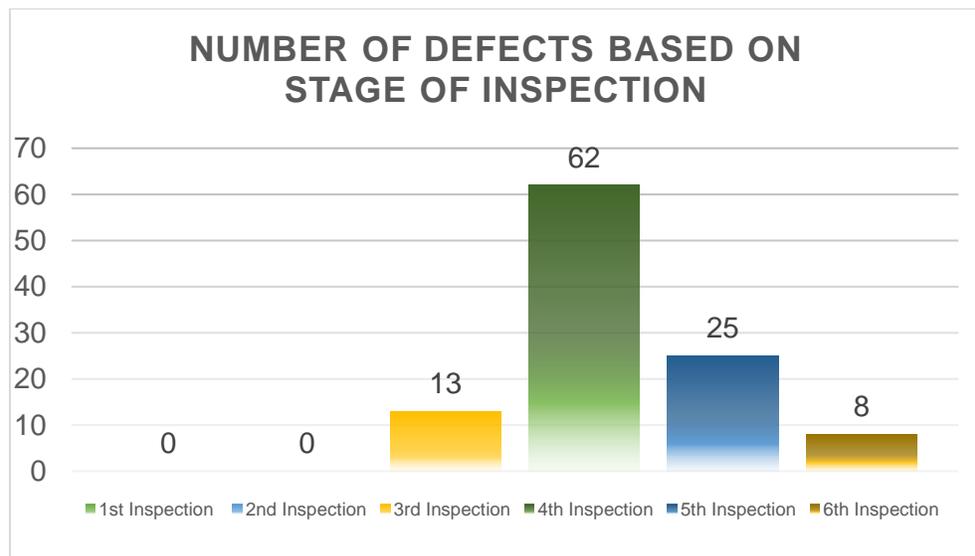
Figure 4.1: Defects Analysis

For this project, there are 6 inspection processes have been carried out in order to monitor and control the quality of the project. Therefore, the chart below shows the number of defects found during the inspection work based on the stage of inspection. This data shows which stage of construction progress are required more monitoring from the inspector during the construction process.

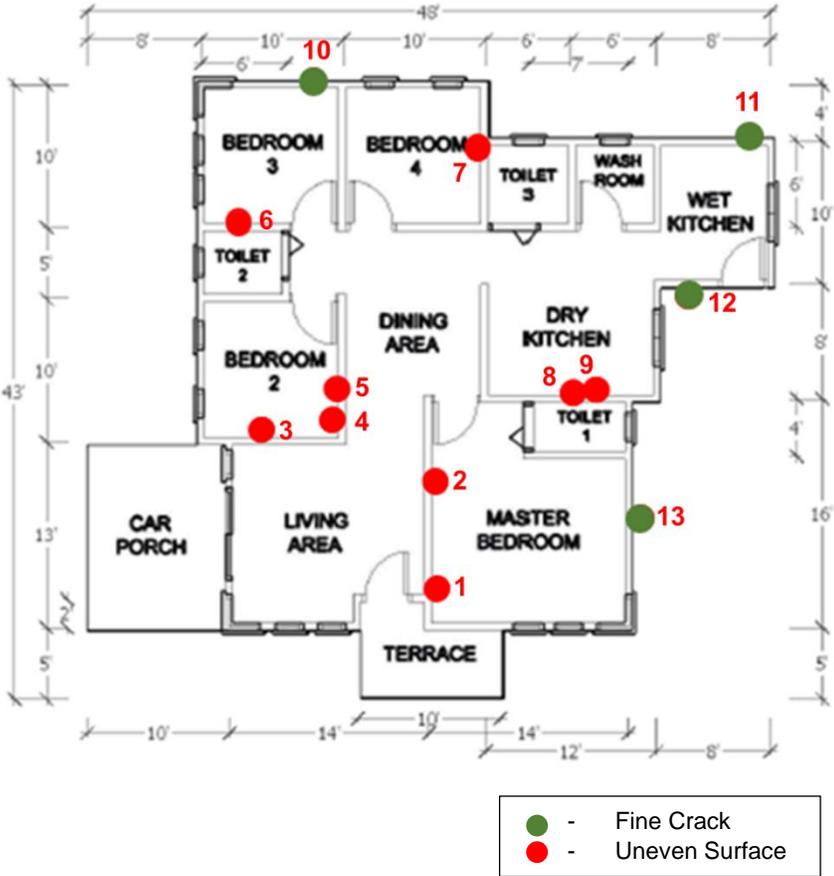
Figure 4.2: Location of Defects For Plaster Work

The third inspection is on the plasterwork of the wall. For this progress of work, there were 13 defects have been found by the inspector. Referring to the figure below, the inspection process found 9 defects which are uneven surfaces labelled with red colour on the internal wall, and another 4 defects are fine cracks on the external wall. This might be happening due to poor workmanship or thermal movement.

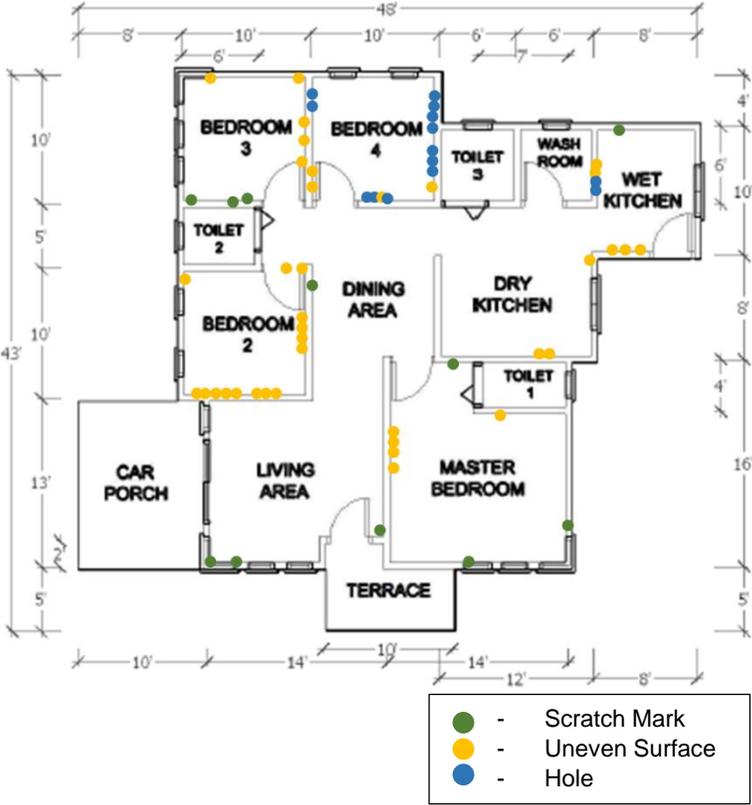
Figure 4.3: Location of Defects For Skim Coat Work

The fourth inspection work is on the skim coat work progress. There were 62 defects found by the inspector. The defects that have been found are uneven surfaces, scratches marks, and bubbles or holes. According to the worker, the uneven surface of skim work is due to the tools that have been used, and scratch on the wall also due to the tools use. For the small hole on the skim coat surface, it might be due to the air bubbles during the mixing process.

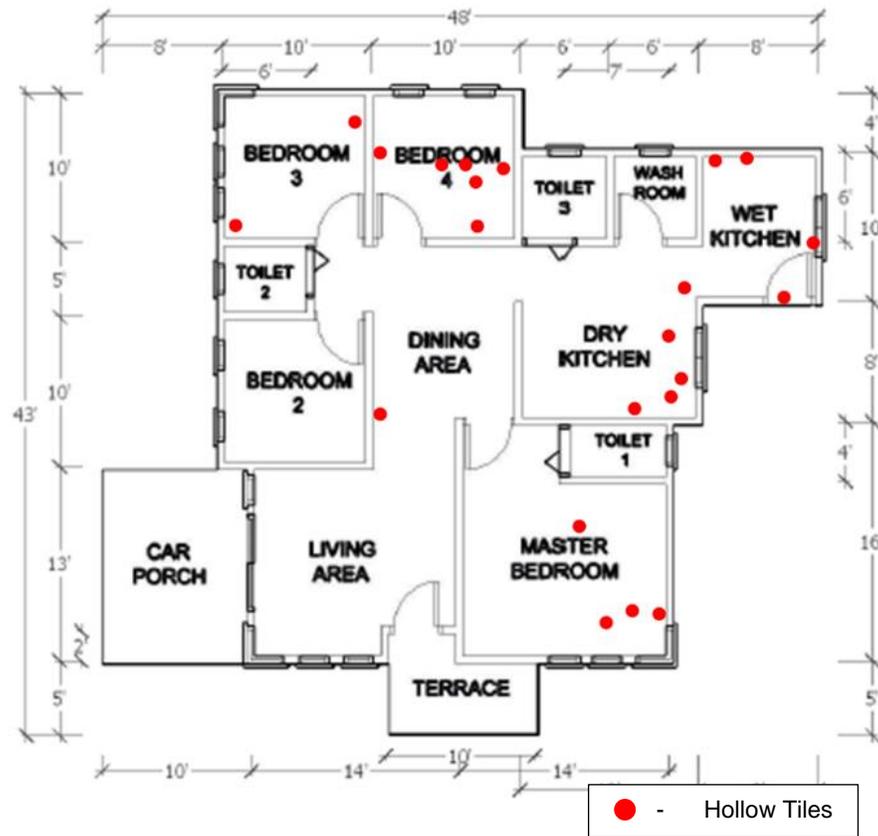
Figure 4.4: Location of Defects For Tiles Work

The next inspection work is on the tile's installation process. During this progress of work, there are 25 defects found on the tiles work which are hollow tiles. Most of the hollow area has been found on the sides and corners of the tiles, but there is only a small hollow area that is within 24mm to 30mm width. This defect occurs might be due to improper installation process or improper mortar mixing. This is because mixing too much water during mortar mixing also will cause evaporation and voids during the drying up process. Therefore, strict monitoring and supervise are required during this process.
