**PRACTICAL TRAINING REPORT**

**RENOVATION WORKS OF JOHOR STATE TOWN AND  
COUNTRY PLANNING OFFICE AT BANGUNAN DATO'  
MOHAMAD SALLEH PERANG, KOTA ISKANDAR.**

**AUGUST 2021 – JANUARY 2022**

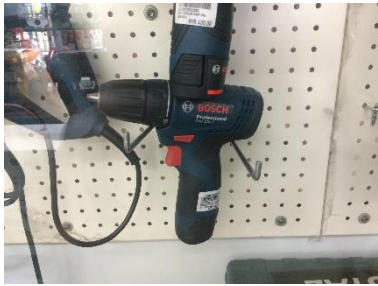
<p><b>Cordless drills</b> are used to remove screws from old furniture sets and to unscrew all vertical blinds in workspaces and officer rooms.</p>
2

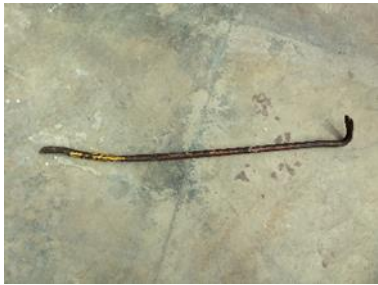
<p><b>Crowbar</b> is used to remove old carpets as well as skirting.</p>
3

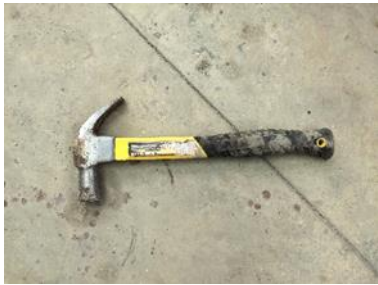
<p><b>Hammer</b> is used to remove any unused nails from old furniture or walls.</p>
4

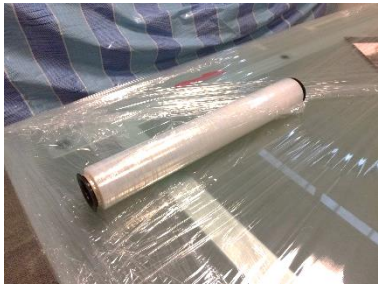
<p><b>Polyethylene sheet roll</b> is used to securely wrap things that will be temporarily stored in the store to avoid breakage and damage.</p>

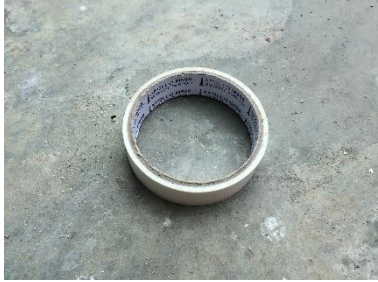
<p><b>Masking tape</b> is used to cover any area that should not be painted, such as door frames, glass windows, ceiling frame and electrical switches.</p>
6

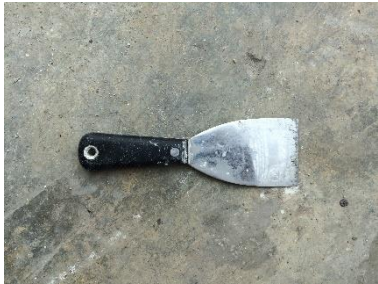
<p><b>Putty knife scraper</b> is used to scrape hardened paint from the ceiling's metal frame as well as uneven cement floor surfaces.</p>
7

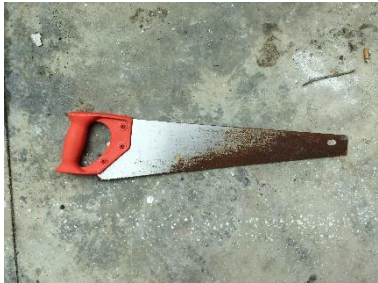
<p><b>Saws</b> are used to cut ceiling boards to specific sizes so that they can be fitted on the ceiling frame.</p>
8

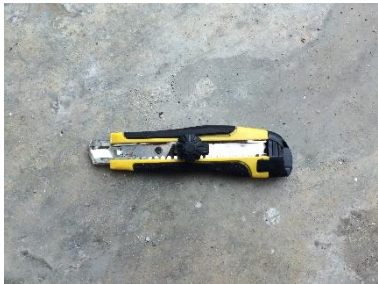
<p><b>Auto lock cutter knife</b> is used to cut old carpets that are trapped in fixed cabinet parts, as well as to cut the carpets into the specific shape of bare floor space so that it can be glued properly.</p>
9

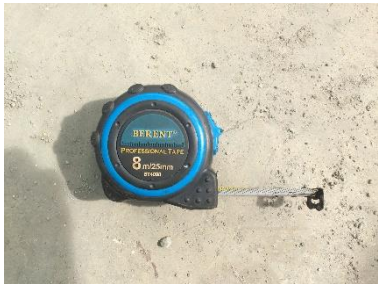
<p><b>Measuring tapes</b> are used to find the length and width on certain areas that needed to be measured.</p>

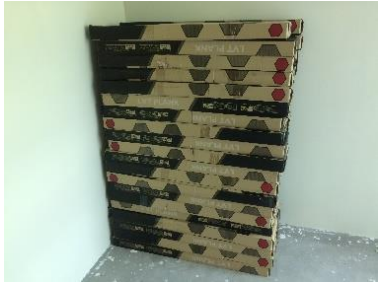
<p><b>Vinyl flooring</b> is used as a new floor finish in workstations and other officer rooms.</p>
16

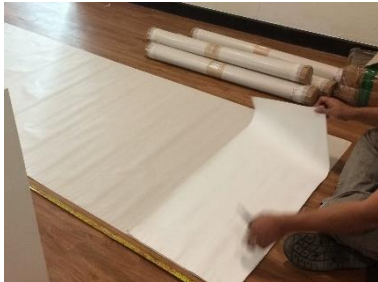
<p><b>Wallpaper</b> is used as a new wall finish in the counter space.</p>
17

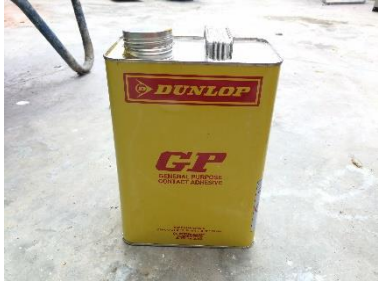
<p><b>Dunlop General Purpose Glue</b> is used to adhere old carpets to the bare floor surfaces in file room and server room.</p>
18

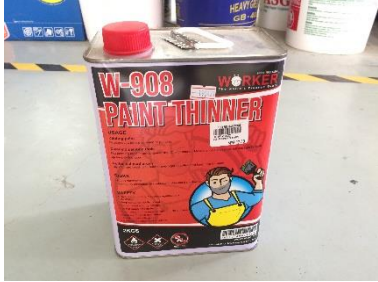
<p><b>Paint thinner</b> is used to remove minor stains, such as smudged paint, on glass windows, skirting surfaces, and other surfaces.</p>
19

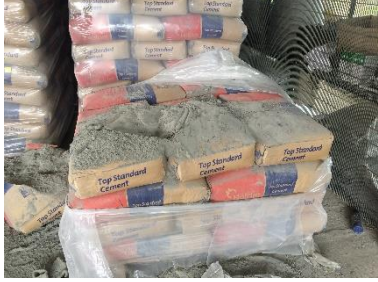
<p><b>Cement</b> is used for perforated or uneven wall and floor scheme works.</p>

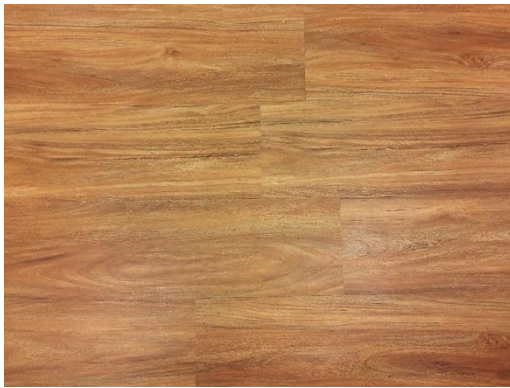
**Figure 3.3.3.1** Vinyl flooring code LA3-6025

According to the client's request, code LA3-6025, as shown in figure 3.3.3.1, must be installed in the workstation and hallway in front of the officer's rooms as well as counter space. While code LA3-2115, as shown in figure 3.3.3.2, must be installed in all officer rooms, *Bilik Solat* and *Bilik Latihan*. From my observations, these vinyl floors are installed using glue-down method. This method requires a steady touch and a lot of patience to achieve a clean appearing installation.

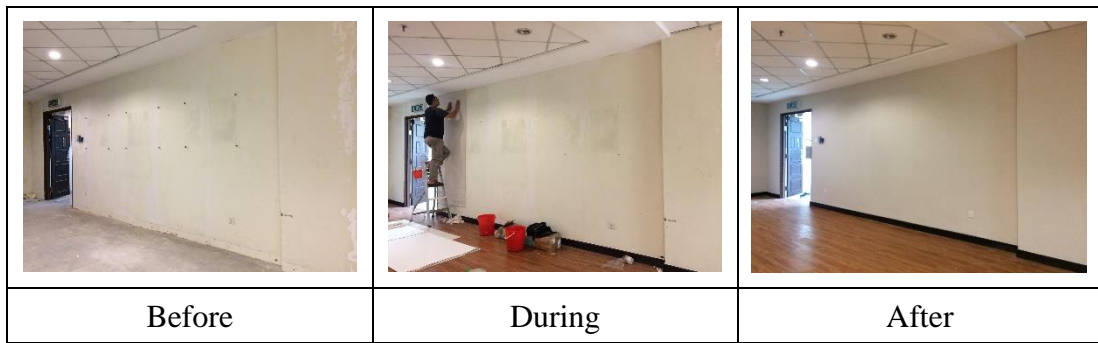
**Table 3.3.3.5** The process of installing wallpaper at counter

The old wallpaper on the counter’s wall was completely removed before installing the new one. It is vital to ensure that the walls are in good condition so that the application looks fantastic and lasts a long time. According to my observations, the workers who are in charged for this job are lightly sanding away any texture of the wall in order for the wallpaper to apply cleanly and with a smooth finish. Furthermore, they were also scrubbing the walls using water, multipurpose soap, and a sponge or rag to remove any dirt or oils that had accumulated. Then, they simply applied an even coat of primer to the walls with a sponge brush and let it to dry completely.

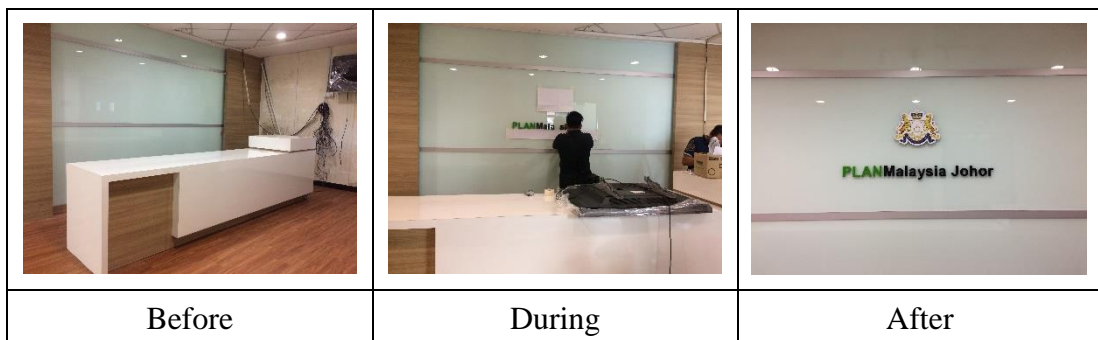
**Table 3.3.3.6** The process of installing the letters 'PLANMalaysia Johor' and the National Coat of Arms logo on the counter's backdrop

For counter space, the letters for the word "PLANMalaysia Johor" made from CLC must be put on the counter backdrop according to the font style, thickness, and height agreed upon by the client. Jomex Global Sdn Bhd is the subcontractor in charge of installing the lettering as well as the National Coat of Arms logo.

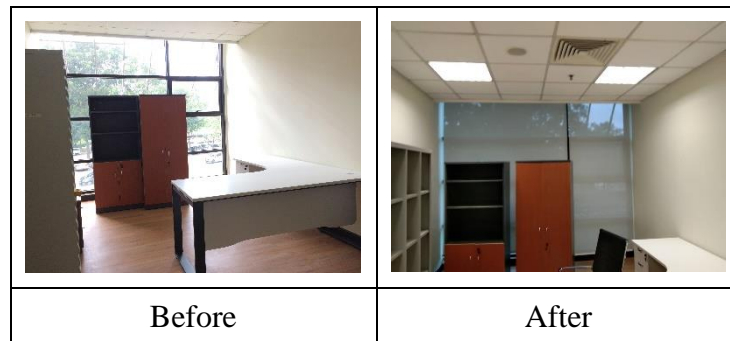
**Table 3.3.3.10** The process of installing roller blind at *Bilik J41* (2)

After all of the tables have been installed, OR Solution is also in responsible of installing blinds on each glass window on level 2. Vertical blinds were originally utilized in this office. However, they have all been replaced with roller blinds. Roller blinds offer better benefits to employees in the workplace because they are easy to operate, can be dusted with little effort, and improve the aesthetics of the office while give enough privacy.

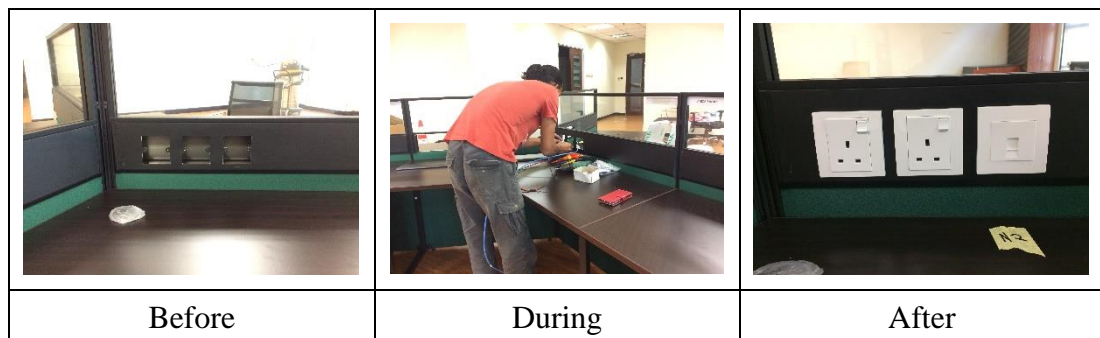
**Table 3.3.3.11** The process of installing electrical sockets on the tables' partition in workstation

The final important installation task is to put electrical sockets on the workspace's table partitions. Sockets enable the interchange of information between processes on the same system or across a network, the distribution of work to the most efficient machine, and the easy access to centralized data. There are three socket holes on the table partition where the sockets must be set. According to my observations, the three sockets installed by the electrical team are two power sockets and one internet socket. Both of these types of sockets are critical to put, specifically in the office.

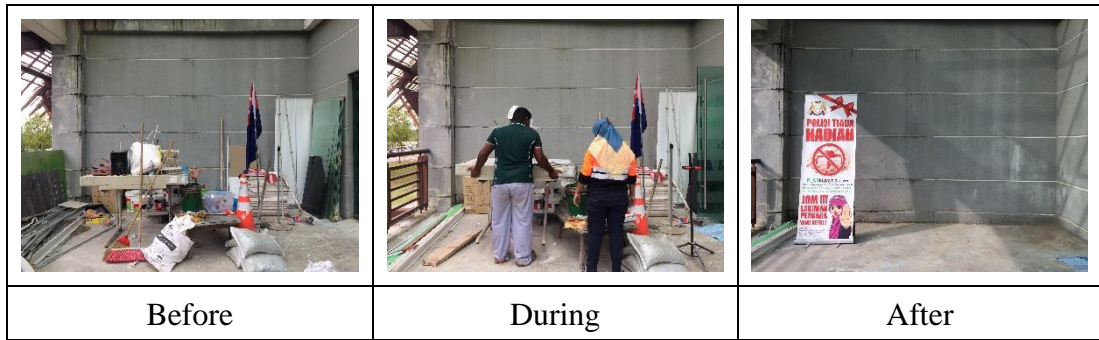
**Table 3.3.4.1** The process of clearing the work site

The final task before handing over the site to the client is cleaning. Sweeping trash or dust, wiping glass windows or other things, and disposing of unused items or equipment into rooro bins are all part of this cleaning and clearing activity. The table below depicts some of the cleaning processes at PLANMalaysia Johor's level 2.

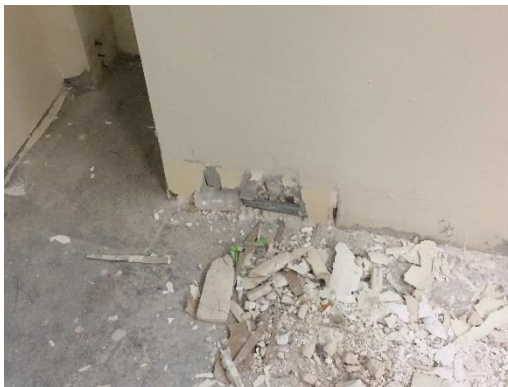
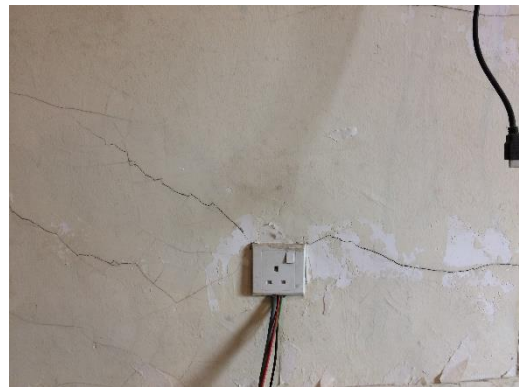
**Figure 3.4.1** Damaged wall paint

**Figure 3.4.2** Crack lines on the wall

During my observation of this site, one of the reasons of cracks that I have noticed is when workers remove old skirting board from the walls which has caused the layer of wall paint and cement on the wall to be lifted together. There are also light crack lines that were previously existed which might have formed prior to the start of the renovation work.

After cleaning the cracks in the wall, the best way to repair them is to fill it with joint compound such as filler or cement mixture. With the scraper, smooth out the surface and let the filling to dry. After the surface has dried, sand it until it is perfectly smooth and even.

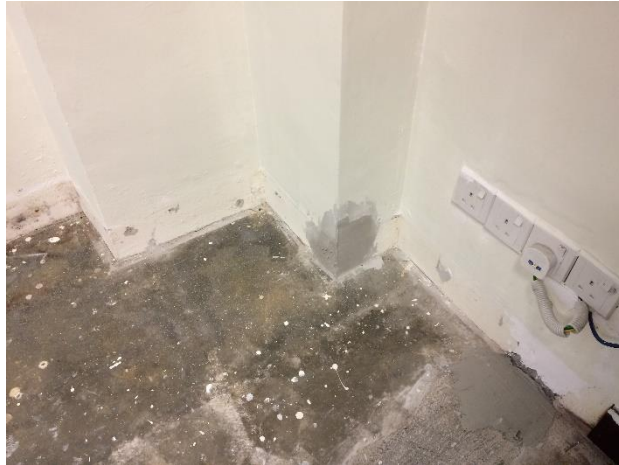
**Figure 3.4.3** Cracks in walls that have been filled with cement mixture

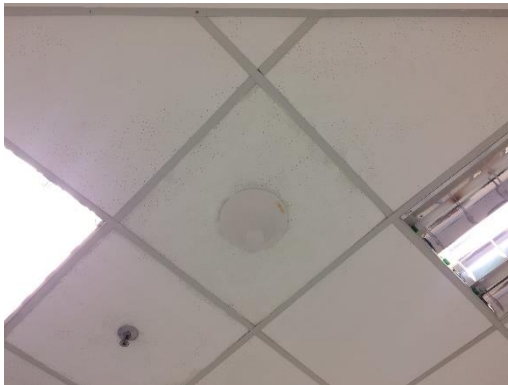
**Figure 3.4.4** Messy paint on ceiling with minor stain on its steel frame

Figure 3.4.4 depicts the appearance of the ceiling after painting without using masking tape on areas that do not require to apply. The paint looked discolored and smudged all over.

Putting masking tape on parts that do not need to be painted, such as door or window frames, steel ceiling frames, electrical switches, and wire casings, is an effective way to avoid such issues. Based on the figure 3.4.5, workers can easily paint with this masking tape on without having to worry about applying in places that do not want to be painted.

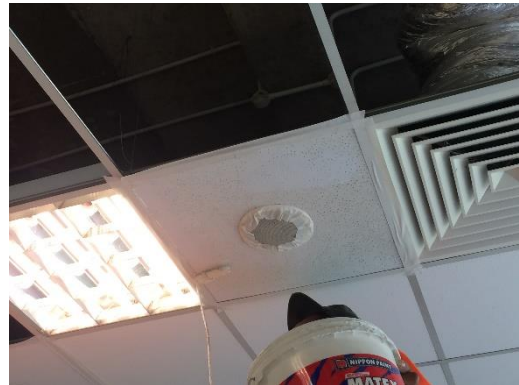
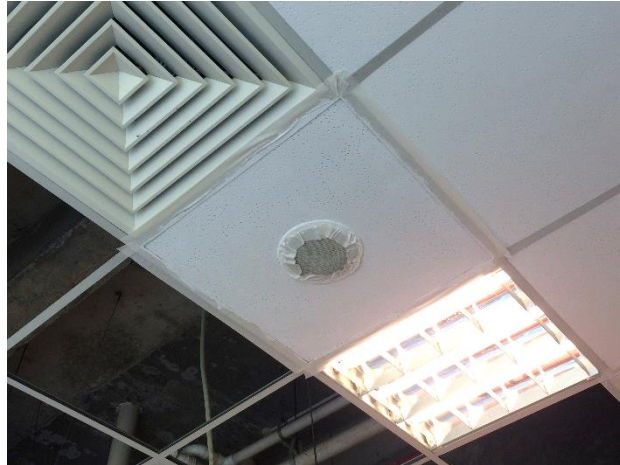
**Figure 3.4.5** Device on ceiling that has been covered with masking tapes

**Figure 3.4.6** The appearance of the ceiling after painting with masking tape on

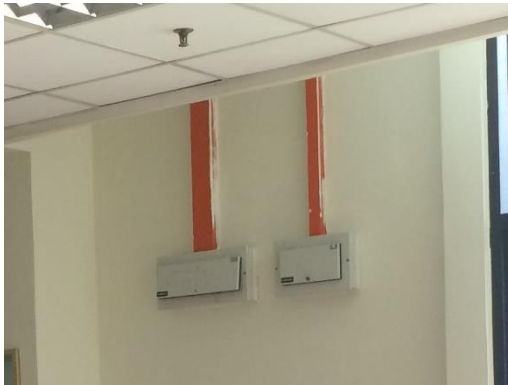
**Figure 3.4.7** Paint stains on wire casing

Paint stains will appear if we do not paint properly. The size of the brush used in painting is also very important. If you're using a wide brush to paint on a tiny surface or vice versa, you will still get messy and uneven paint stains.

As a result, wiping the paint stain on wire casing with paint thinner is an effective technique to remedy the problem of paint stains at an area like figure 3.4.8. Paint thinners can assist in eroding the stained paint until it disappears. Besides, it can also be used to clean the tools and equipment such as paint brushes or paint tray once work is completed.

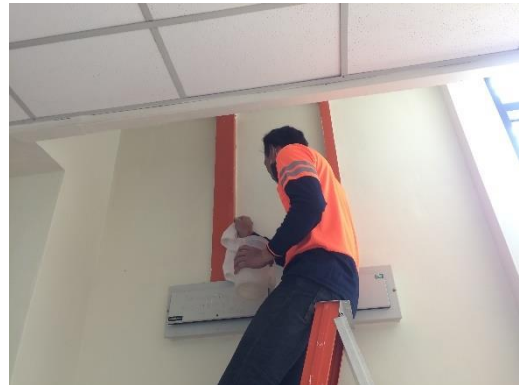
**Figure 3.4.8** Wiping the paint stains using thinner

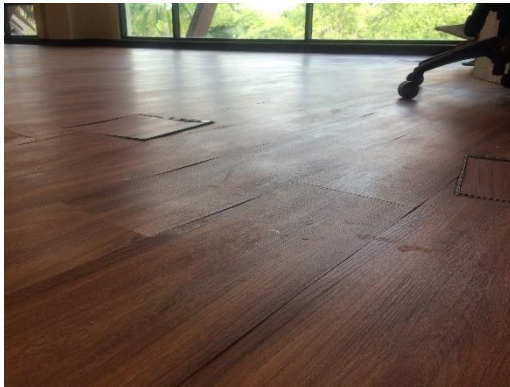
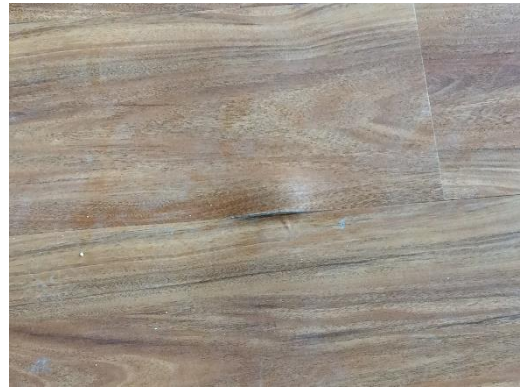
**Figure 3.4.9** The peaked vinyl planks

**Figure 3.4.10** The warped vinyl plank

Vinyl flooring may be easy to install, but they are not without drawbacks. These failures could be attributed to the quality of the vinyl planks, the adhesives used, and the installation techniques used. While inspecting the vinyl floors, we discovered a number of issues. Among them are the peaked and warped vinyl surface, which causes a disturbing sound like there is a gap that is not entirely glued when stepped on.

The solution to this problem is by asking the subcontractors involved in the installation of this finishing floor to repair or replace the new ones and ensure the vinyl floor is laid properly and neatly. One of the ways I identified while they are repairing the vinyl is by scraping or skim the cement floor in order to level the floor surface. This allows the vinyl floor to be easily and flatly bonded.

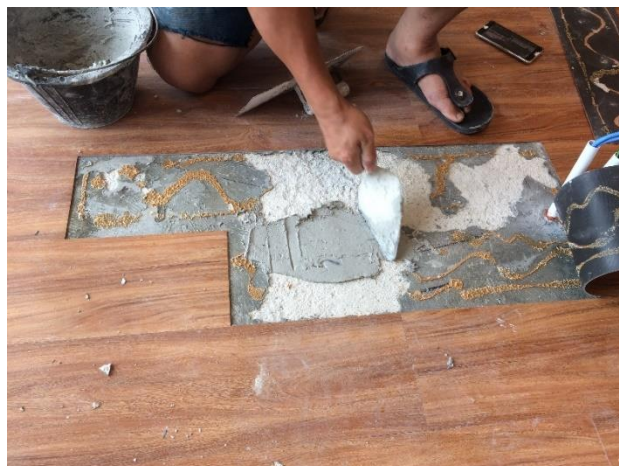
**Figure 3.4.11** Skim work on uneven cement floors

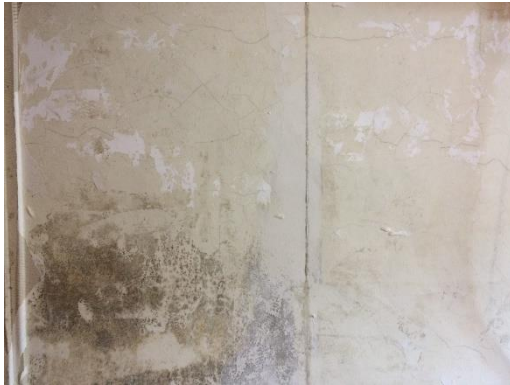
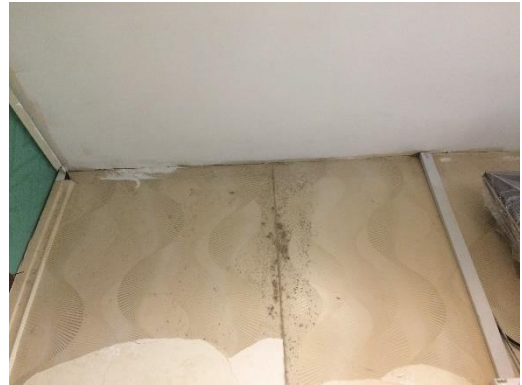
**Figure 3.4.12** The dark and moldy stains on wall

**Figure 3.4.13** The black spots on wall

As we all known, buildings frequently encounter leakage problems. This can happen for a variety of causes, including faulty pipe connections or extreme temperature changes in the pipeline.

The figures above depict the black and moldy stains on the counter's walls. The solution to this problem is to notify management in order to investigate the source of the leak in a specific point, and then inform a plumber the issue to repair the damaged pipe problem.
