**DEPARTMENT OF BUILDING  
UNIVERSITI TEKNOLOGI MARA  
(PERAK)**

**BUILDING STRUCTURAL WORK FOR  
CONCRETE SLAB & COLUMN**

**FEBRUARY 2022**

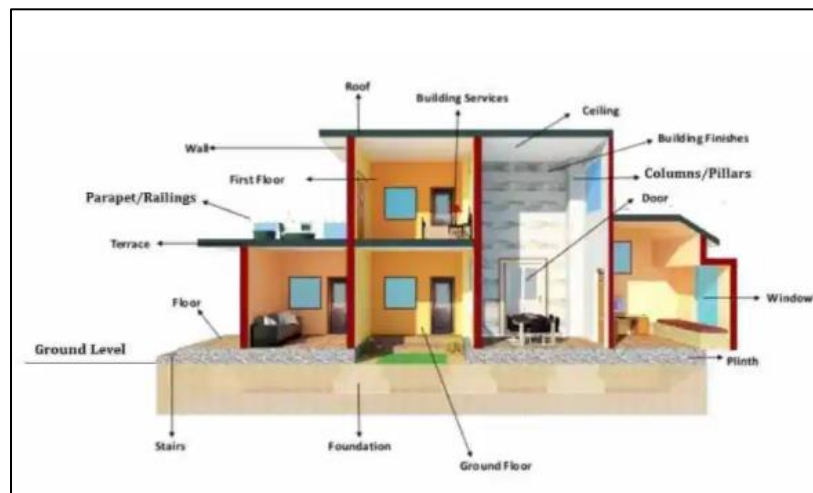
**Figure 1.1: Basic Components of a Building**  
Source: The Constructor (2019)

The basic components of a building structure are the foundation, floors, walls, beams, columns, roof, stair, etc. The purpose of these elements is to support, enclose, and protect the building structure (The Constructor, 2019). Generally building structures are classified as load bearing structure or frame structures depending upon how the load is transferred from various elements of the structure (Rohan Naik, 2019). Besides, trusses, girders, beams and columns of various sections, connectors, and other features are also common in industrial structures. The basic component in the building can be seen in figure 1.1 above.

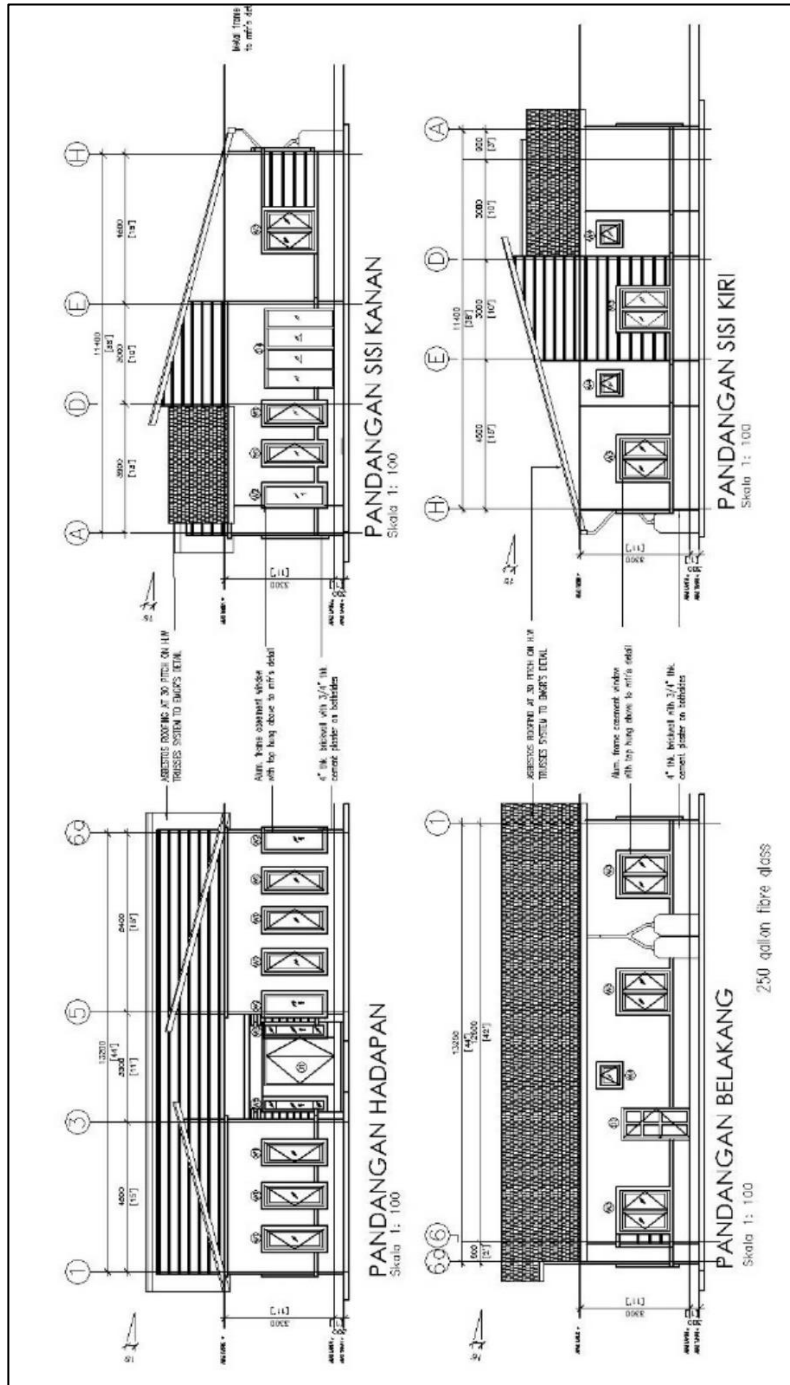
**Figure 3.3: The Elevation of the House.**  
**Source: Hazim Afandi (2021)**

Figure 3.3 above shows drawing plan consists of front elevation, back elevation, left elevation, and right elevation of the house.

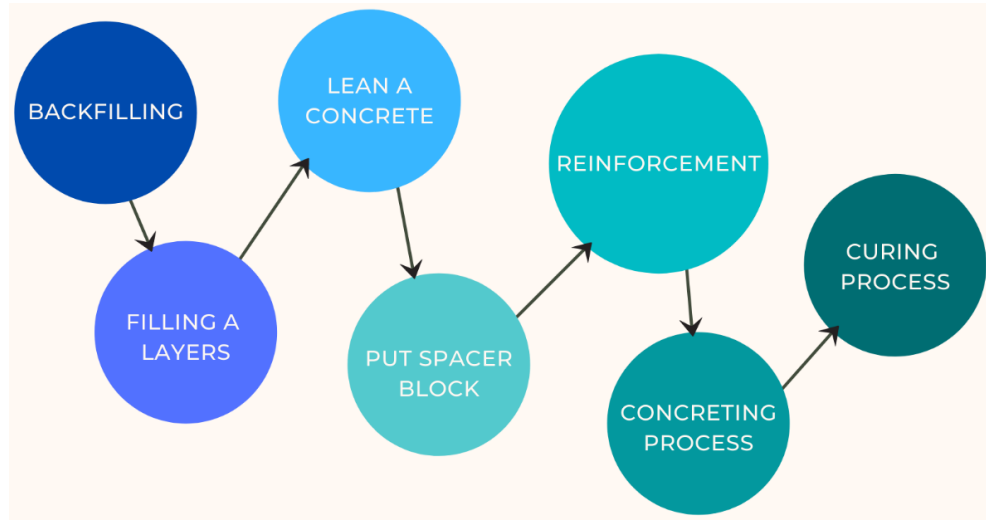
**Figure 3.4: Procedure to Construct Ground Floor Slab.**

A flowchart of the technique for constructing a ground floor slab is shown in Figure 3.4. The step-by-step procedure can be seen in the bubble above.

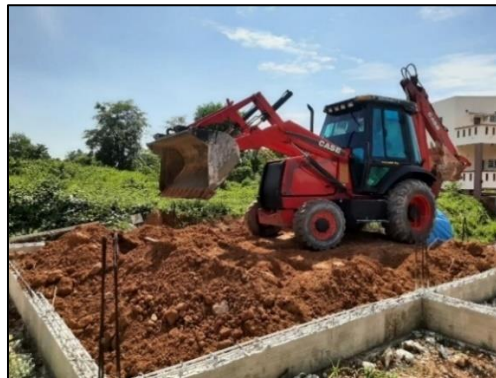
**Figure 3.5: Backhoe Was Backfilling the Soil.**

First and foremost, the soil is lifted and backfilled by the backhoe throughout the slab area using a backhoe as shown in figure 3.5 above. Once all the soil has been placed into the soil area, the workers compacted the soil using a vibrating plate. The work takes two days to backfill and compacted the soil all over the area. Also, it consumes one skilled worker and two unskilled workers.

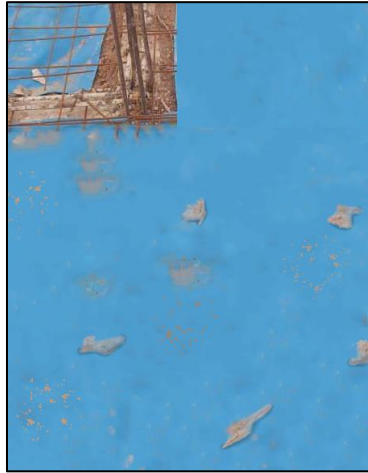
**Figure 3.6: DPM Layered on The Compacted Soil.**

Then, the workers were filled one layer with 150mm thick coarse aggregate, one layer with 50mm sand blinding, and 1 layer of damp proof membrane or as known as DPM, a polythene sheet throughout the house area. It can be seen in figure 3.6 above. The DPM was cut into ground floor area shape size which is 1,479 sq. ft. before it being layered on the compacted soil. The equipment involved wheelbarrow and shovel. The works consumes 2 workers and take one day to cut and filled the compacted soil with layers.

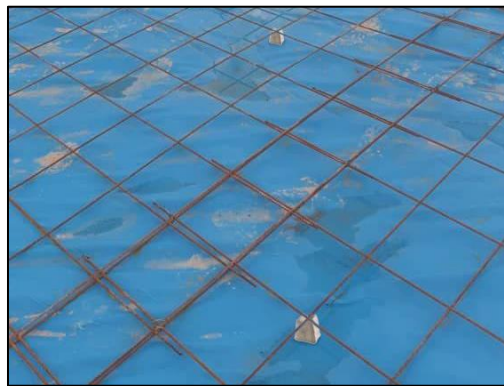
**Figure 3.7: Spacer Block Under the BRC.**

The spacer block then being installed before the workers lay the reinforcement as shown in figure 3.7 above. The spacer block is made of concrete and is necessary in the slab construction process to allow for a spacing between the BRC and the base. The works consumes one worker and take one day to put the spacer block.

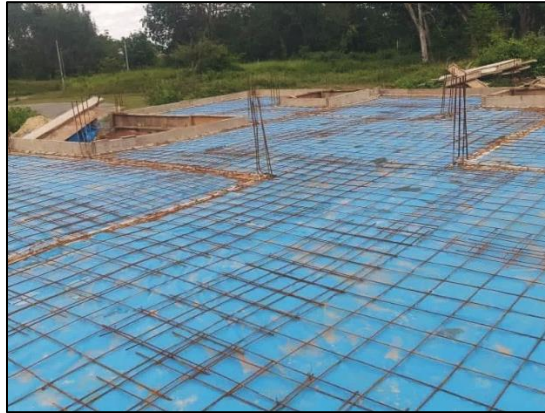
**Figure 3.8: Installed BRC on DPM Layer.**

The workers were installed the BRC reinforcement size A6 on DPM layer and tied the overlapped BRC with a wire. It can be seen in figure 3.8. BRC also had been cut and bend to specific length to ensure the reinforcement can be fit in slab area. The works consumes 3 workers and take one day to cut, bend, and install.

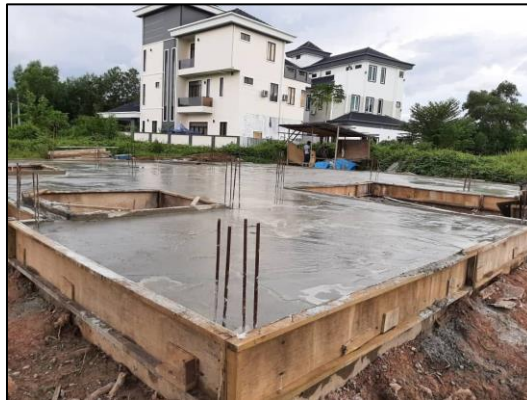
**Figure 3.9: Freshly Poured Concrete.**

There were 16 metre of ready-mix concrete grade 25 had been poured into the slab area using a backhoe. The ready-mix concrete was supplied by concrete mixer truck which was ordered from Macro Dimension Concrete Sdn. Bhd.. The workers then leveled the concrete by screeding it across the top of the concrete forms continuously with a help of other workers who were added or removed concrete in front of the screed while it was being pulled. The screeded concrete can be seen in figure 3.9. The work takes one day to pour and screed the concrete. It consumes four workers.

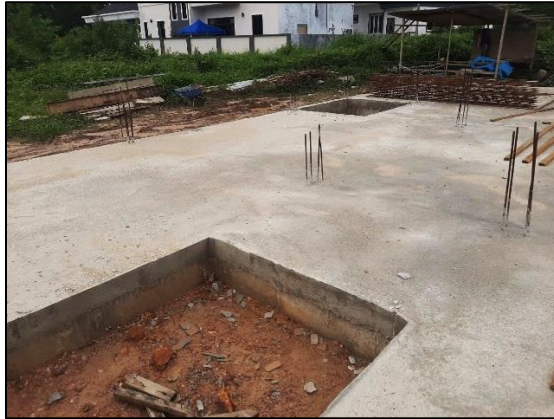
**Figure 3.10: Concrete Slab That Has Been Cure.**

After dismantling formwork process has been done, the workers were curing the concrete slab by draining water on the concrete surface using rubber pipe which carry a water. Figure 3.10 shows the concrete slab that has completed the curing process. Curing the concrete surface helps to prevent it from drying out too rapidly and cracking. The work takes a day to cure the concrete slab and consumes only one worker.

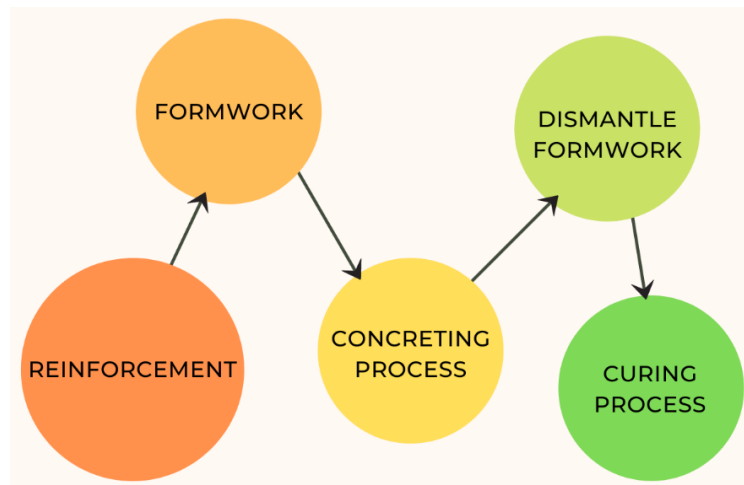
**Figure 3.11: Procedure to Construct RC Column.**

A flowchart of the technique for constructing an RC column is shown in figure 3.11. The step-by-step procedure can be seen in the bubble above.

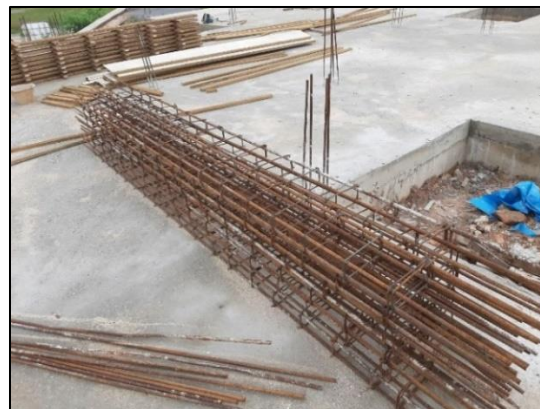
**Figure 3.12: Y12 Steel Bar That Has Been Fastened Together with R6 Steel Reinforcing Link.**

The workers were tied the Y12 steel bar together with the R6 steel reinforcing link using wire as shown in figure 3.12 above. For one column, 4 rods of Y12 steel bar are used, while 16 rods of R6 steel reinforcing link are used. The reinforcement then being installed to the starter bar from column stump. The works duration takes one day and a half to tie and install the reinforcement. It consumes two workers to install the RC column.

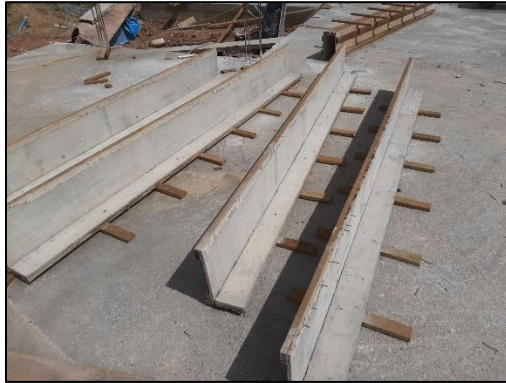
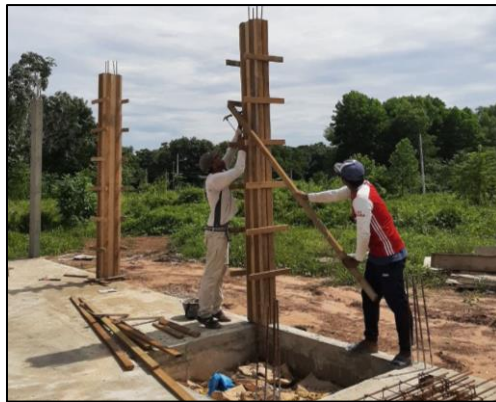
**Figure 3.13: The Column's Formwork That Has Been Form.**

**Figure 3.14: The Column's Formwork Were Installed by the Workers.**

The workers then cut the plywood 11 feet long with stakes using a and installed the formwork. The plywood that had been form can be seen in figure 3.13 above. The plywood nailed it together using a hammer and nails into rectangle's shape in size 4'x 9' as shown in figure 3.14 above. The length of the plywood influenced the height of the column which is 11 feet. The work takes two days and two workers to cut and install the formwork all over the house.

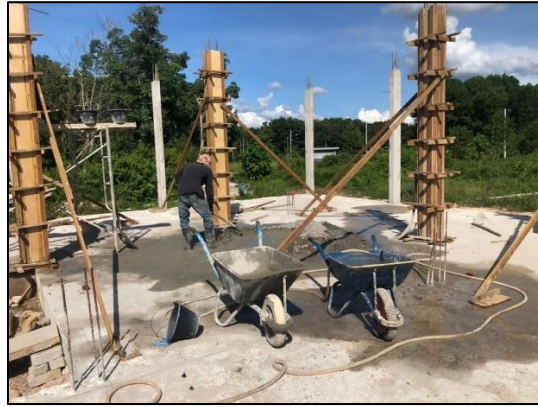
**Figure 3.15: The Concrete Was Mixed by the Worker.**

The workers were mixing the sand, cement, aggregate, and water using shovel to produce concrete grade 25 with the ratio is 1: 1½: 3 mixtures of cement, fine aggregates, and coarse aggregate in which one part is cement, one and a half part is sand, and three part is aggregate as shown in figure 3.15. The concrete is then being poured into the formwork using bucket along with vibrator poker to remove air pocket. The works take two days to mix and pour the concrete. It consumes three workers.

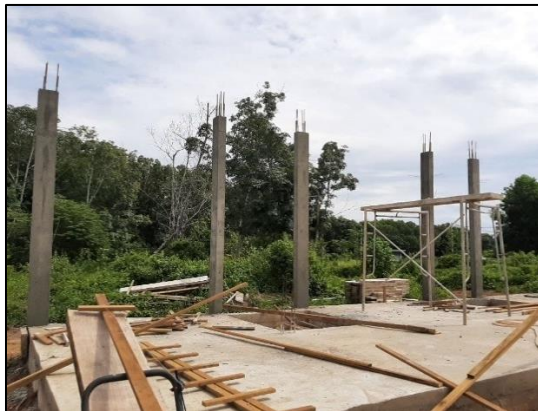
**Figure 3.16: The Column That Has Been Dismantle.**

Since concrete takes 24 hours to 48 hours to be cured, the workers were removed the formwork after 2 days as shown in figure 3.16. They began by removing the nails from the stakes that were holding the forms in position with the use of a hammer. The stakes are then pulled with a hammer's claw as a stake puller to pull the stakes with minimal force to ensure that the stakes or forms are not damaged. The work takes 1 day to remove the form and consumes only one worker.

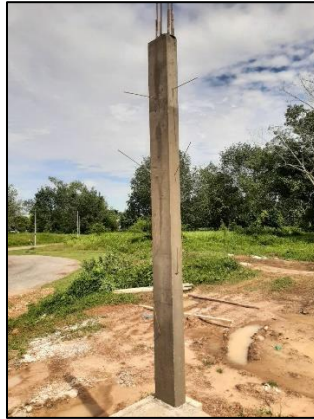
**Figure 3.17: Concrete Column That Has Been Cure.**

After dismantling formwork process has been done, the workers were curing the concrete column by draining water on the concrete surface using rubber pipe which carry a water. Figure 3.17 shown the concrete slab that has completed the curing process. The purpose of the curing process is to allow the concrete to dry fast while keeping moist during the hydration process. The work takes a day to cure the concrete column and consumes only one worker.

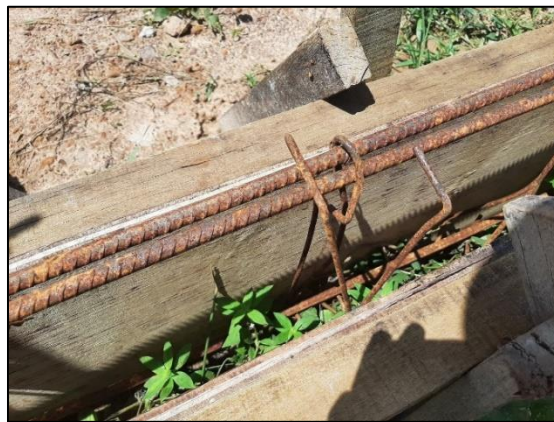
**Figure 3.18: The Reinforcement Link Was Not Tied Properly.**

The first observation that has been obtained is on the ground beam's reinforcement. As shown in figure 3.18 above, it can be seen that the R6 steel reinforcement link did not tie properly together with Y12 steel bar. This is cause of the workers which lack of skill to tie the wire tightly. Ground beam is the core of a building. It carries the load of the building before the load could be transferred on the ground. However, the building will lead to damage since the reinforcement installation work is poor. It's possible that the slab will crack, causing the slab to lose its ability to keep the tiles in place soon. In addition, the building's strength may deteriorate over time.

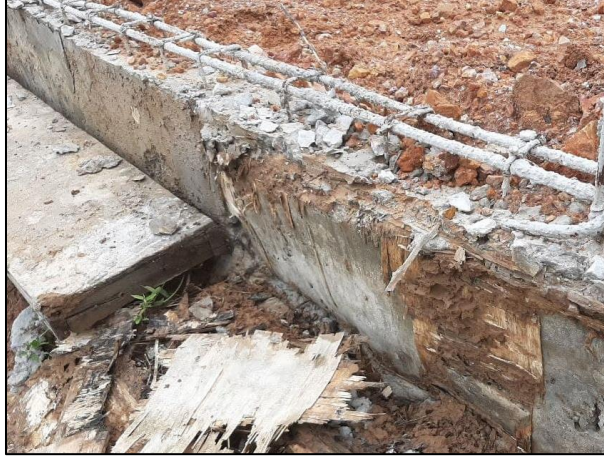
**Figure 3.19: Expanded Ground Beam's Concrete.**

Next, the observation that has been obtained is the ground beam's concrete had found to be expanded after dismantling the formwork. It can be seen in figure 3.19 above. This occurred because the ground beam formwork was not removed in a timely manner and had remained in place for a long time. The weather, which alternated between hot and rainy days, also caused the concrete to expand due to an interaction between the plywood and concrete surfaces with air and water.

As the temperature changes, the concrete expands and presses against adjacent plywood. Concrete is an inflexible substance, so when it expands, it pushes everything around it, causing it to crack. Luckily, the concrete just pushes the plywood and does not crack the concrete, however the concrete had been expanded, making the whole concrete ground beam seem unbalanced.

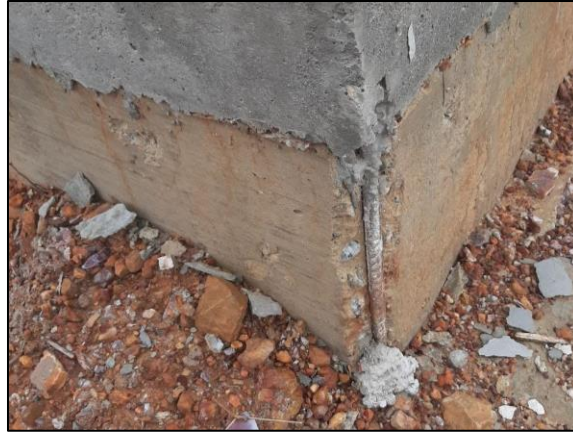
**Figure 3.20: Eroded Concrete of Ground Beam.**

Furthermore, the observation that has been obtained is there is eroded concrete on the edge of concrete ground beam which can be seen in figure 3.20 above. Eroded concrete had exposed the reinforcement of ground beam. This led to building's collapse because the concrete seems to be fragile and easy to erode. This happens as a result of uneven concrete mixing or workers might not remove the air pocket inside the concrete using vibrator poker. The reinforcement also can affect the entire building since it had been exposed. The exposed reinforcement could rust in the future and will make the reinforcement loses its strength and ability to support the load of the building as soon as it will cause the reinforcement to break.

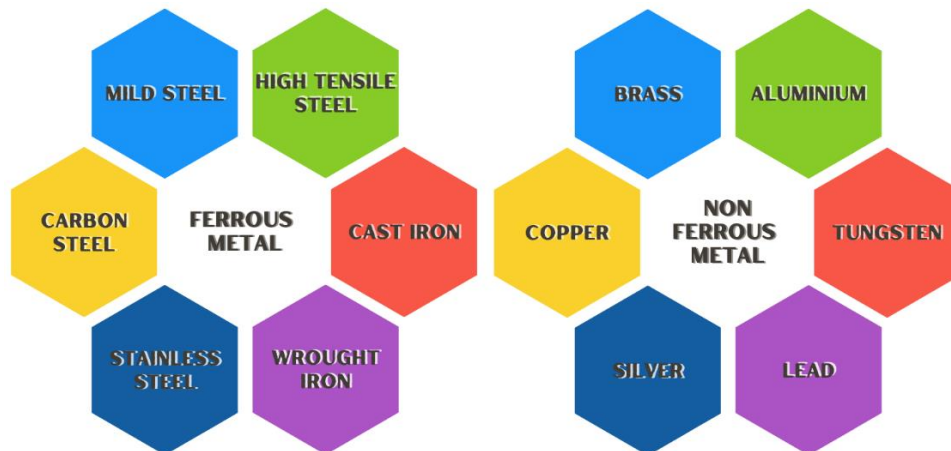
**Figure 3.21: Types of Steel Reinforcement in Metal Categorizes.**

Due to the fact that concrete is strong in compression, it also weak in tension. That is why steel reinforcement should be utilized together with concrete because it is strong in both tension and compression. Also, it can prevent and minimize concrete cracks under tension stresses. The structural element will be designed so that the steel resists the induced tensile and shear forces while the concrete absorbs the compressive forces (The Constructor, 2018). There are several categories of reinforcement that are commonly used in this construction industry. The steels involved are shown in the figure 3.21 above.

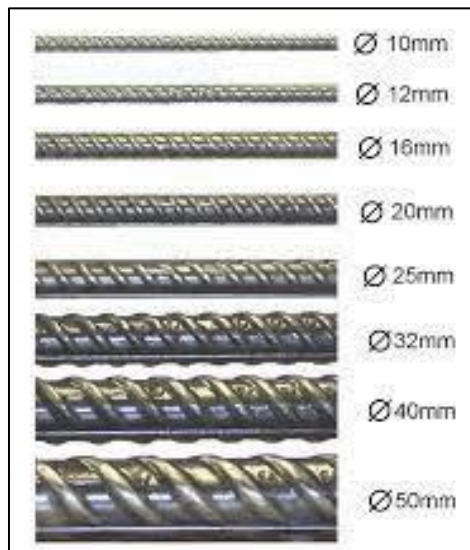
**Figure 3.22: List of High Tensile Steel Sizing's.**

In order to construct a column of a building, high tensile steel is the best choice because of its strength. High tensile steel bar commonly known as Y and has various size such as Y10, Y12, and Y16. The list size of high tensile steel is illustrated in the figure 3.22 above. Y is stand for types of reinforcement and the following digit number is a thickness of the steel bar in unit millimeters (mm). 16mm is a maximum size of high tensile steel bar used in constructing a house. In this project, Y10 is suitable to use in constructing a column since the area of the house is not too big and sufficient to support the load of the building. However, the client request to use Y12 for his house. The overall house costed 25 column that consists of 4 bars of Y12 each RC column.

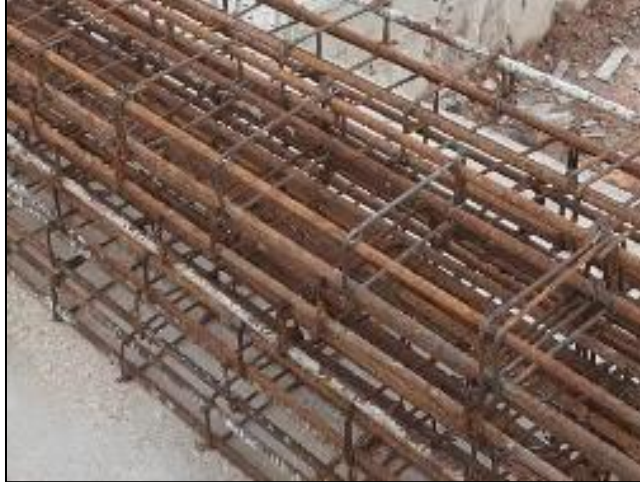
**Figure 3.23: R6 Steel Reinforcing Link Bonded Together with Y12 Steel Bar.**

The bars are then being knot by mild steel bars, R or known as steel reinforcing link. For this study, R6 was used to tie up the Y12 steel bar which can be seen in figure 3.23 above. R6 refers to the thickness of the mild steel bar itself in unit millimeters (mm) which is 6mm. Each RC column required 16 rods of R6 steel reinforcing link with 200mm x 500mm dimension and 6 inches interval length tied together with 4 bars of Y12 using wire. The dimensions of R6 steel reinforcing link were bent by the bar bender. The rods are first cut into many parts in 1600mm length. Then, the bar bender will be bending every part of rods that had been cut into the following dimension which is in 200mm x 500mm. When it has formed a rectangular shape, the free ends of the rods or called as stirrups will be bent at 90 degrees in two-legged stirrup types to prevent them from opening during strong earthquake shaking. Stirrup are anchored to the anchor bars (hanging bar) or the compressive reinforcement in the compression zone of the column (TeamCivil, 2020).

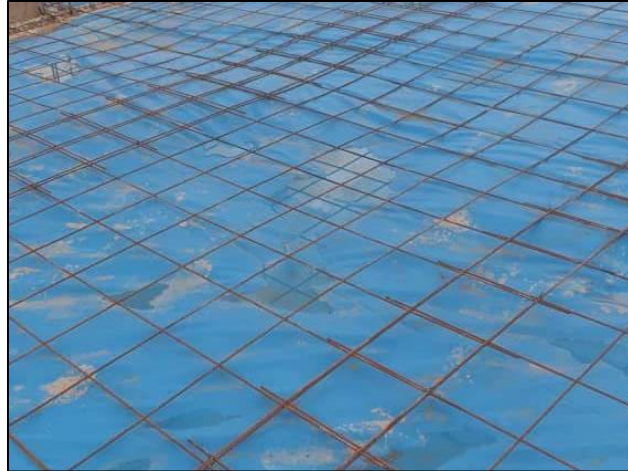
**Figure 3.24: Installed BRC on DPM Layer.**

There is various size for BRC, however size A6 were used in constructing the case study house which can be seen in figure 3.24 above. “A” in A6 size refers to types of main wire used and “6” refers to its thickness of the main wire in unit millimetres (mm) which is 6mm. The spacing for main wire in size A6 is in 200mm. BRC in A6 size were used because the slab area was in small to medium size and sufficient to carry a load of the building. The overlapped BRC were tied together with a wire.
