**DEPARTMENT OF BUILD OF ENVIRONMENT STUDIES AND
TECHNOLOGY, UNIVERSITI TEKNOLOGI MARA
PERAK CAWANGAN SERI ISKANDAR**

HOUSE RENOVATION

**FACULTY OF ARCHITECTURE, PLANNING AND SURVEYING
UNIVERSITI TEKNOLOGI MARA PERAK CAWANGAN SERI ISKANDAR**

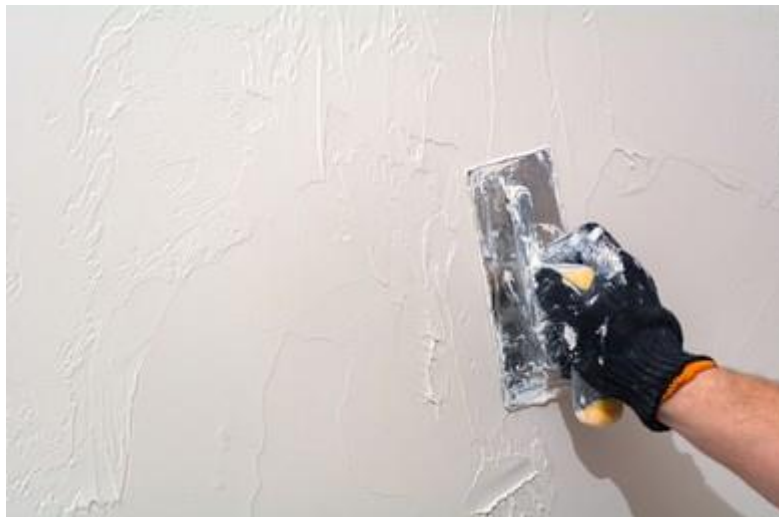
Figure 3.2.1 above shows plastering the wall

3.2.3 The method of wall plastering

For the internal wall, the area where the plastering will take place will be cleaned. The off lines to brick walls set out on floors will be used to install level pegs on walls. (Using a nylon thread and a plumb bob in the centre.) Before applying mortar to the brick walls, they will be moistened. On areas where the required mortar thickness exceeds 25mm, a first coat mortar filling (1:4 Cement and Sand) up to 15 mm will be applied. To obtain a semi-rough finished surface, the walls and columns will be plastered using a 1:4 cement and sand mixture.

The vertical junction of structural columns / walls & brick walls will be handled by securing 200mm wide mesh to the vertical wall joint using wire nails / concrete nails and aligning the mesh. Joints between walls and beams will be made up to a maximum of 20mm and sealed with a flexible filler that is fire rated for 30 minutes. (Material descriptions will be submitted to the Engineer for approval). Internal plastering will be applied to concrete columns, beams, and walls that are aligned with brick walls, and other concrete surfaces will be coated with cement base simple plaster. (Material descriptions will be submitted for the Engineer's approval.)

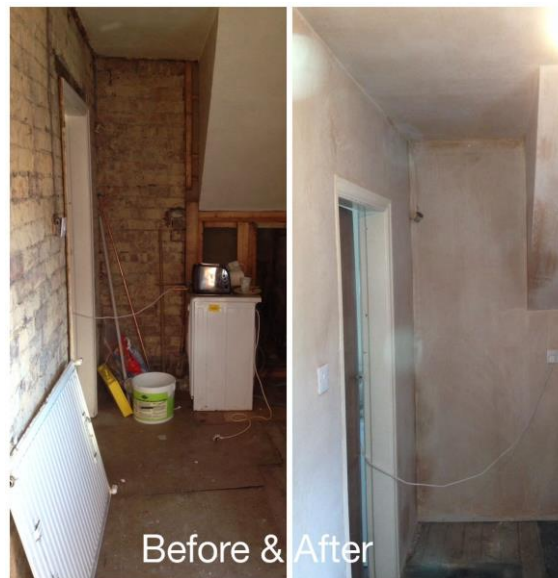
Figure 3.2.2 above shows before and after plastering.

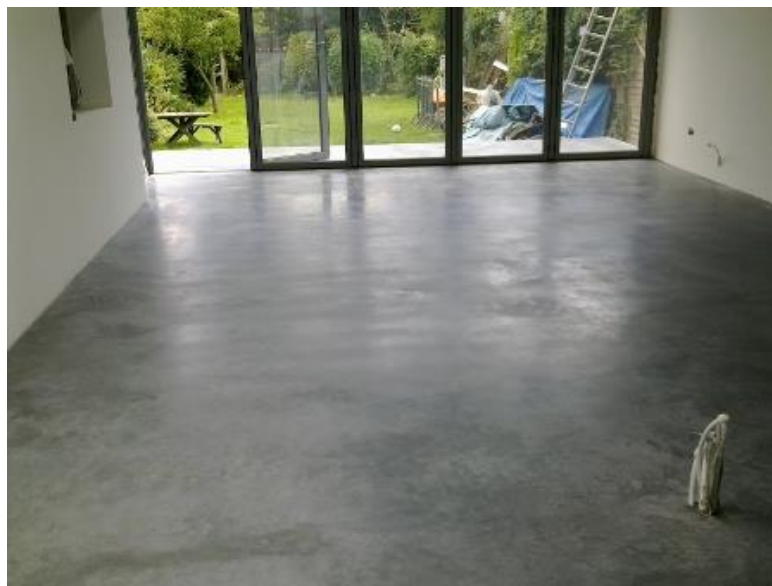
Figure 3.3.2 above shows the concrete floor.

The floor used is concrete floors. Concrete floors have various advantages, including strength, stiffness, span, fire resistance, acoustics, maintenance, and lifespan. A concrete floor consists of a flat slab of concrete that is either poured in place or precast in a factory. Reinforcing steel, often known as rebar, is a steel bar or mesh of steel wires used to reinforce concrete. Rebar is used to compensate for the fact that, while concrete is strong in compression, it is weak in tension. Rebar can carry tensile loads and hence improve overall strength by being placed into concrete.

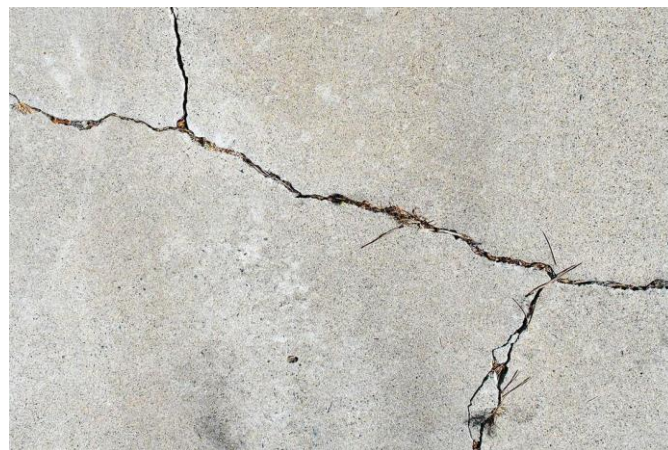
Figure 3.4.1 above shows hairline crack.

Cracked and discoloured plaster are two prevalent concerns in wall plastering. Hairline cracks, settlement cracks, and delamination cracks are three types of fractures that can occur in this case study wall plastering. A thin hairline crack is a small crack that might detract from a home's look. To avoid this, the labourer in this case study made sure that the amount of sand in the lime plaster mixture did not exceed 3 trowel scoops, and that he did not use very fine sand because it requires more water and can cause future cracking. If this type of crack resurfaces in the future, it can be repaired by filling holes or cracks with a lime-based putty and rubbing the filler with sandpaper to get a smooth surface.

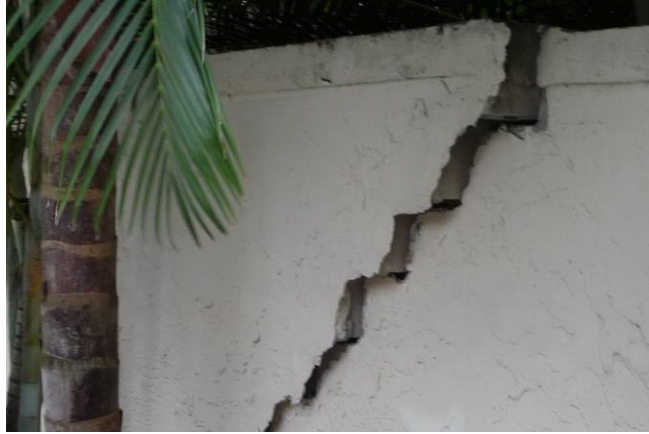
Figure 3.4.2 above shows settlement crack.

Settlement cracks are most common when a house is being renovated. These cracks are characterised by groups of cracks that run in the same direction and should be watched since they are structural fractures that require professional assistance. Large variances in foundation settlement induced by variable soil and loading conditions are likely to generate this sort of crack. The delamination crack indicates that the plaster behind it is moving away from the wall or ceiling stud. There is a risk of the plasterboard falling if these fissures run parallel to both ceilings and walls. As quickly as feasible, these should be repaired or replaced.

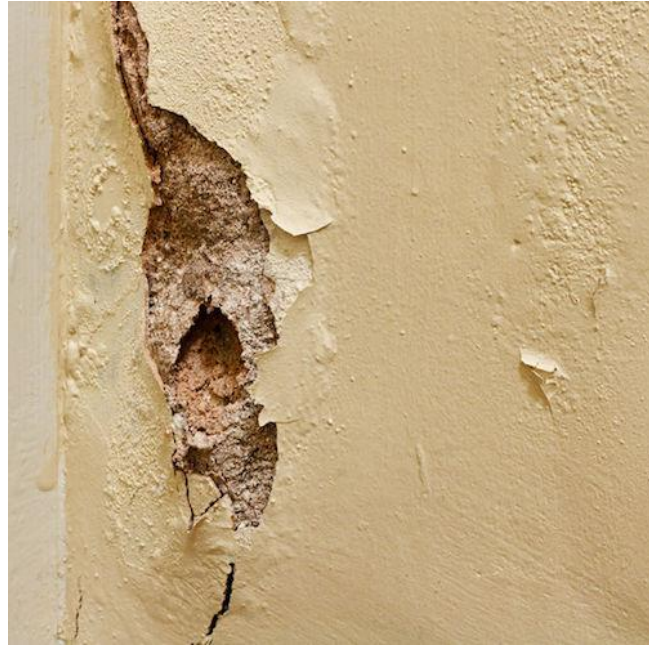
Figure 3.4.3 above shows delamination crack.
