**DEPARTMENT OF BUILDING
FACULTY OF ARCHITECTURE, PLANNING AND
SURVEYING
UNIVERSITI TEKNOLOGI MARA
(PERAK)**

**CONSTRUCTION AND MAINTENANCE OF PUBLIC
FACILITIES:
BUS STOP**

**PREPARED BY:
ZAIDATUL SALWA BINTI HASSAN
2019279432**

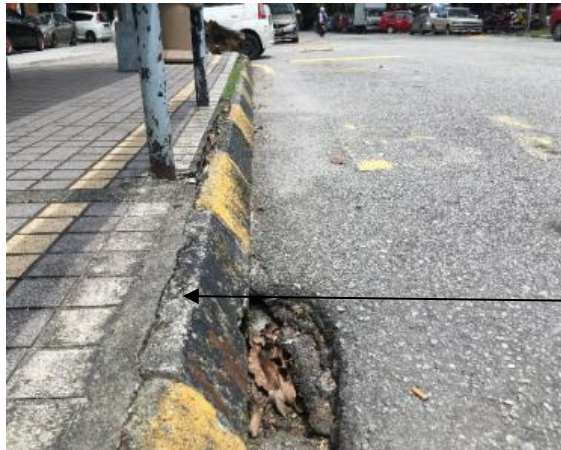
Efflorescence

1. Efflorescence.

The formation of salt deposits on the concrete surface is referred as efflorescence. The colour of formed salts is often white. It is caused by the presence of soluble salts in the water used in the concrete mix. When the concrete hardens, these soluble salts are lifted to the top surface by hydrostatic pressure and salts deposits accumulate on the surface after complete drying. The pictures below show the efflorescence on the site.

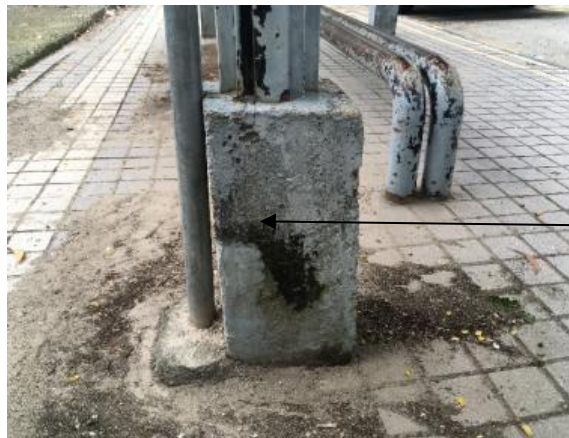
2. Mould on Concrete Stump.

Condensation can form on the cool surface of a concrete wall when the temperature drops. This increased surface moisture eventually generates an environment suitable to mould growth. Mould development on concrete caused by dampness is often broad and widespread.

Figure SEQ Figure * ARABIC 4 shows the mould growth on the stump's surface.

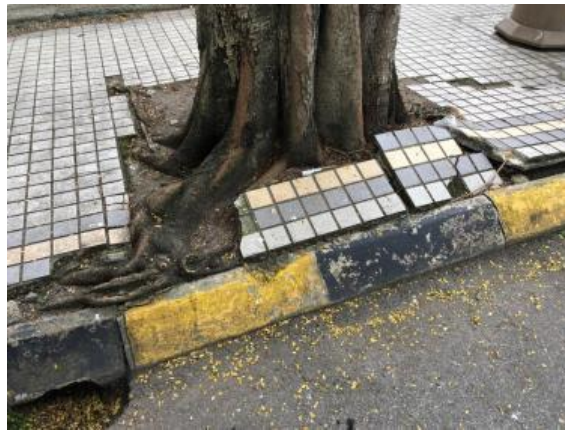
3. Cracking Finishes Tiles.

Cracking floor tiles were discovered is one of the problems when examining the site. An uneven surface caused by extensive tree root growth is a major cause of the tile finish cracking. Tile flaws occur as a result of faulty installation techniques or materials that are not suited for the tile surface.

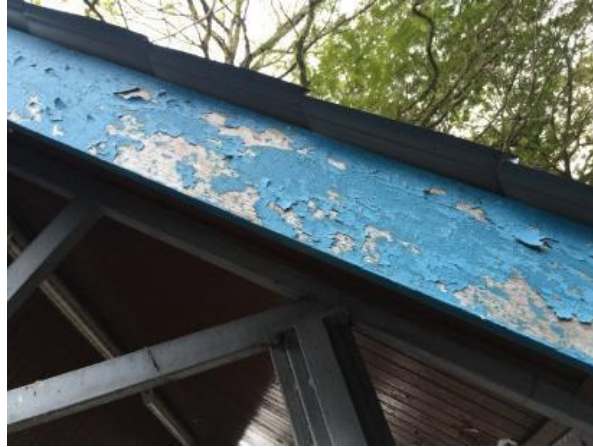
4. Blistering and Peeling Paint.

Blistering and peeling are flaws caused by expansion of the paint film. The swelling is caused by the creation of an air bubble beneath the paint film as a result of the presence of moisture, oil or grease.

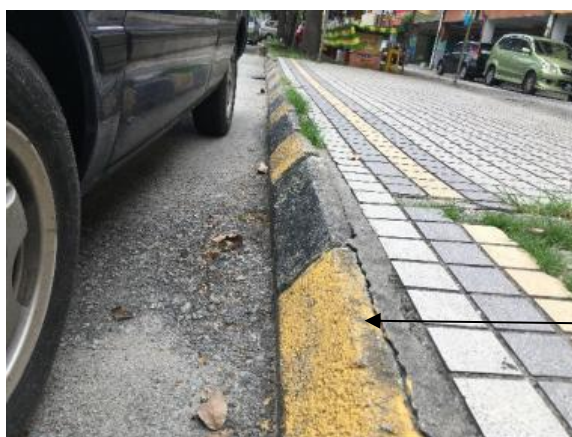
Faded Painting

5. Faded Painting.

Faded paint occurs when the surface is exposed to sunshine and begins to fade faster than intended. The sun's high quantities of ultraviolet (UV) radiation have a significant impact on paint pigments, making them susceptible to variety of painting issues, including fading. Second, a quick shift in temperature is a significant role in fading too. The higher the temperature fluctuations that surround a kerb surface, the greater the stress on the paint system, which accelerates the paint breakdown.

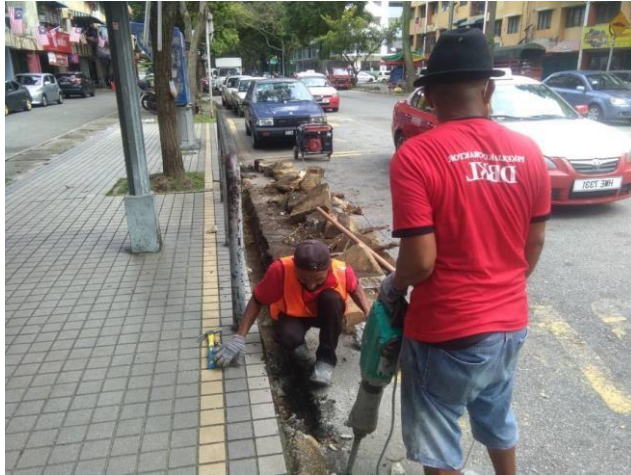
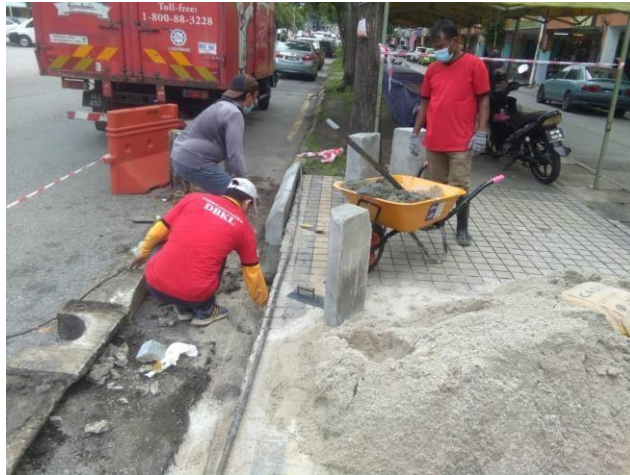
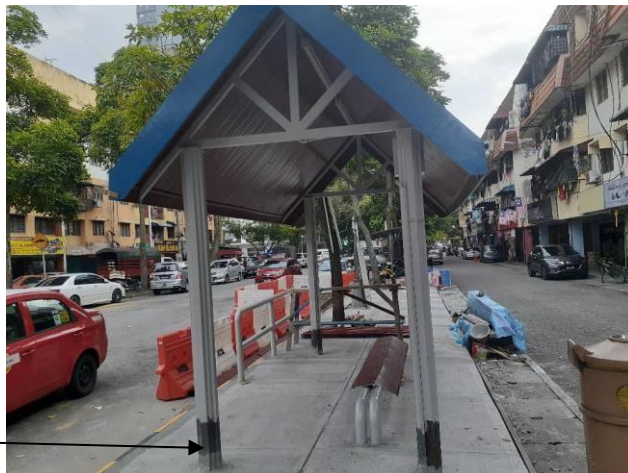
Stumps had been removed

1. Site clearance.

First, excavate and break up the existing kerbs, then install new kerbs in their place. Then, cut, break and clean all tiles before re-levelling the floor according to the broom finish requirements. Finally, existing unreinforced concrete such as stumps need to be dismantled or disposed of.

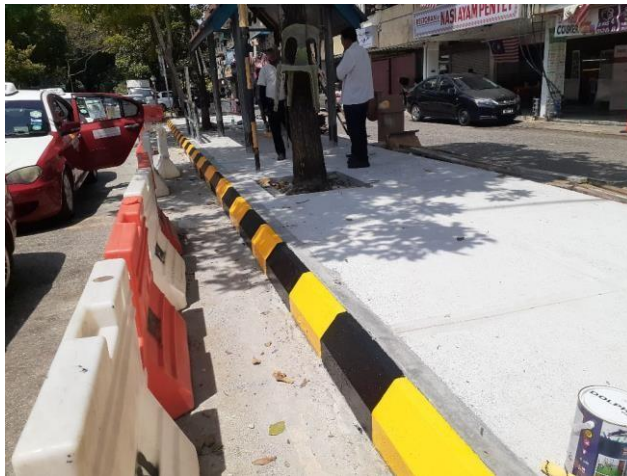
2. Concrete works.

After all the tiles had been removed, the installation of steel reinforcement (BRC) and pouring and compacting of concrete mix 1:2:4 (grade 25) are completed in accordance with specification. Then, poured 30mm cement and sand (1:3) screed over the concrete with a broom finish.

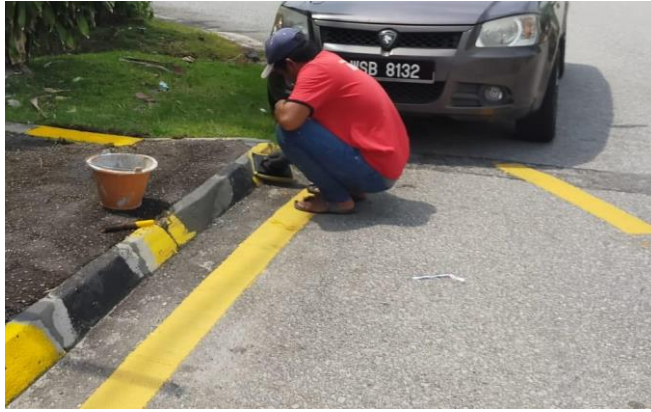
3. Painting works.

Scraped the paint on fascia board, wooden, kerb and steel structures. After that, wash, paste the cracked areas, and putty to prepare for new paint. On plastered surfaces, wood, and metal, apply one coat of cement-based paint (undercoat). Then dab a layer of 'primer' red oxide or chromate over the iron's surface. Apply two coats of 'weather shield' type exterior mixture paint on the plastered surface, followed by two coats of 'gloss' on wood and metal surfaces.

Figure 12 shows the worker is painting the kerbs.

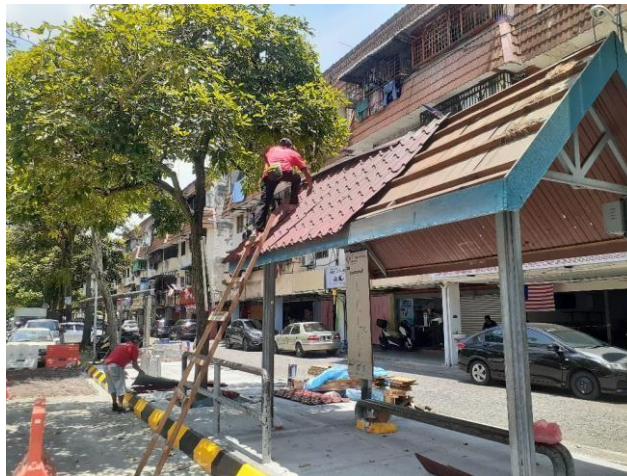
4. Roof structure maintenance.

Demolished the roof structure section and rebuilt with the new metal deck SWG 30 type of roof and rafters. Then, install the new fascia board with the size of 25mm x 200mm.

Figure 13 shows the demolishing of roof structure.
