**DEPARTMENT OF BUILDING
UNIVERSITI TEKNOLOGI MARA
(PERAK)**

**WORKPLACE SAFETY INSPECTION AT PROJECT SITE OF
RENOVATION AND MAINTENANCE WORK**

This study is carried out to investigate the safety in building renovation and maintenance work which located at the A341 Building. The project is built at BASF Petronas Chemical Sdn. Bhd. Jalan Gebeng, 26100, Kuantan, Pahang. Consequently, the intent of this inspection is to learn more about the health and safety in the renovation workplace, maintenance work, and piping system. In order to focus on the project safety and health, Hazard Identification (HI), Risk Assessment (RA), and Risk Control (RC) are important throughout the practical is being carried on.

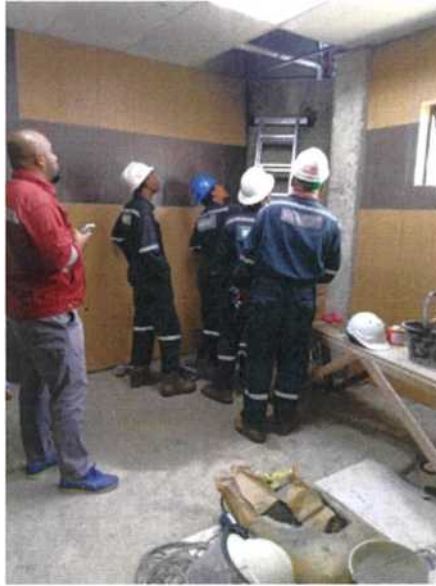
Figure 3.2 Inspection by Safety Officer during plumbing work

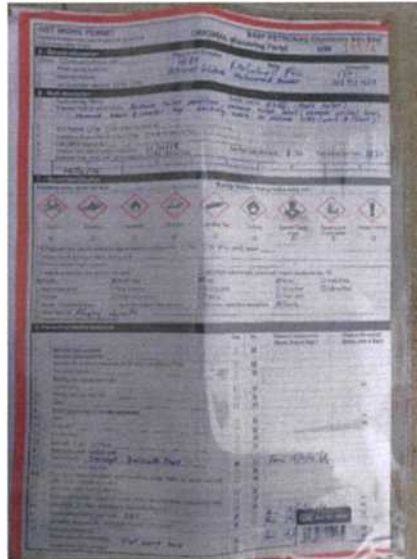
Figure 3.3 Hot work permit

Permit to Work (PTW) was a key part of managing work activities that have inherently higher risks or unique aspects that could lead to a higher level of risk than routine or daily

work activities. It was supported by management policies, procedures, and processes to regulate all work activities and manage risk. Encik Anwar as a PTW receiver and Civil Engineer was responsible for implementing the control and safety precautions. This permit was checked and fill in before the work started.

The issues contributed towards major hazards were wrong information about work required on the work permit, failure to hand-over plant in a safe condition on completion of work or canceling of work permit. Wrong location or relocation was one of the hazards associated with which multiple hazards exist in moving existing equipment, furniture, and personal effects.

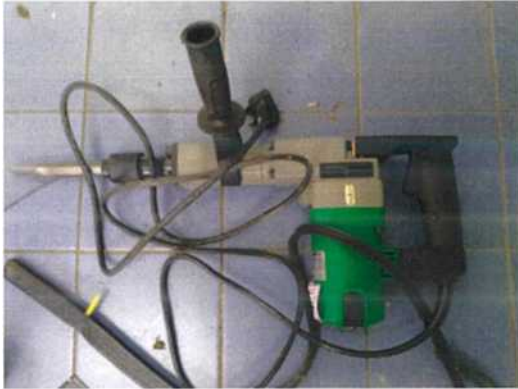
Cordless drill, impact drill, extension cable, grinder, and ladder were often used during renovation work. The type of hazard was an electrical hazard. Electrical hazards will exist during hacking work, remodeling, and construction phases of the project.

Figure 3.4 Impact Drill

Function failure was one of the potential hazards because the tools and equipment were not to be inspected and approved by STM (E & I) with color-coding. Plus, the ladder also not inspected and approved by BPC Health, Safety, and Environment which was one of the caused of risk to the workers. Safety Officer of BASF Chemical Sdn Bhd has checked all the tools twice a week

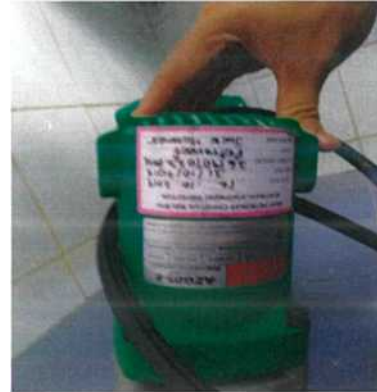
Figure 3.5 Impact Drill Sticker

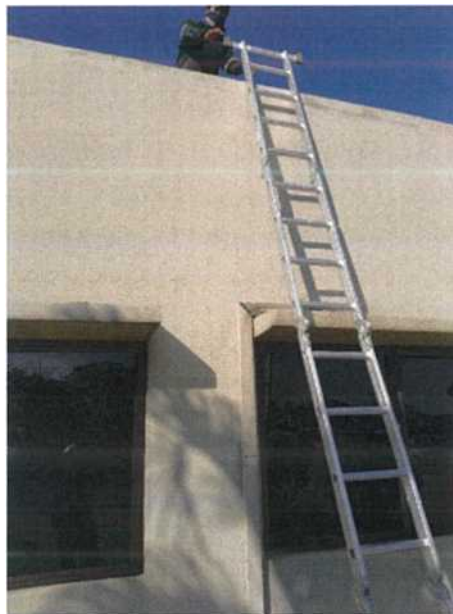
Ladders were often used in renovation and maintenance work and probably potential hazards might happen during work. Ladders were another source of injuries and fatalities among workers during re. There were some injuries and fatalities due to falls on ladders used in work. Nearly half of these injuries were serious enough to require time off job.

Figure 3.6 Ladder

The correct ladder was used for the task. The competent person visually inspected a ladder before use for any defects such as grease, dirt and other contaminants that could cause slips or

falls. The ladders were surely long enough to safely reach the work area and the ladder feet placed on a level, solid surface, ensuring the feet grip. Besides, three points of contact were used while going up and down the stairs and hands-free from carrying any tools.

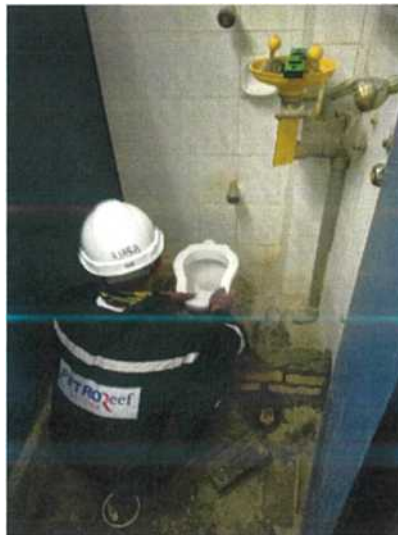
The first step for replacement of toilet seating bowl was the water was turned off at the shut off valve silicon or seal was trimmed that attached between bowl base and floor. The washers and nut were losing and be removed. The potential hazards for workers during replacement were hand injury because of the sharp edge of some toilet items. Besides ergonomic hazard was one of the potential hazards too. Ergonomic hazards cause painful and disabling injuries to joints and muscles on the work site.

Figure 3.7 Installing squatting toilet

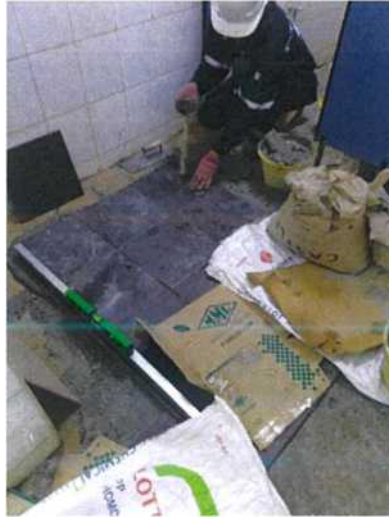
During hacking work, all the existing tiles were removed by the workers using impact drill and the surfaces were clean, smooth, and dry for the best result. The cement and sand were mixed to make a cement render. After that, the new tiling area rendered. The porcelain granite tiles (30cm x 60cm) were cut by using tiles cutter and the tiles were laid.

Based on this work, workers who set on hacking work were face hazards which is hand injury because there were a lot of broken tiles with a sharp edge. Hand injury may occur if the workers were not using the grinder machine properly. Often these injuries occur when the workers did not wear hand gloves or PPE during hacking and cutting tiles work.

Figure 3.8 Worker is installing tiles
5. Housekeeping

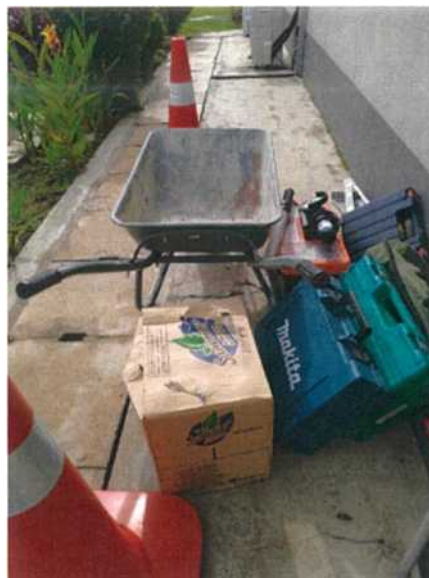
All the materials and tools were arranged properly inside and outside the work area which to prevent it from becoming a hazard to the workers. There were be a lot of waste debris during and after activity at the workplace which might become hazardous. Hazardous waste was generated during the project from the demolition and the renovations in the identified three toilets. Sharp edges, material falling, and combustibles were a risk and injury. The site safety officer was inspecting and concerned about the housekeeping area because it may disturb and risk for other workers and the environment.

Figure 3.9 Tools and Equipments

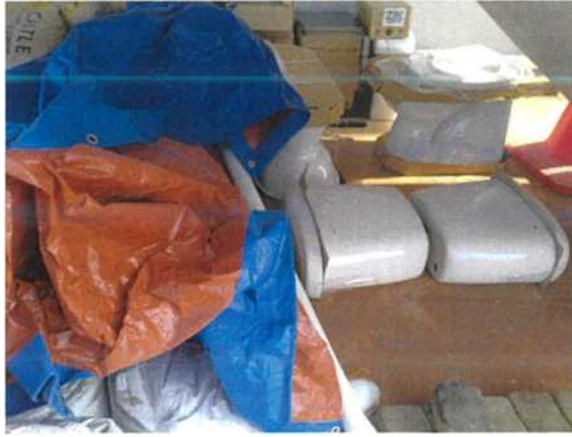
Figure 3.10 Material arrangement and cement stored

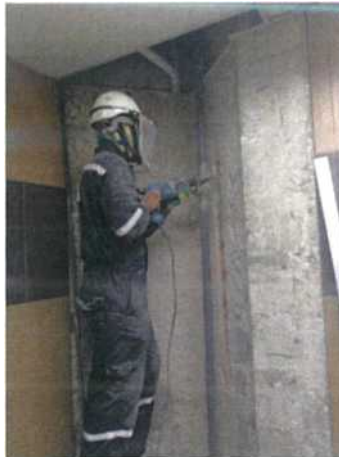
Personal Protective Equipment (PPE) was provided by the employer for all workers which act as the first line of defenses against injury. Safety glasses or face shields were worn anytime work operations that can cause foreign objects getting into the eye such as during welding, cutting, grinding, and nailing. Eye and face protection were selected based on anticipated hazards. The employers have provided eye protection where during hacking work that involve dust, the workers can use it to prevent dust from entering the eye.

Figure 3.11 Worker wear face shield during hacking work

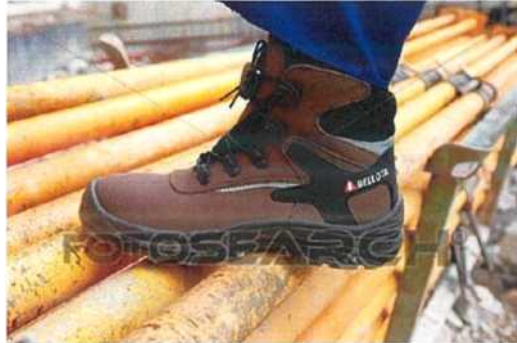
Every worker was using the suitable safety foot gears that required to be used while in renovation and maintenance place. Safety foot gears was designed to protect feet against wide variety of injuries such as impact, compression and puncture. The right foot gears can also be choosen according to the types of hazard.

Figure 3.12 Safety boot that worker wear (Source: Google)

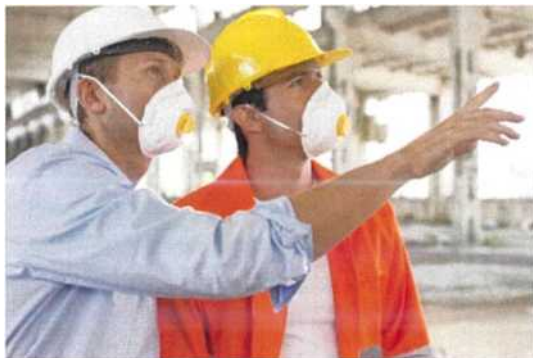
Dust mask was required in some situation in construction and it was also provided by the employer for the worker to protect against certain danger as well as to protect the wearer from inhaling dust or sand in a dust storm as the places were about making a renovation and maintenance work which also consist some dust.

Figure 3.13 Dust mask used when the workers need to involve in much of dusty area (Source: Google)
