**DEPARTMENT OF BUILDING
UNIVERSITI TEKNOLOGI MARA
(PERAK)**

DEFECT OF FLOOR TILING

The project in progress is proposed to develop of 2 blocks of 37 story apartment building that included 1018 units. The name of the condominium is Riana Dutamas and it is located at Segambut, Kuala Lumpur. This project is divided into two phase. Phase 1A and phase 1B which have 509 units from level 5 to level 36, 1 level of population facilities at level 5, 1 level of mezzanine at the podium level and 5 levels of parking on the ground floor up to level 4. After that, the project value is RM 188,000,000.00 and expected to be done by the end of March 2020.

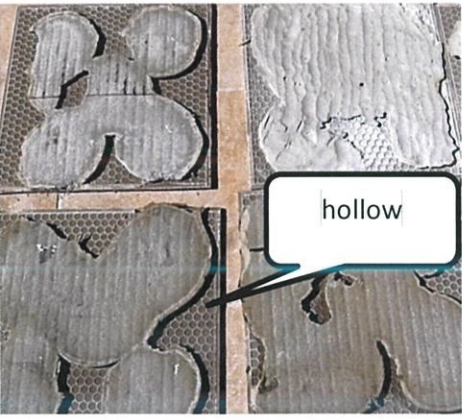
<p data-bbox="418 1621 785 1657">Figure 3.4 : Hollow of tile</p>	<p data-bbox="868 1191 1362 1451">The tile having a hollow sound could be an indication that there is a void under those hollow sounding spots. It can be determined by using the tool called tapping rod.</p>

A low pitched sound that detected by the taping rod can also occur and not signify there is a problem because the real defect of hollow tile is when the high pitched sound be heard. Therefore, the reason of that defect occur is because of an improper installation method called spot bonding.

The spot bonding of the tile is typically can be seen after it is reopened during repair that has various spots on the back of the tile that leaves substantial voids behind the tile.

However , the taping rod that used to check the hollow sounding also can cause the hollow defect. This problem will happened when the inspector using the taping rod with incorrect method. The incorrect method is when the inspector heavily tap on the whole surface of tile many times using taping rod but the correct method is they need to sweep and after found the hollow sound. They must tap slowly repeatedly to conform it is correct. This is the major problem that have in Riana Dutamas's site where their staff has use the wrong method to check the hollow until cause a lot of hollow defect.

- a) The primary method to repair the hollow of tiles is reopened , then fill the empty area or the hollow area with the adhesive until it pass to closed again. This method must to do care fully to ensure the tile not broken to avoid from replaced with the new tiles. Thus, it will reduce the cost of tiling.
- b) However, if the tiles are broken while the reopened process. The tiles will replaced to the new tiles and install again.
- c) Lastly, after the repair process is done. The defect area will inspected by the installer using the taping rod after 24 hours to make sure the tiles are successfully repaired.

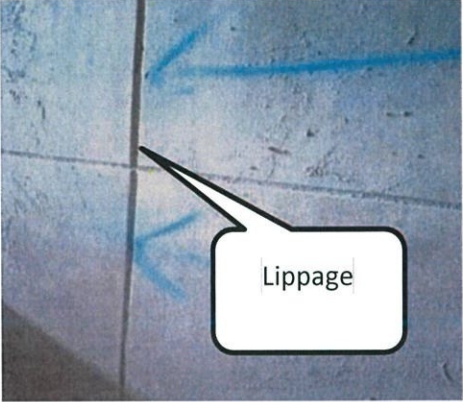
<p>Figure 3.5 : Lippage of tile</p>	<p>Lippage of tiles can be described as the different in elevation between edges of adjacent tile modules. Taping rod also used to determine the defect but the extreme lippage can detected by visual. More sound hear will prove that the lippage between two tiles were very uneven. Furthermore, the extreme lippage of flooring tiles can detected without tools but visual because it's so obvious.</p>
<p>3</p>

Lippage is the difference in height between two adjacent floor tiles. Therefore, the higher of the lippage not only affect of the aesthetics but it is a potential tripping hazard. Subsurface is the first major causes of lippage tile that need to be careful. Thus, the installer should give their best attention to ensure there is a solid and level subsurface before laying the tile on the slab.

Other than that, the size of tiles is also will affect the lippage. The bigger of size tiles will give more challenge. This is compounded by the increasing demand for larger tiles. However, the small tiles are easily to handle and aligned to adjacent tiles because easy adjust if have any lippage that has been seen. Unfortunately, larger tiles are not as expected and an unlevel surface will increase lippage.

Furthermore, the small causes also one of the reason why the tile is getting lippage. That is the proper cleaning before start the tile installation. This is because if not cleaning properly, it may be that some hard debris such as small steel or timber is stuck in the adhesive tile at the edge of tiles causing lippage problems.

- a) The primary method to repair the lippage between tiles is the tiles will reopened and reinstalled after ensure the adhesive back of tiles in the align condition.
- b) While the reopened process of tiles, the installer need to be careful to avoid the tiles from crack or pop up.
- c) The installer should to use the tile spacer to ensure the position of tiles are align.

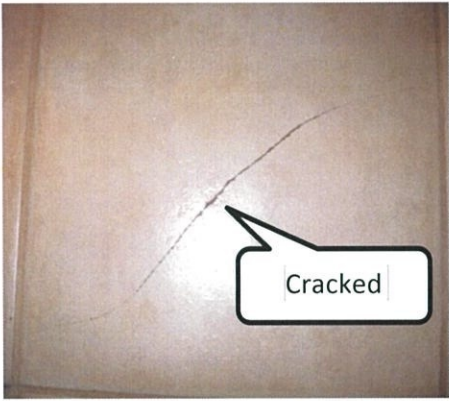
<p>Figure 3.6 : Cracked tile</p>	<p>Whenever tile is bonded to concrete, movement in the concrete will cause cracks to occur in the tile layer. Should cracks occur in the concrete, these cracks will reflect through the tile that often to called “reflective cracking”.</p>
<p>4</p>

The defect about crack is the problem that was often heard because it can be seen that crack can occur anywhere if not properly monitored during the scratch of installation flooring tile. The first major reason why the floor tile is crack is due to the uneven concrete slabs where at the starting of casting the concrete were not according the formwork with accurate. Therefore, when the floor tile has been installed and many labour stepped on or walking on the floor tile, it will give the pressure to the tiles that can cause the cracked.

After that, the heavy object dropped on the floor tiles such as the tools that used during installation of the floor tile. Furthermore, poor handling by the installer also the one of reason why the tile is cracked. This is happened when the installer just doing their work without guidance form their sub-contractor or supervisor and they did not take the series to install the tile.

- a) There are two types of repair for the crack tiles. First is apply the paint that closely match the colour of that floor tiles if the cracks are not too large.
- b) The second is replace the new tiles which have same design if the cracks are too large. This is because, if use the closely match colour paint to the floor tile. The large crack still will reveal itself too.
- c) Allow to use the movement joints in tiles to avoid the tiles cracking.
- d) Add the steel reinforcing bars to the concrete slab to prevent cracks in the concrete from forming into the surface of tiles.
- e) Use the proper cutting equipment when cut the tiles to prevent from cracking.

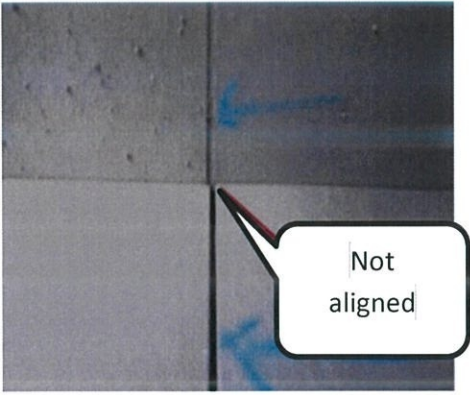
<p>Figure 3.7 : Tile not aligned</p>	<p>The figure shows that the tiles was not alignment where the position of tile were not in the right position. However, the defect of tile not alignment can knows through the observation or other word that could called visual.</p>

The installer not follow the layout of position of each tile. This is to ensure the position of each tile are at the right position because the layout is very important to avoid the misalignment of tile. So that, this is the first causes of that the installer must to be careful.

Moreover, the installer not put the plastic spacer between the floor tile after it has been install also the causes of why the tile are not alignment. The plastic spacer used to ensure the space between tile are follow the right size of space and also make the tile in the right position. Thus , the plastic spacer are very important to make the tile in the right size of alignment. The standard space between tile is 2mm to 3mm.

- a) The defect area will reopened to repair their base at layer of thinset mortar which holding tiles on the floor. Then, the tiles will reinstalled after the base are align.
- b) The tile spacer will used to avoid the tiles from misalignment again.
- c) Lastly, after the tile has repaired. The inspection by the architecture department will approve that it has passed or not.

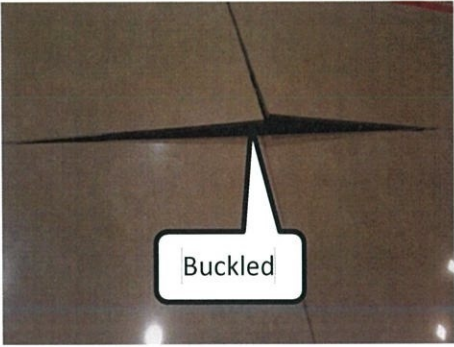
<p>Figure 3.8 : Buckled tile</p>	<p>The other name for buckled tiles is pop up tiles or tented tiles. It happened when the floor tiles start to pushing other tiles against one another. This defect will appear in all types of tiles.</p>
<p>6</p>

Improper set tiles by the installer are the reason why buckled tile was happened. The wide tiles require a certain technique to ensure that it will achieve a strong bond with the adhesive. Furthermore, the major reason the tile get buckled is uneven subfloor . For example, when the pressure to the tiles was given by the heavy object, it will causes the tiles got buckled or pop up.

Moreover, the tiles not using the adhesive or adhesive were not solid also the reason of this defect was appear. Therefore, the installer need to give more attention while the tiles was laying the adhesive. Lastly, if the poor quality adhesive are used for floor tiles and it exposed to the sunlight. This will make the tiles easy to buckled or tented because of the adhesive are not strong.

- a) The solution for buckled tile is not use old tiles but use the good quality adhesives and good quality material such as cement, sand and each other. After that, the installer must to ensure the tiles are clean and in good environmental condition and need to always according to the manufacturer guidelines strictly during using bonding material for installation of tiles. Lastly, If the tiles are buckled over the large area, the tile must to replace into all tiles with new one of same design. Below will discuss about how to repair the buckled tiles in general .

- b) The old tiles will replaced into the new tiles because of old tiles could not be used due to the defect.
- c) In the wet area, the method is same. The floor tile that was buckling will carefully removed to install the new tiles.

- d) The other way is reinstall the tiles if they can inject the areas with the spot of adhesives.

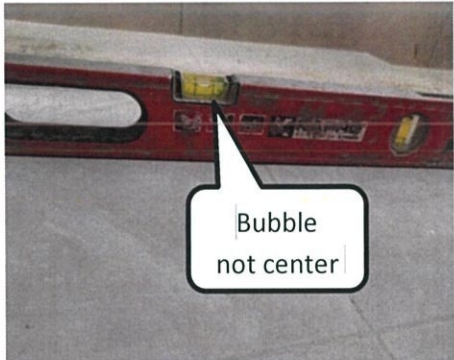
<p>Figure 3.9 : Uneven tile</p>	<p>The figure shows that the tile was uneven where the reason for this defect is an uneven layer of thinset mortar holding tiles on the floor. This defect can know through used the spirit level where the bubble in the spirit level at balanced position, so it shows that the tile was even except for wet place such as toilet and balcony where has falls direction for water.</p>

According to the requirement of floor tiling, the surface of the tiling must be evenness with follow the tolerance that the evenness of tile must below of 3 mm . Therefore, the first causes of unevenness floor tile is because the installer not use the spirit level while install the tiling. The spirit level is important to know that the tiles that has been installed are below of 3mm or not. From that , the installer can repair as fast as possible before the tile adhesive are getting hard.

After that, the installer also not use the spirit level during installation the floor tile at the wet area such as toilet, yard and balcony. It will cause stagnant water during raining if the tile does not falls into the trap. Therefore, the requirement has set that the area that will be exposed to water should be falls in right direction.

- a) Usually, the all unevenness floor tiles at wet area like toilet, balcony or yard will reopened because want to repair at the base of tiles. The repair method is to ensure the direction of fall of tiles are directly to the trap. This is important to avoid that area from stagnant water during raining. Lastly, after the repair process has done, the installer will checked the tiles using the spirit level to make sure the tiles surfaces are falls into the trap.
- b) For the area which not exposed to the water like living room, kitchen and bedroom. If the defect was detected , the all tiles will reopened to align the base of tiles. After the tiles has reinstalled , the tiles will checked by the installer using the spirit level to ensure the tiles are even.
