**DEPARTMENT OF BUILDING  
UNIVERSITI TEKNOLOGI MARA  
(PERAK)**

**HONEYCOMB DEFECTS WORKS**

**DECEMBER 2019**

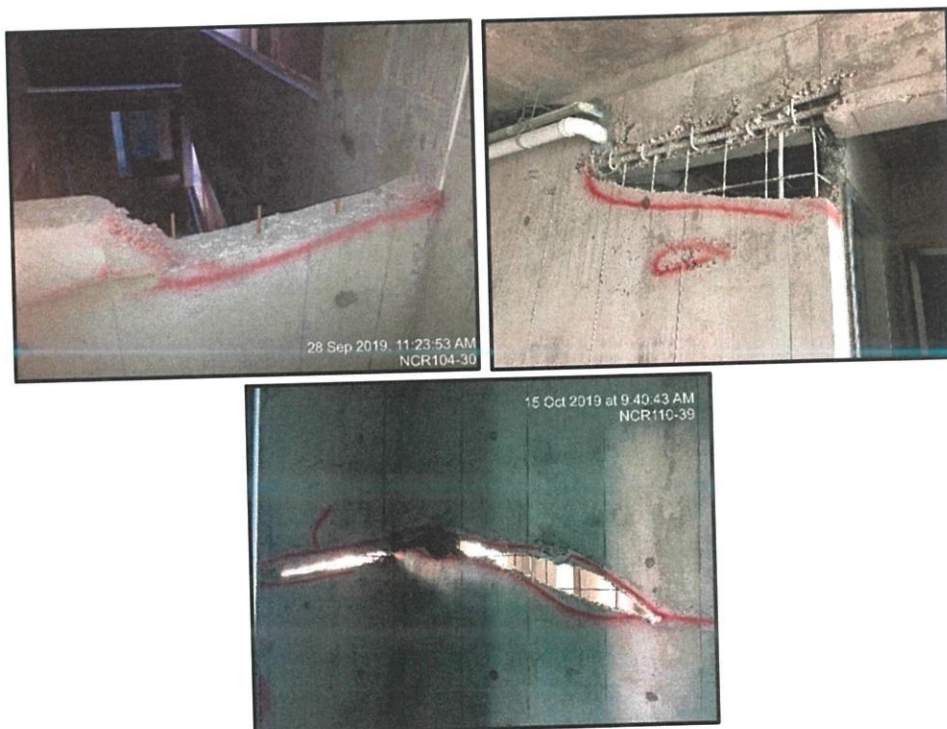
**Figure 6:** Example of major defective honeycomb

#### I. Major defective honeycomb

Using same grade of design concrete by properly vibration to achieve monolithical structure.

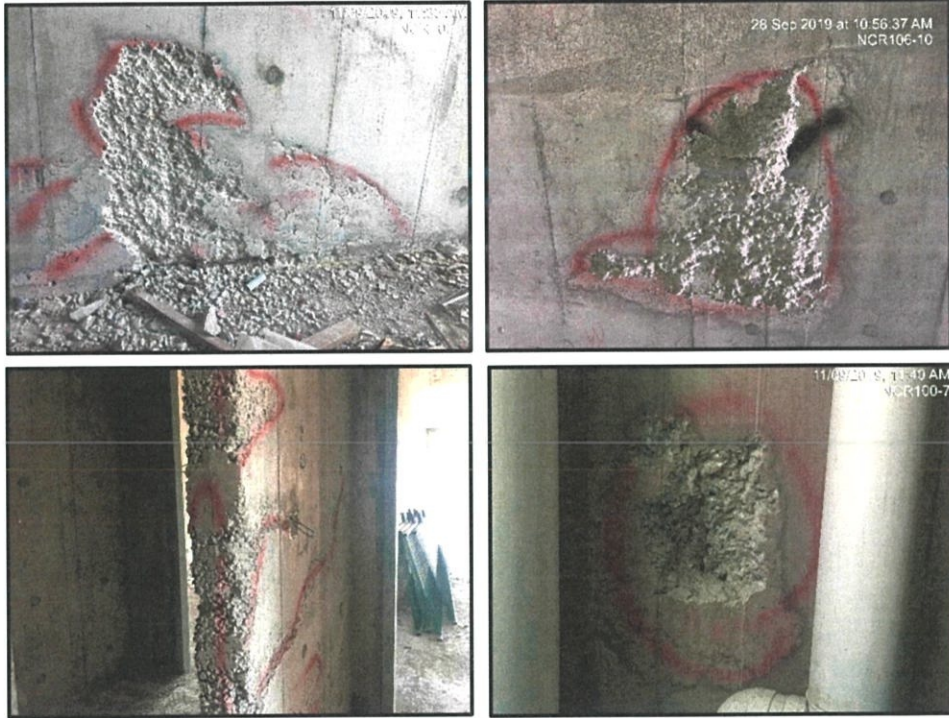
Figure 7: Example of minor defective honeycomb

## II. Minor defective honeycomb

Structure repair >10mm deep using SIKA215 non-shrink grout (cementitious repair compound).

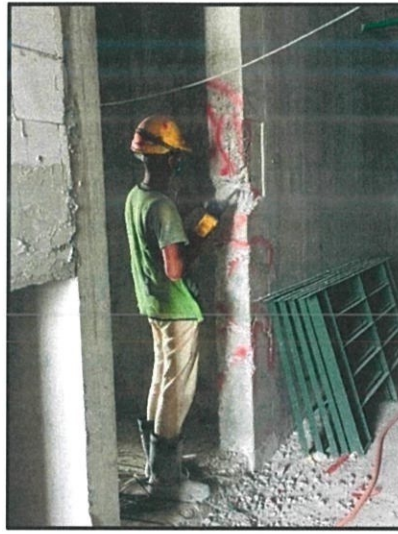
**Figure 8:** Hacking work

- i. All the loose parties at the honeycomb defective area will be hacked off until the firm surface reach.

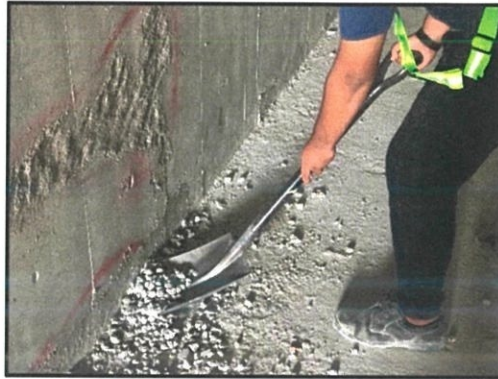
**Figure 10:** Clear debris and dust

- ii. After minor hacking work is done the defective area and reinforcement bar exposed will be clean before the rectification work commence.

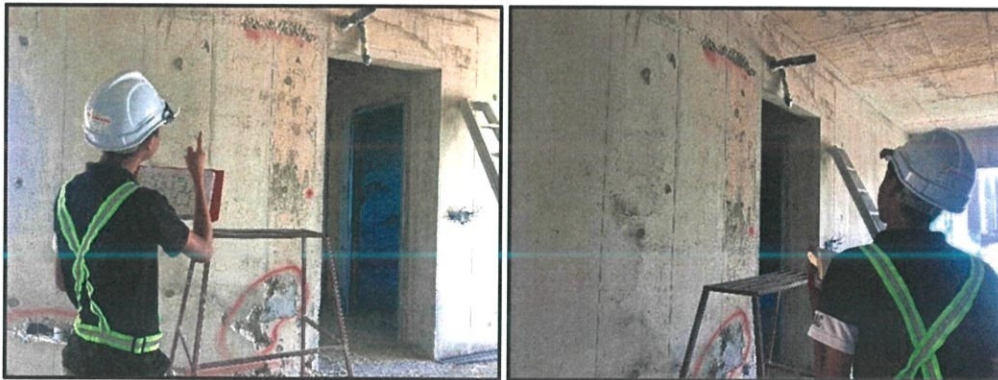
**Figure 11:** Inspection with (IOW)

- iii. Supervision officer (IOW) inspection will be carry out after the hacking and cleaning work is done.

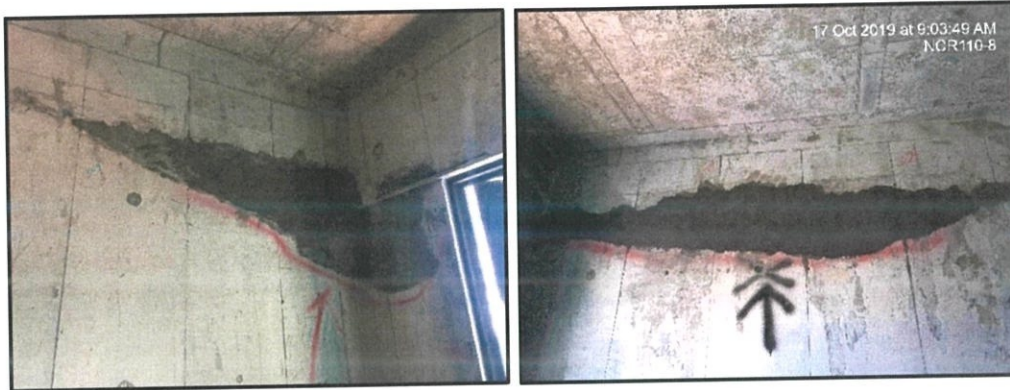
**Figure 12:** Complete honeycomb defect repaired

- iv. When the inspection complete, same grade of concrete to be pour at defective area. SIKA215 non shrink will be used on the infill material for small quantity and small area.

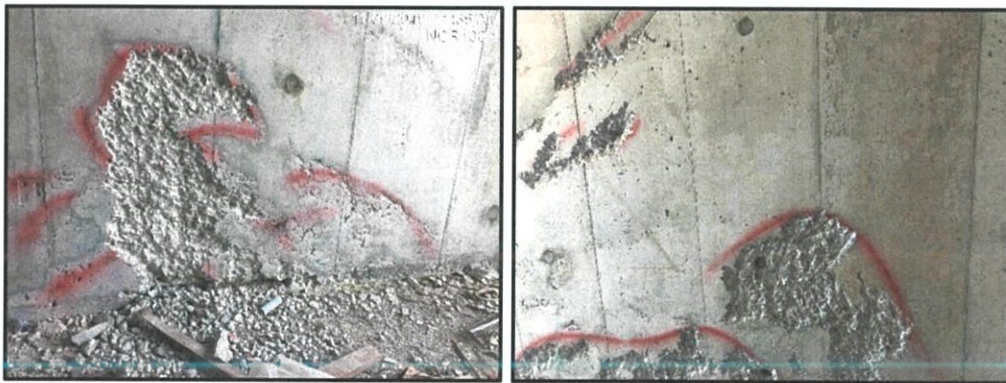
**Figure 13:** Example of minor defective honeycomb

- i. If the honeycomb occurs in a big area underneath the structure member with congested steel reinforcement, where the void may occur during the repair process, pressure grout shall be used. The prepared void shall be profiled so that entrapment of air during the repair process can be avoided. The minimum depth of repair shall be profiled so that entrapment of air during the repair process can be avoided. The minimum depth of repair shall be 40mm throughout. For the pressure grout, the entry point of the feed pipe into the form shall be at the lowest point of void. Sufficient hydrostatic head or pumping pressure shall be maintained to ensure that the void is filled completely and no air entrapment occurs. Where necessary, provision shall be made for bleed or exit points to prevent air entrapment and enable the extent of flow of the concrete grout to be assessed.

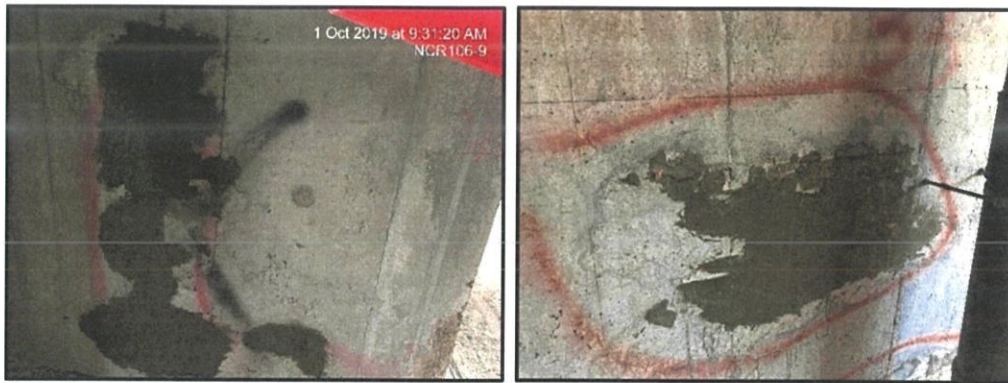
**Figure 14:** Example honeycomb that have been complete patching

- ii. If the honeycomb occurs in a big area with open access, pouring cementitious grout by using SIKA215 non shrink shall be placed. For thicker section it is necessary to fill out SIKA215 will graded to minimize heat build up.

Before apply concrete grout or repair compound, the prepare surface shall be saturated thoroughly with clean water but free of any surface water of puddles.

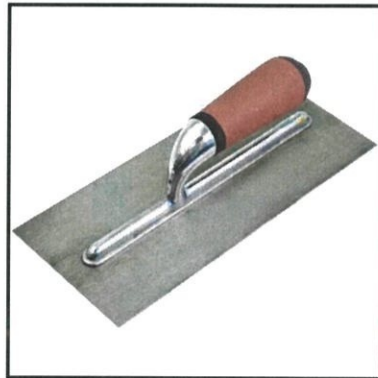
**Figure 16:** Trowel

- iii. If the honeycomb occurs in a small area, the materials shall be applied by gloved hand or trowel to be prepared and primed surface of the substrates and will be well worked in, paying particular attention to packing behind and between the reinforcement. Particular care shall be taken in application of the repair materials. Where necessary, it should be built up in successive wet on wet layer to the required profile.

If sagging occurred, the materials shall be completely removed and the void filled in two or more successive application or by the use of formwork in accordance with the manufacturer's recommendations. After applying sufficient mortar to build the surface to the require level or to achieve the require cover to the reinforcement, the surface shall be troweled smooth to the finished profiles.
