**DEPARTMENT OF BUILDING
UNIVERSITI TEKNOLOGI MARA
(PERAK)**

**PRACTICAL REPORT TITLE:
METHOD INSTALLATION OF FENCING WORKS**

METHOD INSTALLATION OF FENCING WORKS

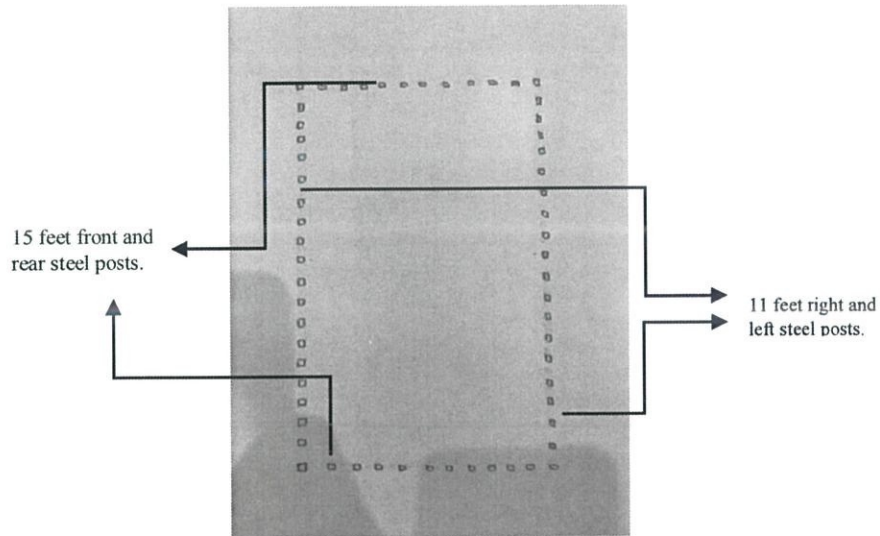
Figure 3.1 Steel posts layout

Then, excavation work around the site were undertaken. For this work, the workers excavated one foot depth of the soil using a hoe to set up the steel posts. There are two different height of the posts required such as in 15 feet (front and rear) and 11 feet (right and left) as illustrated in **Figure 3.1**.

A total of 24 holes has been excavated in front and rear while 36 holes at the right and left side of the futsal court area. Then, eight workers set up all of the steel posts in the position and grouting the steel posts holes with the cement which has been mixed up using the mixer machine as portrayed in **Figure 3.2**.

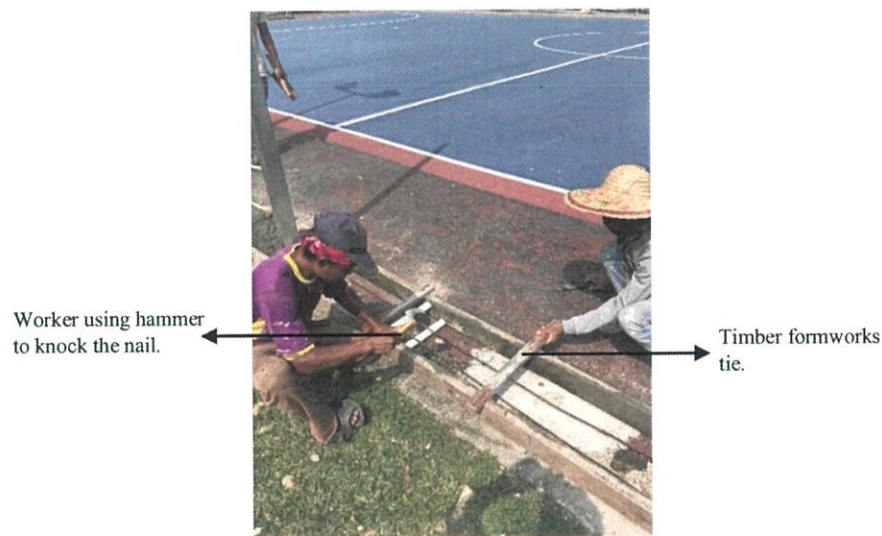
Figure 3.3 Formworks installation.

To construct a concrete base, the formworks, which made from timber must be installed around the area of futsal court. The workers are using the hammer to knock the nail to connect all the timber to form the formworks around the futsal court as shown in the **Figure 3.3**. The installation finished in 3 hours.

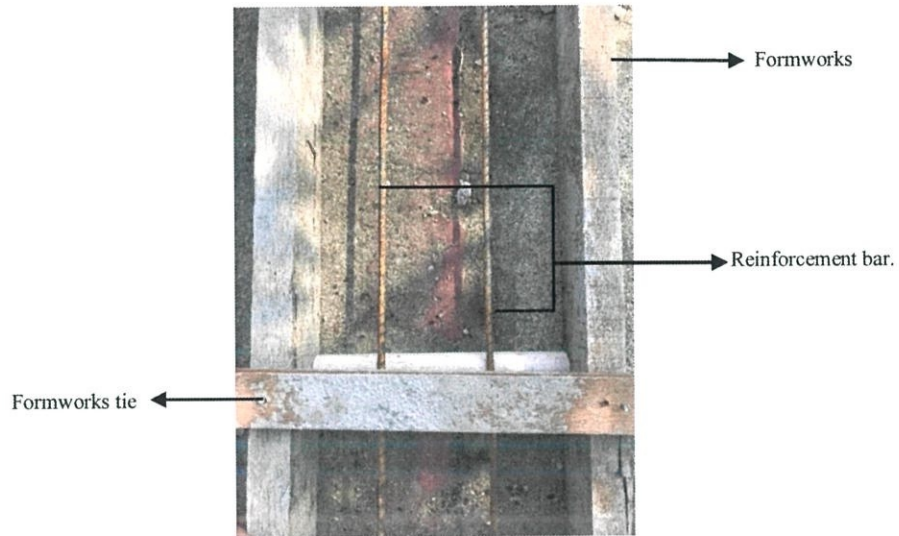
Figure 3.4 Reinforcement bar in the formworks.

Reinforcement bar were then installed before tie of the formworks are knocked using hammer. The function of reinforcement bar are to strengthen and hold the concrete tension. As shown in **Figure 3.4**, two 6mm diameter reinforcement bar are installed inside the timber formworks on the top of 50mm spacer block.

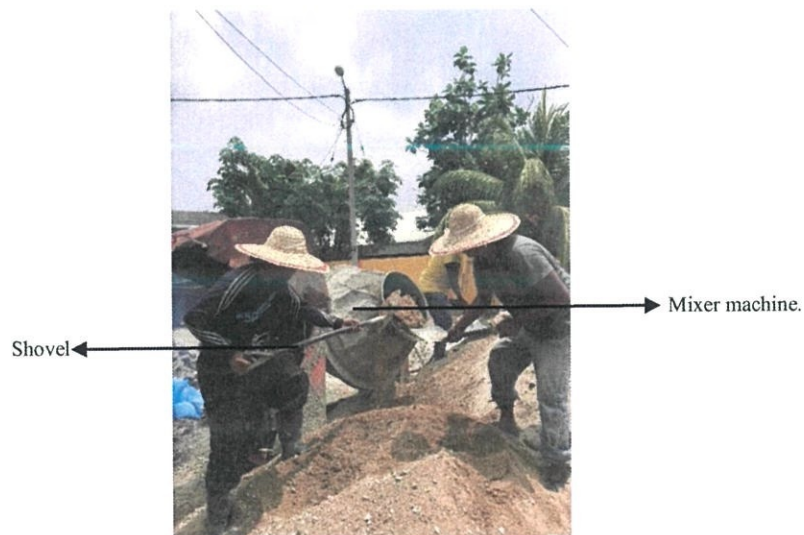
Figure 3.5 Concrete mixing work.

After that, inspection was carried out by the head worker in order to make sure the concrete base formwork and reinforcement bars were in place and ready for concreting work. Upon observation, two of the eight workers started to mix the raw materials such as aggregate, sand, cement and water in appropriate ratio. Hence, small mixer machine was used including shovel during the mixture of concrete were undertaken. All these activities were demonstrated in **Figure 3.5** below.

The plastering mixture consists of sand, cement and water. All these materials were mixed up using mixer machine as shown in **Figure 3.5**. Then, with wheel barrow, the plastering mixture was carried out to the located area and poured on top of concrete strip foundation to start plastering process. The plastering process continued with trowelling activity using cement spatula tool to smooth the surface and skimmed coat which was conducted by four workers. Skimmed coat was the last process before the installation of wire mesh fence started. **Figure 3.8** demonstrated the plastering and skimmed coat activities as indicated below.

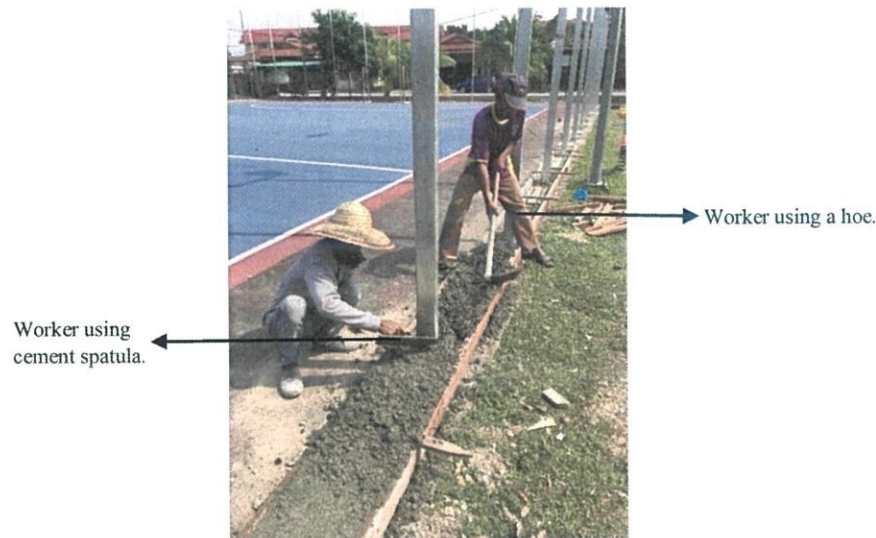
Figure 3.6 Concrete spread into formworks.

The method of concrete placement to the concrete base formwork was using 2 wheel barrow. After that, the next process is trowelling using hoe and cement spatula to smooth the surface as demonstrated in the **Figure 3.6**.

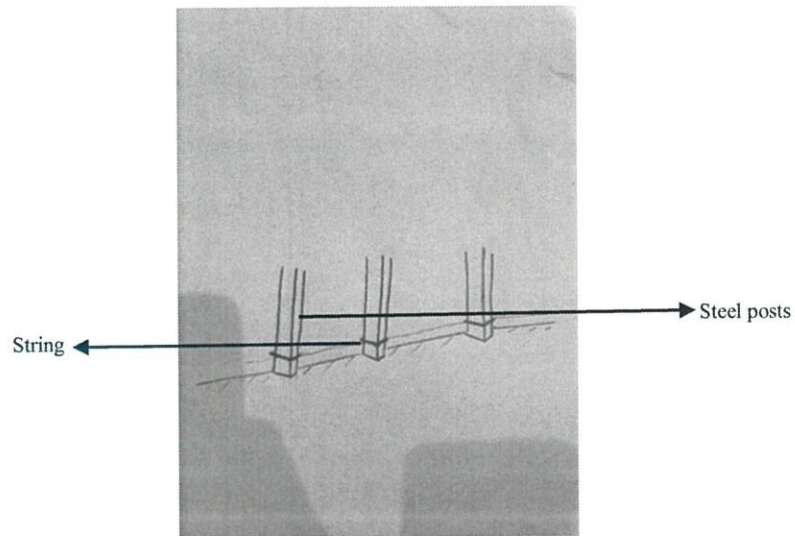
Figure 3.7 String pulled from post to post.

Before plastering work begins, the concrete must be hardened and dry for 3 hours. After the concrete has been confirmed hardened and achieve the target strength, there were three workers dismantled the formworks using hammer, by pulling off the nails as a joint of each timber formwork panel. Then, the workers did several inspections by measuring the thickness of concrete base, just to make sure the dimension of 150mm (height) and 300 mm (width) was accurate before proceeding to the plastering process. After inspection, the workers marked using string by tying up from one post to another post for levelling marking for plastering as demonstrated in **Figure 3.7**.

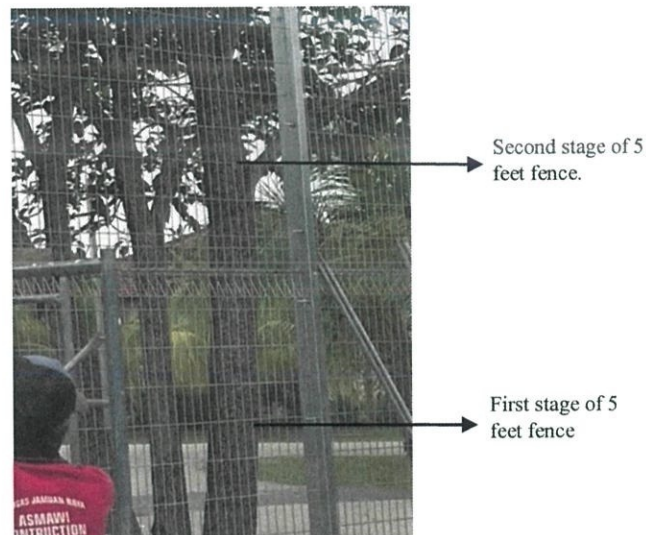
Figure 3.9 Fences jointing.

There are two sizes of the fences, such as 5 feet for right and left sided, and 7 feet to be installed in front and rear sided area of the outdoor futsal court. Each side, required two stages of wire mesh fences. Firstly, the fence was installed of left and right sided, with the total height was 10 feet (5 feet of each height) and 14 feet (7 feet of each height) for the front and rear. **Figure 3.9** shown the jointing of the first and second stages of the wire mesh fences.

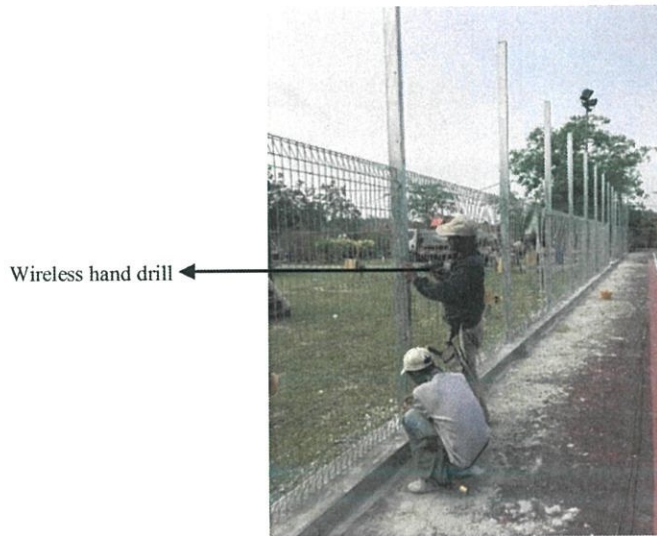
Figure 3.10 Tighten the bolt and nut.

At the first stage, three workers were lifted of the 5 and 7 feet fences and connected the fences to each other using bolts and nuts, then wireless drill as demonstrated in **Figure 3.10** used to tighten the connection. Meanwhile, the steel posts purposely to hold each wire mesh fence at the certain distance.

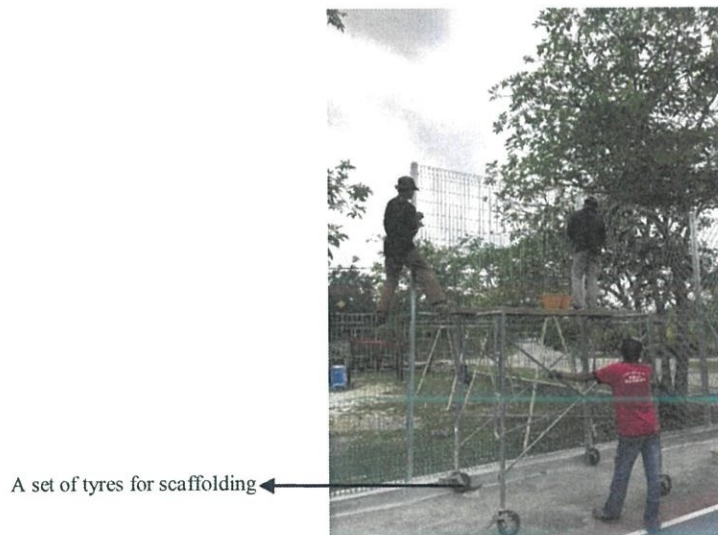
Figure 3.11 Scaffolding.

After completed the first stage. The workers used scaffolding for the installation at the top layer at each side. This process required scaffolding equipment to carry the fences and installed at the higher level as portrayed in **Figure 3.11**.

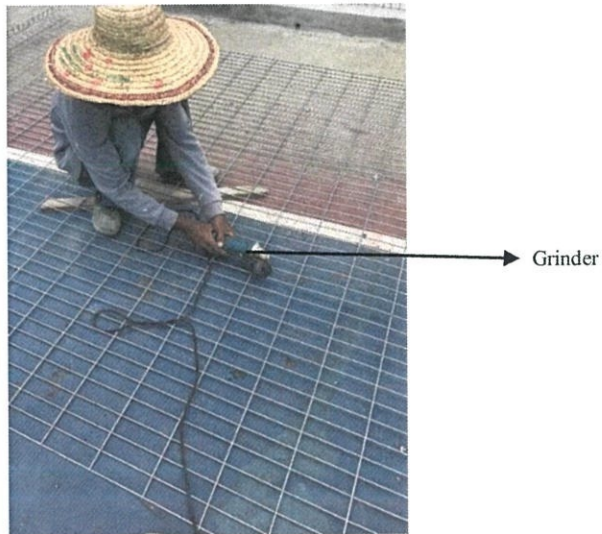
Figure 3.12 Cutting the fences.

Opening needs to be done as an access into the futsal court. So, one worker use measuring tape to measure the opening size 900mm x 1200 at the wire mesh and using the grinder to cut the wire mesh fence, as demonstrated in the **Figure 3.12**.

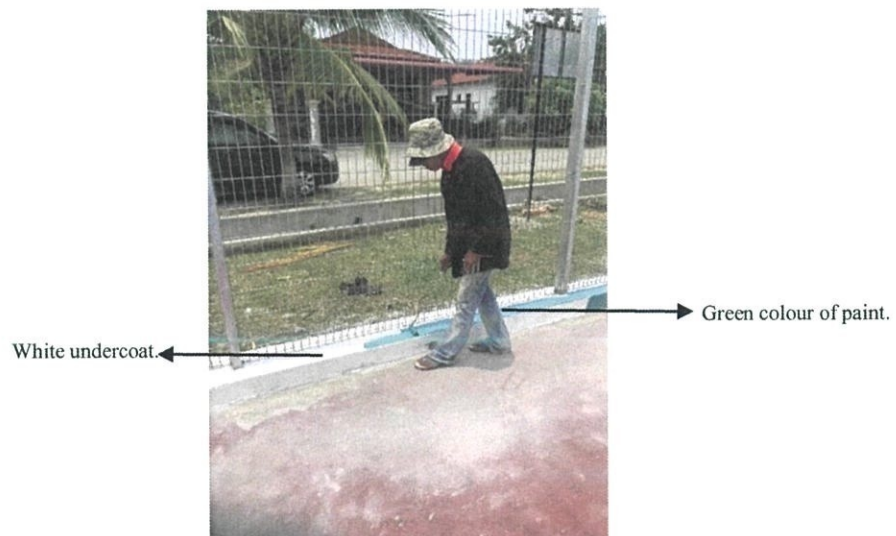
Figure 3.13 Painting works.

Painting is important for aesthetic value. Using the paint roller, painting process was carried out at the concrete based in two layers, undercoat with white colour and main coat with green colour as shown in **Figure 3.13**.

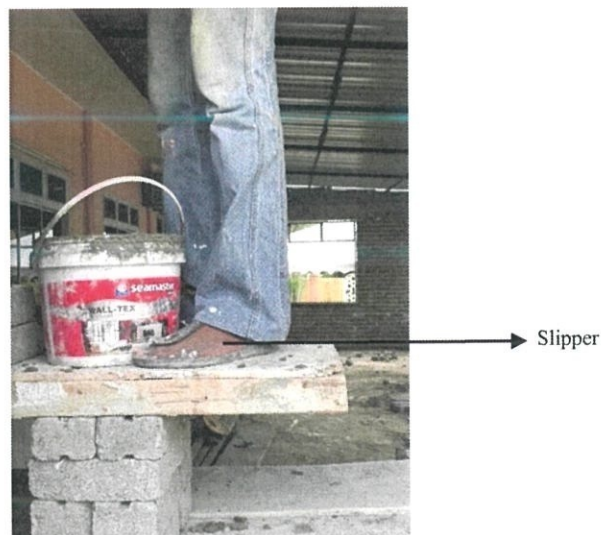
Figure 3.14 Worker wearing slipper.

There were several problem occurred during installation process and the strategy to solve the problem also determined as well. First, from the safety aspect, all the workers do not wear the right protective equipment such as, safety helmet, proper safety boots, glove, face mask, and vest while doing the work. As portrayed in the **Figure 3.14**, some of the workers are just wearing slippers during their working time. There are cases happens which one of the workers, step on the formwork's nail and causing a bleeding. This will lead to another problem which is the shortage of workers and might delayed the duration to complete the job. Workers also only wears cap, instead of safety helmet. Thus, workers have high potential of the risk to exposes hazardous at site. To solve this problem, site supervisor has to provide the workers with suitable personal protective equipment. As well as regularly brief on awareness regarding safety at the site during the working day. Another solution is construction team must provide safety signs on the project site to warn site workers. So, the workers will be more careful.
