**DEPARTMENT OF BUILDING
UNIVERSITI TEKNOLOGI MARA
(PERAK)**

INVESTIGATION OF DEFECTS DURING LIABILITY PERIOD

This project is located at Jalan Langkawi, Kampung Kuantan , 53300 Wilayah Persekutuan Kuala Lumpur. The project was to construct one block of 30 floor apartment that consist 23 floor with total of 800 units. The other 7 floor is the podium for parking lot and a lower ground parking level. There is also one main switch station, one unit of guard house, a garbage house, and a facilities at lot 22526, 22527, 22528 (old lot 224) lot 225, lot 6781 and lot PT9900, off Jalan Langkawi , Mukim Setapak , Wilayah Persekutuan Kuala Lumpur for owner of WENG WAH DEVELOPMENT SDN BHD. The project cost approximately RM 3.05 Million and the area of this project is about 4.08 acre or 16512.27 m². The main-contractor for this project is BINASTRA CONSTRUCTION SDN BHD. This project started construct on September 2016 and gain its Certificate of Completion and Compliance (CCC) at 11th of September 2019 .The building was built near many Platinum Victory's condominium such as Teratai Residence, PV 16, PV 12, PV 10 and more. The CCC was gained at 11th September, therefore the building is having t

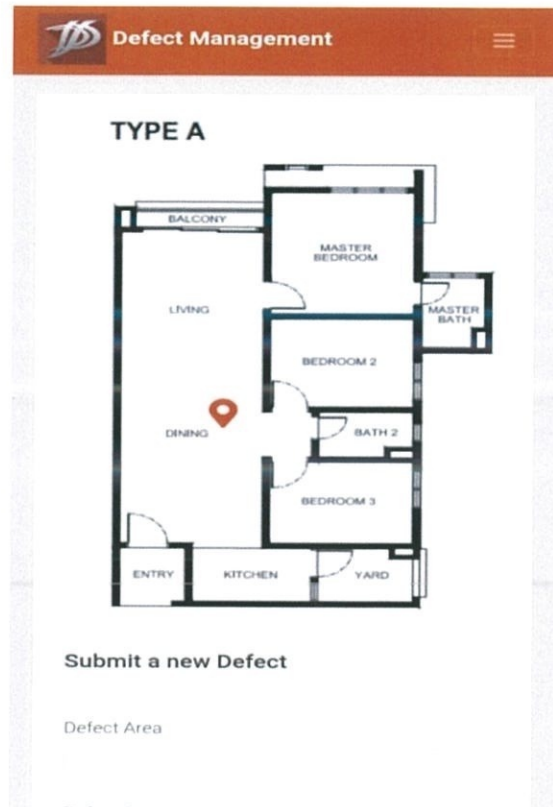
Figure 10 : Submission page

User clicks on the ‘ Submit Defect ’ button in Home Page and submit defect by the following:

- a) Place the pin on the affected area
- b) Input your defect area (i.e living/dining/ master bedroom etc)
- c) Describe your defect
- d) Attach the image of your defect (Maximum : 2 images)
- e) Click on ‘ submit ‘

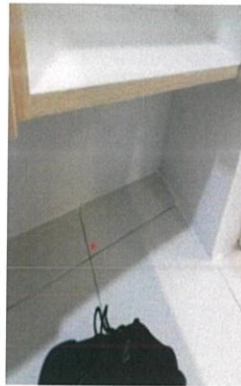
Figure 22 : Hollow tiles

The mortar between the tiles and inside the floor tiles are shrinking or can be called as thining because of poor finishes in constructing.

4	<p>Hollow tiles</p> <p>These happens because of the mortar that was used to join the tiles and the concrete are very thin. Therefore the mortar will slowly disappear during the curing stage and will not compact as it should be</p>	<p>The tiles will be removed because of thin mortar inside it. Therefore, the surface area will be clean to prevent from any inconvient to happen again and the reinstalled the tiles.</p>
5	<p>Wrong floor slope</p> <p>Creating a gradient in a wet room is one of the most important components of wet room construction and to guide water to drain efficiently. The minimum recommended fall is 12mm, and the slope needs to be formed into the floor itself.</p>	<p>Wrong floor gradient can be resolved by taking off all the tiles. Cleaning process is needed in order to remove dusts and dirt after all the tiles is removed. Then, apply mortar and adjust the gradient using the water balance tool. Wait until the mortar to dry in 2-3 days then install the tiles as usual.</p>

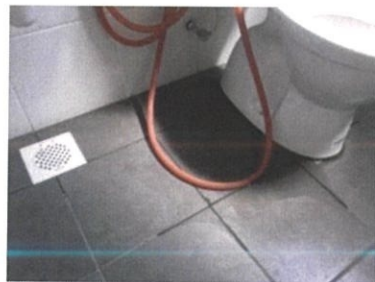
Figure 24 : Stagnant in toilet

The water inside the toilet are not flowing to the drain. Besides it gather at the corner of the toilet. This may happen because of the wrong floor sloping method.
