**DEPARTMENT OF BUILDING
UNIVERSITI TEKNOLOGI MARA
(PERAK)**

**THE CONSTRUCTION OF REINFORCED CONCRETE SLAB AT
RIANA SOUTH CONDOMINIUM**

**Prepared by:
QAMARUL AZARIN BIN RUSLI
2016454922**

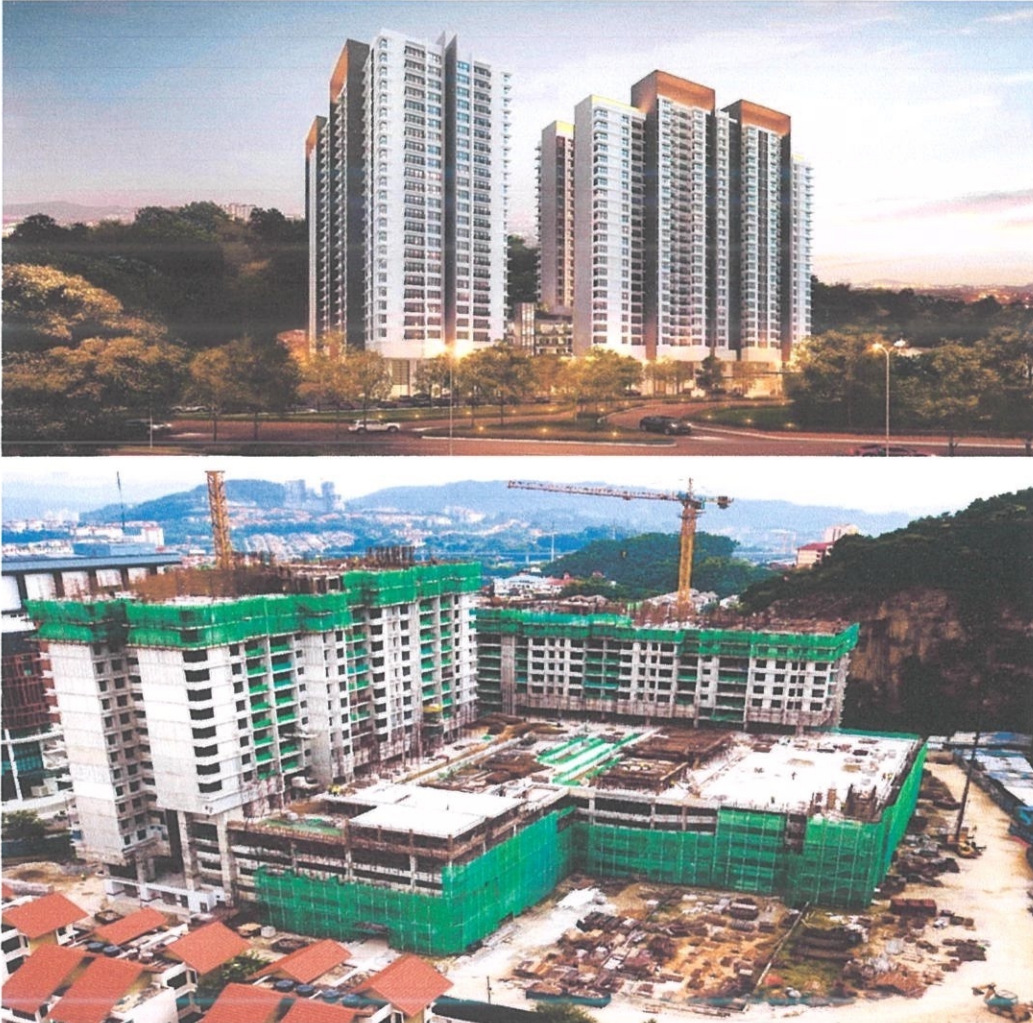
Figure 3.1.1: Riana South Condominium, Cheras.

Riana South @ Bukit Mandarina, Cheras is a construction of 536 units luxurious condominium developed by IJM Lands Berhad located at along Persiaran Alam Damai, Cheras, Kuala Lumpur. Nestled at the heart of Bukit Mandarina, this construction project was started on November 2017 and is estimated to be completed by April 2020. Riana South constructed with a value of RM119,721,700.00 consists of two blocks and 536 units situated on 5.79 acres of leasehold land. There are three types of layouts which are A1, B1 and B2 of 3 bedrooms 2 bathrooms to 3+1 bedrooms 2 bathrooms with sizes ranging from 947 sq.ft. to 1,238 sq.ft. Each unit will be provided 1-2 parking bays.

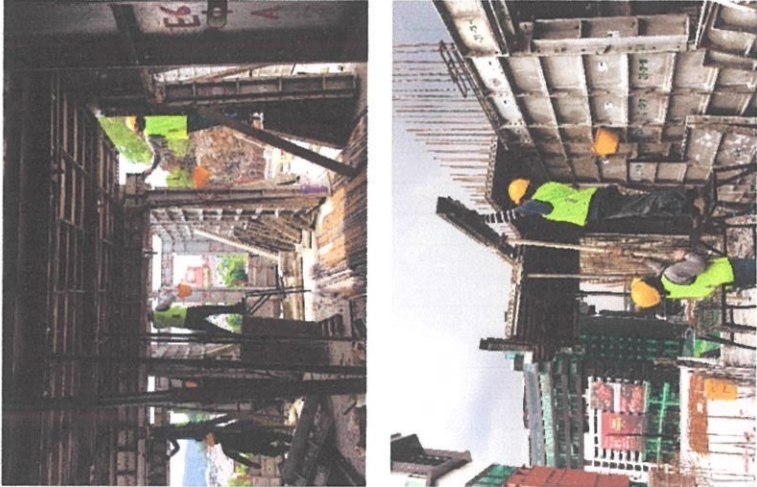
NO	METHOD	SEQUENTIAL DIAGRAM	MANPOWER	MACHINERIES/ TOOLS	DURATION
1.	<p><u>Installing Aluminum Formworks</u></p> <p>As the shear wall area has completed, aluminum formworks were placed throughout its section. Bolts and nuts were used to make sure the formwork stays firmly at their area situated. Struts were placed under the formwork of the slab zone to make certain that the formwork would not plummet.</p>

<ul style="list-style-type: none"> - 7 aluminum laborers - 1 supervisor 	<ul style="list-style-type: none"> - bolts and nuts - hammers - ladders 	<p>Each slab is constructed base on zones. For this particular part, it took around 3 hours to completed this one zone.</p>

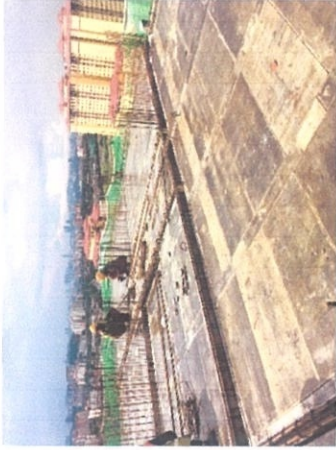
NO	METHOD	SEQUENTIAL DIAGRAM	MANPOWER	MACHINERIES/ TOOLS	DURATION
2.	<p><u>Placing of Starter Bars</u></p> <p>As the slab area is finish, other works such as beam and shear wall reinforcement steel parts is being done. Starter bars were also placed.</p>

<ul style="list-style-type: none"> - 2 to 4 steel workers. - 1 supervisor 	<ul style="list-style-type: none"> - rebar tying tool 	<p>Takes about 4 hours to complete.</p>

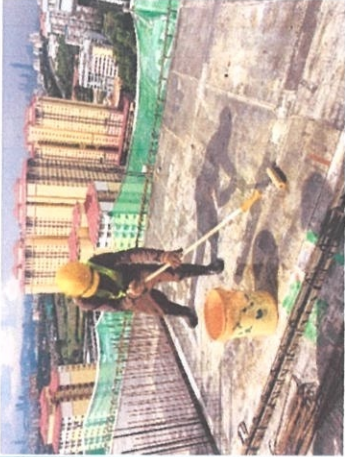
NO	METHOD	SEQUENTIAL DIAGRAM	MANPOWER	MACHINERIES/ TOOLS	DURATION
3.	<p><u>Oil Placement</u></p> <p>Furthermore, oil is being placed on to the aluminum formwork's surfaces. This is done to prevent the concrete from sticking to the formwork after its dry.</p>

<p>- 1 laborer</p>	<p>- oil - roller - bucket</p>	<p>Takes up to 2 hours for zone 1. Other zones may affect the duration as it is different.</p>

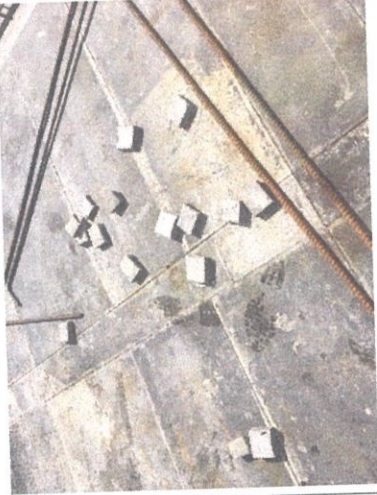
NO	METHOD	SEQUENTIAL DIAGRAM	MANPOWER	MACHINERIES/ TOOLS	DURATION
4.	<p><u>Placing Spacer Blocks</u></p> <p>After oil has been placed, spacer blocks were arranged on to the surface of the aluminum formwork. These spacer blocks will prevent the bottom reinforcement bar from emerging into the ceiling after casting is done.</p>

- 1 laborer	- spacer blocks	Around 1 hour to finished arranged all the blocks.

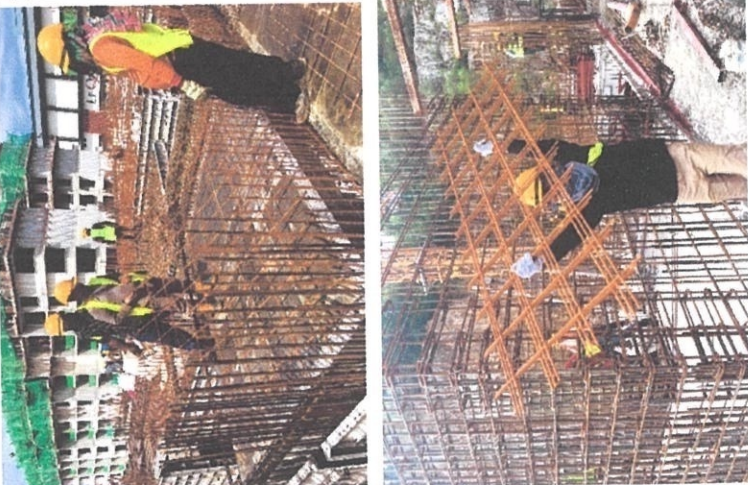
NO	METHOD	SEQUENTIAL DIAGRAM	MANPOWER	MACHINERIES/ TOOLS	DURATION
5.	<p><u>Bottom RC Bars Placing</u></p> <p>Bottom reinforcement bars are set on to the surface of the aluminum formwork by using the tower crane.</p>

<ul style="list-style-type: none"> - 3 steel workers - 1 laborer - 1 supervisor - 1 signalman - 1 tower crane operator 	<ul style="list-style-type: none"> - tower crane 	<p>Takes about 4 hours to complete all the work.</p>

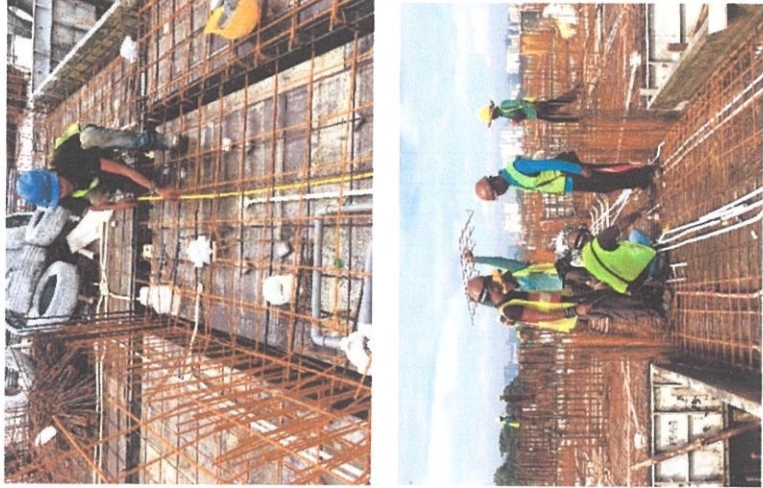
NO	METHOD	SEQUENTIAL DIAGRAM	MANPOWER	MACHINERIES/ TOOLS	DURATION
6.	<p><u>Installation of M&E Services</u></p> <p>After all bottom reinforcement bars has been placed, M&E services such as plumbing pipes, electrical pipes for wires, air conditioner pipes and fire safety panels were installed before laying of the top reinforcement bar.</p>

<ul style="list-style-type: none"> - 2 plumbers - 2 electrician - 2 laborers - 1 M&E supervisor 	<ul style="list-style-type: none"> - bar cutters - pipe cutters - glue - measuring tape 	<p>All of the process takes about 3 hours to finish.</p>

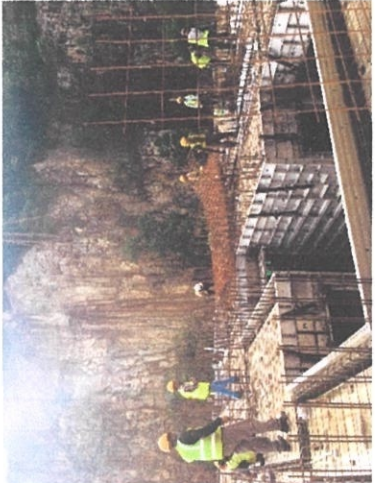
NO	METHOD	SEQUENTIAL DIAGRAM	MANPOWER	MACHINERIES/ TOOLS	DURATION
7.	<p><u>Top RC Bars Placing</u></p> <p>Top reinforcement bar are placed after all the services has been done. Tower crane was used to carry the top bars into placed above the bottom bar and the services.</p>

<ul style="list-style-type: none"> - 3 steel workers - 1 laborer - 1 supervisor - 1 signalman - 1 tower crane operator 	<ul style="list-style-type: none"> - tower crane 	<p>Takes about 3 to 4 hours to completion.</p>

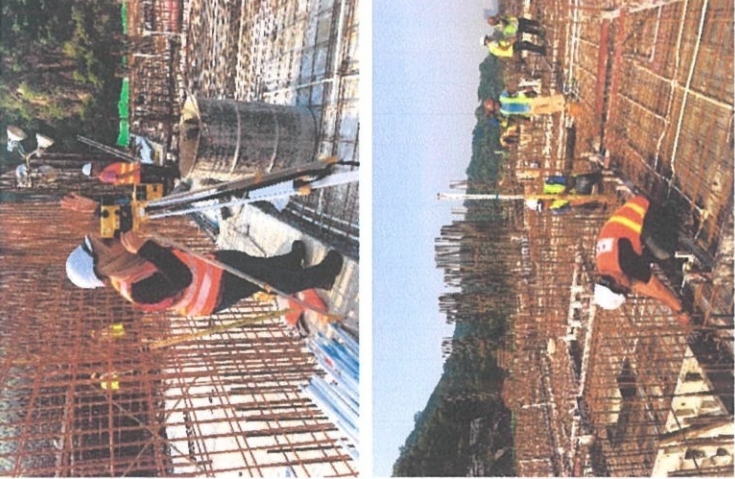
NO	METHOD	SEQUENTIAL DIAGRAM	MANPOWER	MACHINERIES/ TOOLS	DURATION
8.	<p><u>Levelling</u></p> <p>Levelling was done to obtain the absolute height for the concrete slab. The points were marked onto the starter bars as a guidance for concrete slab height with masking tapes.</p>

<ul style="list-style-type: none"> - 1 surveyor - 2 chainman 	<ul style="list-style-type: none"> - automatic level instrument - staff - measuring tape - masking tape 	<p>Takes about 2 to 3 hours to finish each zone depends on the weather.</p>

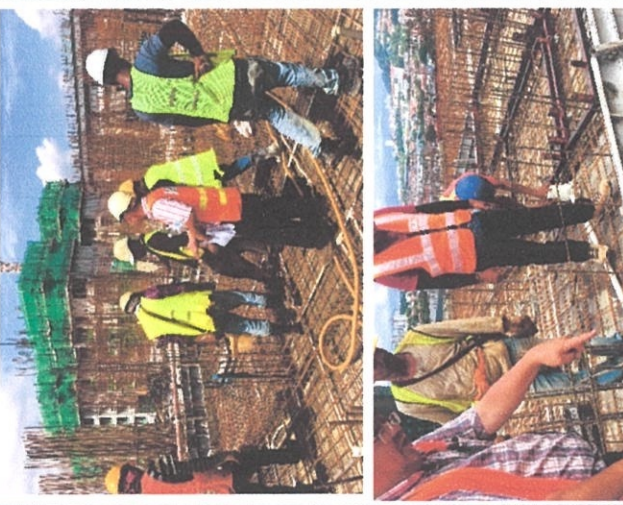
NO	METHOD	SEQUENTIAL DIAGRAM	MANPOWER	MACHINERIES/ TOOLS	DURATION
9.	<p><u>Site Inspection</u></p> <p>After all that has been done, joint inspection was executed with SO's Representative on all steel reinforcement placed to comply with the construction drawings and criteria listed in the drawings. All final alteration will be made during this process.</p>

<ul style="list-style-type: none"> - 1 supervisor - 1 site engineer - 1 laborer - 1 consultant 	-	<p>Around 2 hours to make sure all correction has been made.</p>

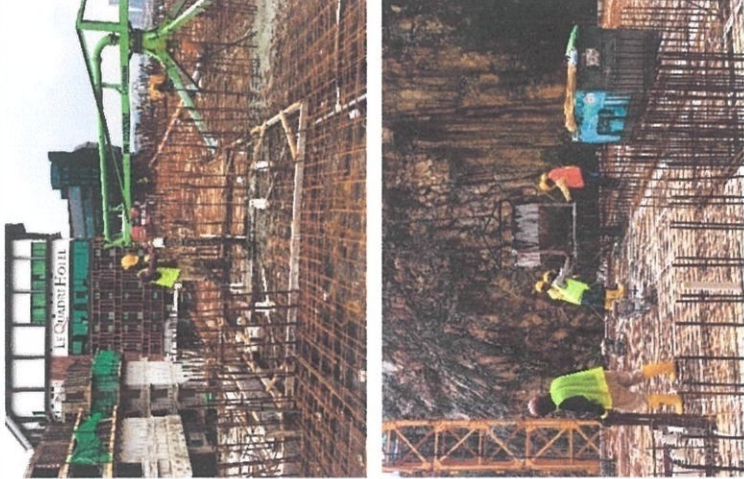
NO	METHOD	SEQUENTIAL DIAGRAM	MANPOWER	MACHINERIES/ TOOLS	DURATION
10.	<p><u>Concrete Casting</u></p> <p>Casting of concrete was done after joint inspection has finished. Concrete is placed onto the slab to cover all bars and services using static pump or concrete bucket. Ready mixed concrete was transferred by mixer trucks from the plant. The concrete was compacted by mechanical vibrators to make sure all the concrete worked into all structural members.</p>

<ul style="list-style-type: none"> - 5 concreter - 1 site engineer - 1 site supervisor - 1 signalman - 1 tower crane operator 	<ul style="list-style-type: none"> - static pump - concrete bucket - shovel - mechanical vibrator - tower crane 	<p>Takes about 10 to 13 hours depends on the zone. The process may take longer if transport was jeopardizing.</p>

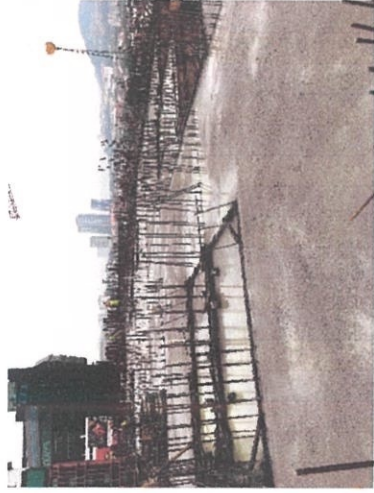
NO	METHOD	SEQUENTIAL DIAGRAM	MANPOWER	MACHINERIES/ TOOLS	DURATION
11.	<p><u>Curing</u></p> <p>After the concrete has been set, it is left to cure. The aluminum formwork can be remove once the concrete is hard enough.</p>

- 1 site supervisor	- curing compound	Takes about half a day or around 13 hours to fully mature.

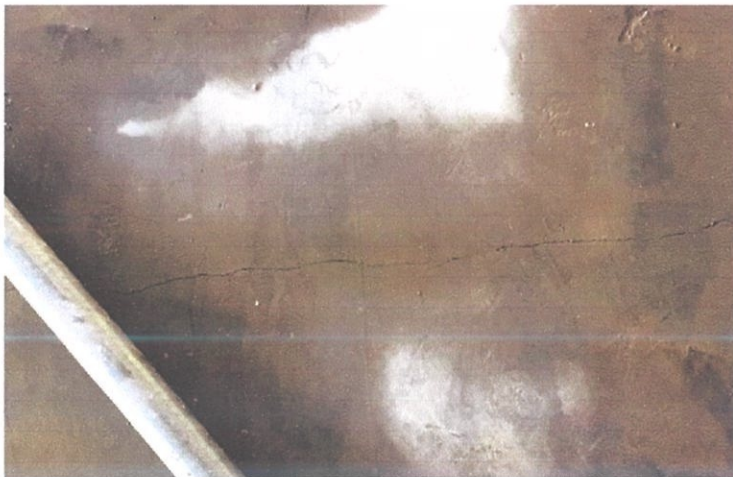
Rapid drying of the slab will significantly increase the possibility of cracking. The chemical reaction, which causes concrete to go from the liquid or plastic state to a solid state, requires water. This chemical reaction, or hydration, continues to occur for days and weeks after pouring of the concrete.

Figure 3.3.1.1: Example of cracking

20mm deep x 20mm wide were saw cut include 10mm on both sides of the RC slab crack lines by using diamond concrete cutter. Next, Slab is hacked by using electrical breakers along the pre-cut cracks to form 20mm x 20mm U' grooves to receive epoxy resin grout. All Losses materials, dust and laitance in pre-hacked grooves are cleaned

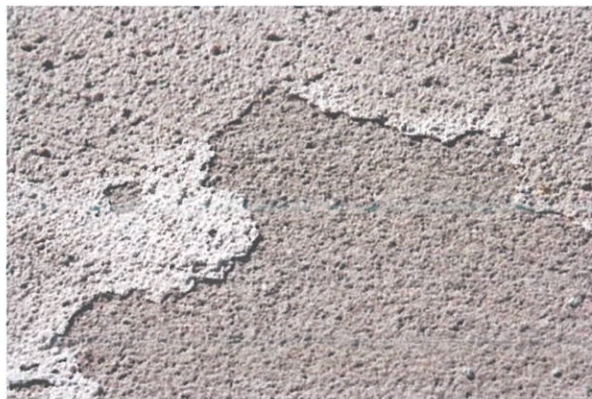
Blisters are formed when bubbles of entrapped air get stuck underneath an already sealed surface and produce bumps of varying sizes. These defects are typically identified when the concrete slab is being laid and simply requires some alteration to the actual concrete mix in order to prevent more blisters from appearing.

Blisters are more of an annoyance than they are a structural problem and shouldn't cause any long-term issues for homeowners. One or a combination of these factors may be responsible: winds blowing over concrete surface and reducing surface moisture; a subgrade that is cooler than the concrete; a sticky mixture with excessive fines that seal the surface quickly; lean mixtures that have to be worked excessively to produce desired finishes; concrete that's finished too early, by hand or machine; and improper use of tools.

Figure 3.3.2.1: Blisters on slab

If blisters are forming, try to either flatten the trowel blades or tear the surface with a wood float and delay finishing as long as possible. Under conditions causing rapid evaporation, slow evaporation by using wind breaks, water misting of the surface, evaporation retarders or a cover of polythene film.

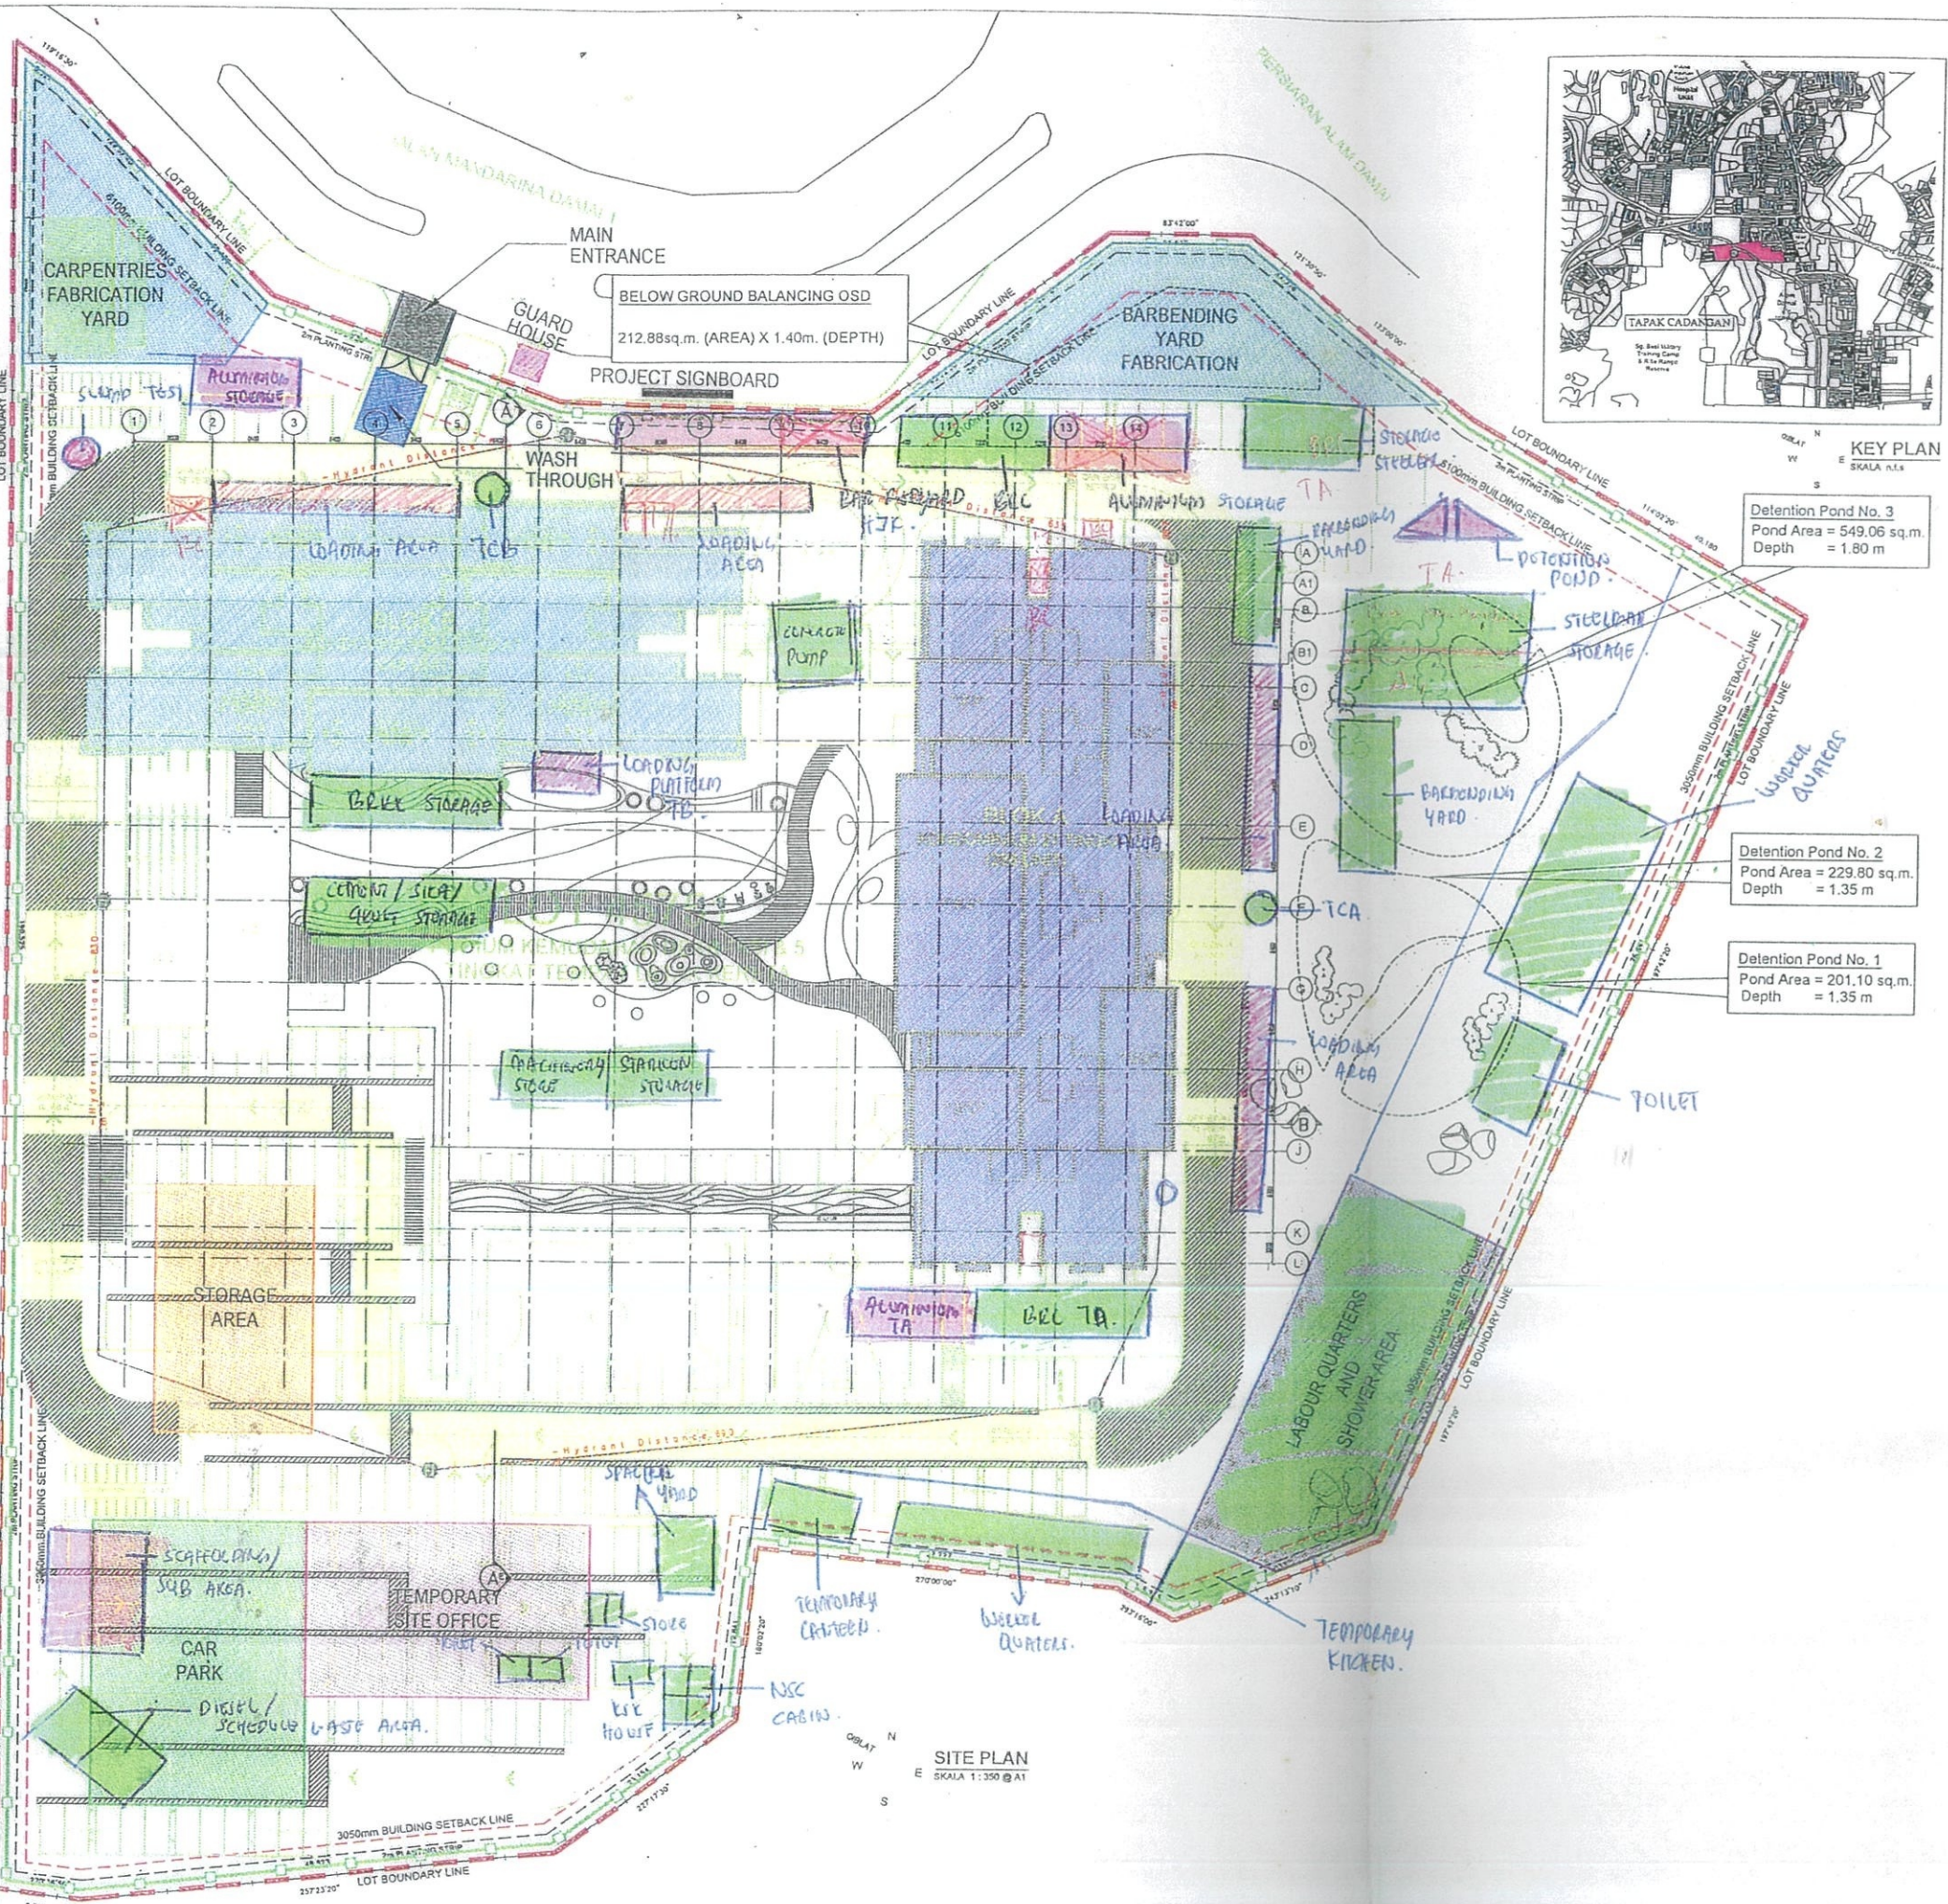
SITE PLAN
SKALA 1:350 @ A1

BELOW GROUND BALANCING OSD
212.88sq.m. (AREA) X 1.40m. (DEPTH)

Detention Pond No. 3
Pond Area = 549.06 sq.m.
Depth = 1.80 m

Detention Pond No. 1
Pond Area = 201.10 sq.m.
Depth = 1.35 m
