EFFECTIVE SHEAR STRENGTH PARAMETERS OF SOIL SAMPLES TAKEN FROM SLOPE FAILURE ALONG THE KULIM – BALING ROAD

Damanhuri Jamalludin[1], Nur Syazana Mohamad Sharom[1], Mohamad Zain Hashim[1], Azura Ahmad[1], Mohd Mustaqim Mohd Nordin[1] and Anas Ibrahim[1]

UiTM Penang, Jalan Pematang Pauh,13500, Pematang Pauh, Penang, MALAYSIA

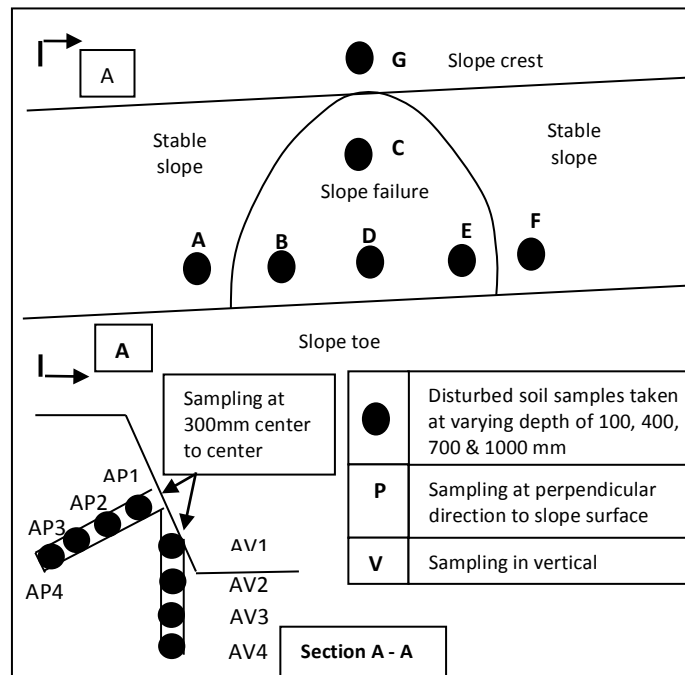
Figure 2: Locations of soil samplings at slope failure zone. Soil samples were taken at varying depths of 100, 400, 700 & 1000mm in both vertical and perpendicular directions.

The disturbed soil samplings are shown in Figure 2. Seven sampling points were selected. At each sampling point, 8 soil samples were collected whereby 4 samples were in vertical direction while another 4 soil samples were collected in perpendicular direction to the slope surface. At both directions, the soil samples were collected at depths of 100, 400, 700 and 1000mm from slope failure surface. Due to limited time, only 5 samples namely BP1, CP1, DP1, EP1 and FP1 were tested from a total of 56 soil samples collected. Soil samples tested in this study were collected at a depth of 100mm in a perpendicular direction to the existing slope surface.

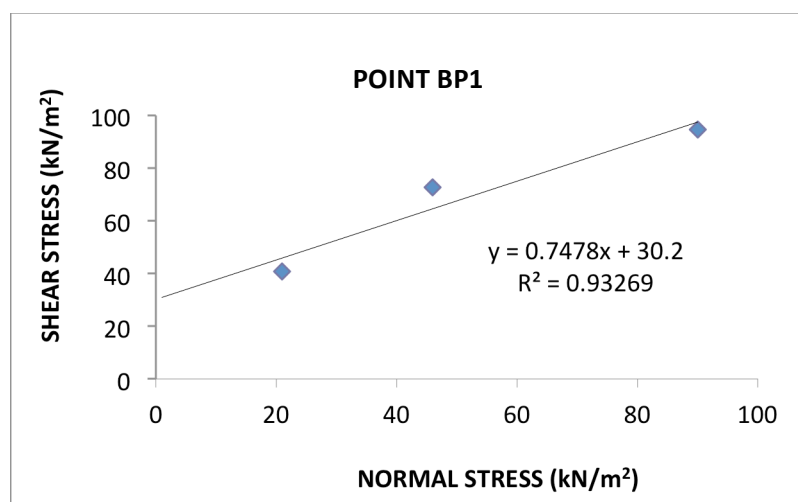
Figure 4: Typical graph of shear stress at failure, τ_f (kN/m^2).versus normal stress, σ (kN/m^2) applied

Figure 4 shows the graph of shear stress versus normal stress. The shear stress is the maximum shear stress obtained from shear stress versus horizontal displacement as in Figure 3. From Figure 4, equation y = 0.7478x + 30.2 can be generated from the graph. From the generated equation, shear strength parameters can be obtained. The friction angle was obtained by using the gradient from the generated equation, meanwhile cohesion was the value of y-intercept from the generated equation. The values of effective shear strength parameters, the results shown in Table 1. The effective shear strength parameters were highly variable where c' varies from 0 to 30.2 kN/m^2 while ø' varies from 22.8 to 47.3^0. This observation was in line with Brenner et al. (1997) where the shear strength parameters of residual soil were highly variable.

y = 0.7478x + 30.2
R² = 0.93269

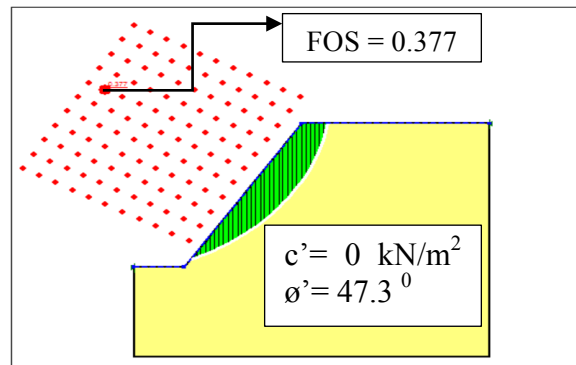
Figure 5: Typical SLOPE/W output using minimum
value of effective shear strength parameters.

Figure 5 shows the SLOPE/W software output where minimum value of FOS was obtained. The SLOPE/W output was using the stable cross section of slope and the shear strength parameters. Water table was considered at the surface of the slope where the slope was assumed to be fully saturated. Table 1 shows the shear strength parameters and FOS obtained. When using the effective shear strength parameters of c'= 0 kN/m^2, ø'= 47.3^0, minimum FOS equal to 0.377 was obtained. The FOS varied from 0.377 to 0.749. However all the FOS in Table 1 are less than 1. Since the FOS < 1, it confirmed that the slope had already failed as what occurred at site.

From Table 1 there are only 5 data of effective shear strength parameters and all the output of SLOPE/W were less than one with soil sample CP1 giving the lowest FOS. This research is at its initial stage where only 5 data out of 56 data were available. When all the 56 data are available, it is expected that extremely high shear strength parameters will be obtained giving FOS > 1. As observed by Jamalludin (2016) even though the soil samples were taken from slope failures, few extremely high values of effective shear strength parameters were found giving the FOS > 1 when analyzed using SLOPE/W software. Due to saturation and loss of negative suction, there was a reduction in values of the effective shear strength parameters. The effective shear strength parameters were not constant and they were in dynamic in nature of as explained by Neoh and Alimat (2002). If any portion of a stable slope having low effective shear strength parameters with FOS < 1, it will trigger the failure. Once the slope cracked and soil stated to move downwards, more rain water will enter the failure zone causing more saturation and loss of more negative suction. Erosion will further cause the slope to fail and become larger. Slope failure has generally occurred after heavy rainfall as described by Morgenstern (2007).
