ESTEEM

Volume 5, Number 1

Experience in Stabilisation of Rock Slopes in Pahang

Two cases regarding the histories of rock slopes repair and stabilisation of unstable boulder along Bukit Cincin to Genting Highlands and along the road from Gap to Fraser Hill in Pahang are presented. On 30th October 1997, 10 locations of road failure occurred along the road from Bukit Cincin to Genting Highland and in December 1997, 33 locations of slope failures occurred along the road from Gap to Fraser Hill during the monsoon seasons. Loose and fractured rocks were removed and covered with polyvinyl chloride (PVC) coated anchored wire netting to prevent rocks fall while rock buttress was used to stabilise unstable boulders in soil slope. The repair works at Location 5 along the road from Bukit Cincin to Genting Highland where highly fractured rock slope and unstable boulder in soil slope occurred and the repair works at Location 10 along the road from Gap to Fraser Hill where highly fractured rock slope occurred are fully discussed in this paper.

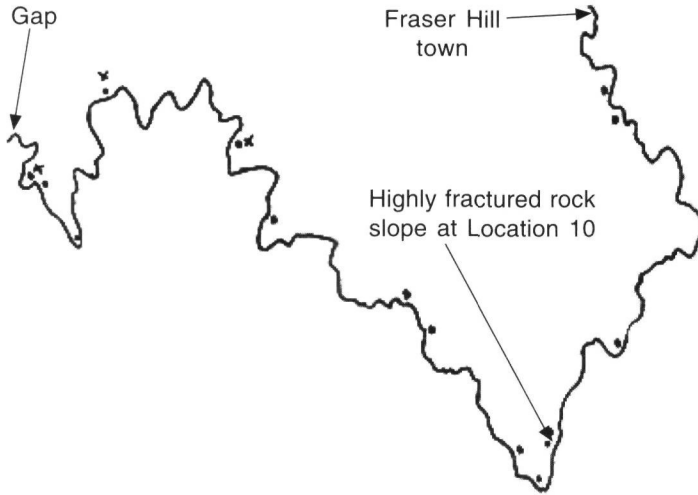
The Gap route to Fraser Hill links the town of Kuala Kubu Bharu in the state of Selangor and Raub in the State of Pahang via the hill resort of Fraser Hill, which is about 300 m above the mean sea level. Figure 1 shows the location plan of Fraser Hill. The newly constructed road is supposed to ease the congestion of the present route to Fraser Hill, which is quite narrow and cannot cater for two-way traffics. Before the completion of the new route, vehicles going up and down the Fraser Hill have to queue up and wait for their turn. Once completed, the existing route was used as the road leading up to Fraser Hill from Gap while the new route allowed vehicles to travel down from Fraser Hill to Gap. The new Gap route was about 9 km long and the total cost was RM25 million. The road has a maximum climbing gradient of about 15%. The slope failures occurred in December 1997 during the monsoon season and they occurred during the defect liability period which ended in August 1998. After the occurrence of the slope failures, an assessment of the new road was carried out to identify the existing and potential slope instability problems. A selective tender was called in May 1998 so that repair works can be carried out. A total of 33 locations of slope failures were identified along the route. Only the repair works at Location 10 is fully described in this paper. Figure 3 shows the location of the highly fractured rock slope at Location 10.

Figure 3: Plan Showing Highly Fractured Rock Slope at Location 10 along the Road from Gap to Fraser Hill Town
