**MANAGEMENT AND SUPERVISING OF MECHANICAL AND
ELECTRICAL WORK AT PHASE 2 THE HAVRE BUKIT JALIL**

**Prepared by:
AZAD BUKHARI BIN AZIZ
2016458536**

**DEPARTMENT OF BUILDING
FACULTY OF ARCHITECTURE, PLANNING AND SURVEYING
UNIVERSITI TEKNOLOGI MARA
(PERAK)
DECEMBER 2018**

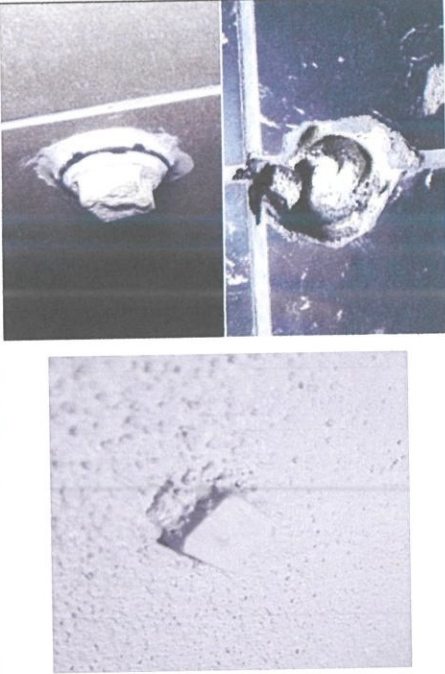
NO	WORK	DIAGRAM
1	<p>Cold water point</p> <ul style="list-style-type: none"> • The cold water is not allowed to install over the wall tile level like the Figure • Also when the cap is sink in the wall tile level • It must be in same level like third Figure

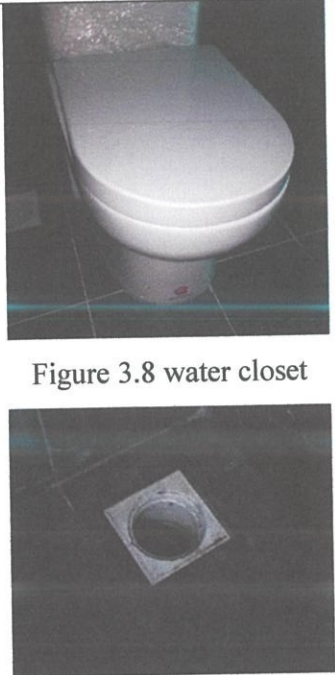
<p>Figure 3.8 water closet</p> <p>Figure 3.9 floor trap</p>

<p>Figure 3.7 Cold water point</p>
2	<p>Sanitary ware and floor trap</p> <ul style="list-style-type: none"> • Related for units • The water closet and basin must have a layer of protection • To keep the quality of material and thrusworthy of customer • Floor trap must be closed to prevent cement and trash turn inside

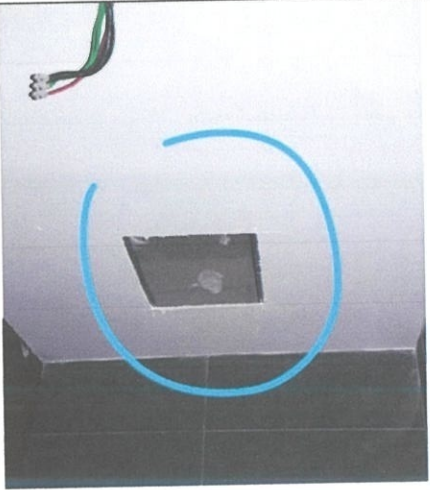
<p>Figure 3.10 opening ceiling</p>

<p>3</p>	<p>Ventilation ware</p> <ul style="list-style-type: none"> • Only for toilet with no window • Check the opening and dimension first • Inform sub-contractor to install the exhaust fan

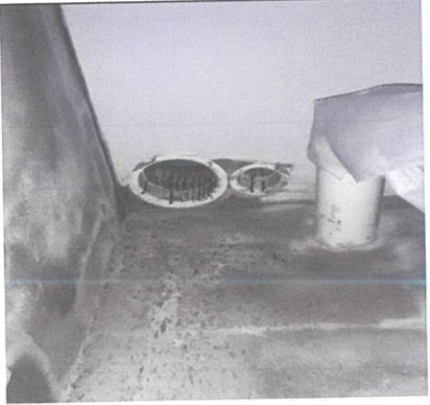
<p>Figure 3.12 floor pipe opening</p>

<p>Figure 3.11 Exhaust fan</p>
<p>4</p>	<p>Yard pipe</p> <ul style="list-style-type: none"> • Check the wall render and paint finish first one day • Check the wall skirting for not use the pipe opening • Install the pipe <p>Balcony rain pipe</p> <ul style="list-style-type: none"> • Check the wall render finish first with one day • Check the balcony tile, cut to size of pipe done • Install the pipe

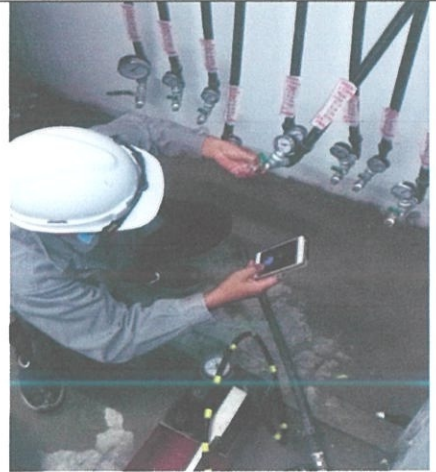
<p>7</p>	<p>Clerk of work inspection</p> <p>Pressure test</p> <ul style="list-style-type: none"> • Close the cold water point in units • Install the gas meter at meter room • Pump gas 100 psi to every unit with meter • After a day check the pressure, fall 20 psi is allowed

<p>Figure 3.17 install water tank</p> <p>Figure 3.18 pressure test</p>

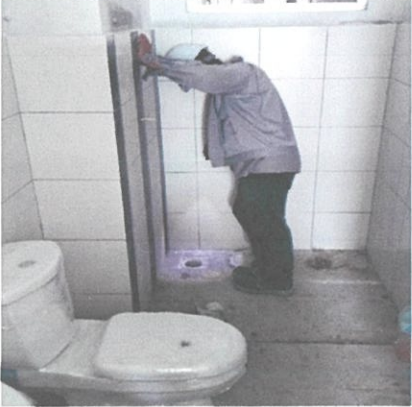
<p>Figure 3.19 flow test</p>
--	--	---

<p>Flow test</p> <ul style="list-style-type: none"> • Give water to discharge pipe below the basin in kitchen and toilet • Make sure the water flow seen in the floor trap

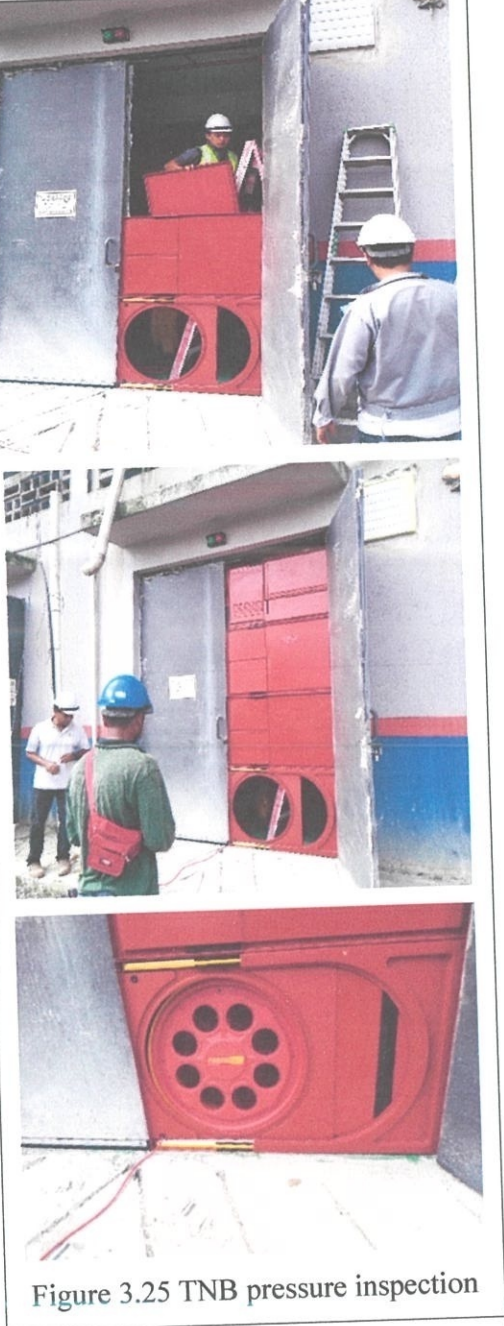
<p>5</p>	<p>TNB room inspection</p> <ul style="list-style-type: none"> • The area and inside is clean and clear from water and leakage • Part involve is main-contractor supervisor, TNB Officer and their staff, related sub-contractor supervisor, Clerk of work • To check the air pressure inside the room for burning purpose • Closed all the opening at door leaf slit and exhaust fan with masking tape • The portable door is installed and the fan is open to give pressure

<p>Figure 3.25 TNB pressure inspection</p>
<p>6</p>	<p>Clerk of work inspection</p> <p>Meggar Test</p> <ul style="list-style-type: none"> • To check all the cable is function and no shot • The meggar box is inspect first before apply on site

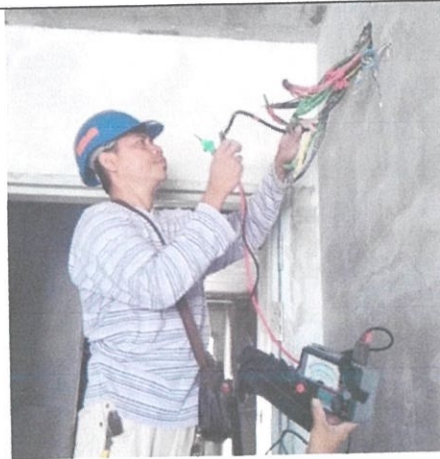
Figure 3.26 Meggar test

- First check the 1000W cable, it has 3 nos. It is from riser to unit
- Second check the 600W cable that connect to every plug and switches in unit
- If the needle move a bit, the reading is accepted, if the needle move fast, there has short wire
- The short caused by wire rolling or sink in the wall

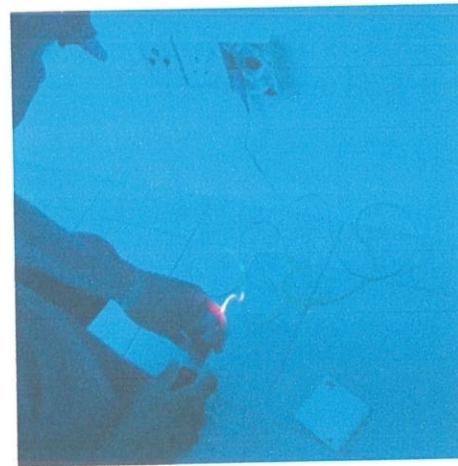
Figure 3.27 continuity test

Fiber Optic Test/Continuity Test

- To make sure the fiber cable is in good condition without bend in the pipeline.
- Worker torch the laser light in the unit
- Inspector stand at ELV Riser that connect to all units
- The good condition is the cable at riser will be light up

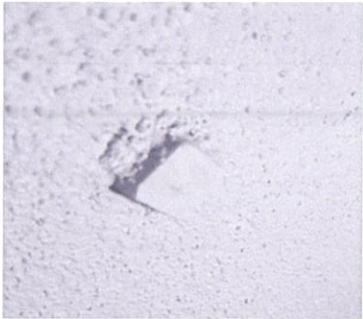
NO	WORK	DIAGRAM
1	<p>Quality installation (piping and electrical)</p> <ul style="list-style-type: none"> • Check after the installation • The peeling of paint will repair with skim coat • The condition of pipe must be 100% perfect

<p>Figure 3.29 correct water point</p>
2	<p>Lift inspection</p> <ul style="list-style-type: none"> • Inspect by JKKP • The lift motor room must be clean and dry from watermark and water pond • Check the room, car speed, car top, lift pit, the button accuracy, door leaf speed

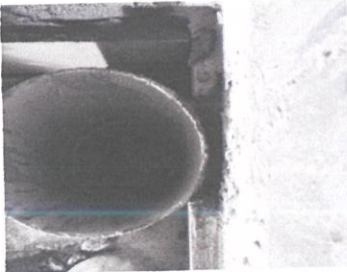
NO	PROBLEMS & SOLUTION	DIAGRAM	PARTY INVOLVE
1	<p>Piping work</p> <ol style="list-style-type: none"> 1) Ask permission from architect department to repair the point if the tile broke with proper information 2) Inform to sub-contractor to repair the point in given date 3) After finish, inform to architect department to repair the finish. <ol style="list-style-type: none"> 1) When the skirting disturb the pipe area, ask the tiler to cut and customize the size 2) Then ask the plumber to install the pipe

<p>Figure 3.42 yard skirting tiles</p>	<ul style="list-style-type: none"> • Mechanical and electrical department • Architect department • 1 plumber/work • 1 tiler

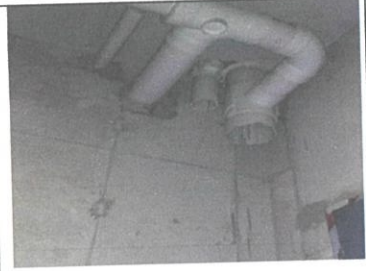
<p>Figure 3.48 yard pipe</p>

<p>Figure 3.47 mistake cutting position</p>	<ul style="list-style-type: none"> • Mechanical and electrical department • Architect department • 1 sub-cons worker • 1 plasterer • 1 tiler
<p>4</p> <p>Operation procedure</p> <ol style="list-style-type: none"> 1) The render work will start first before anyone take place 2) Once render finish, either pipe or paint can start work 3) Inform to plumber to break the pipe and give way to renderer run their work 4) Once finish a day, the pipe may install
