Settlement Monitoring of Georehabilitation Solution at Bridge and Culvert Approaches using Polyurethane Foam Injection System

Keywords: Bridge Approach, Culvert Approach, Differential Settlement, Georehabilitation, Polyurethane Foam

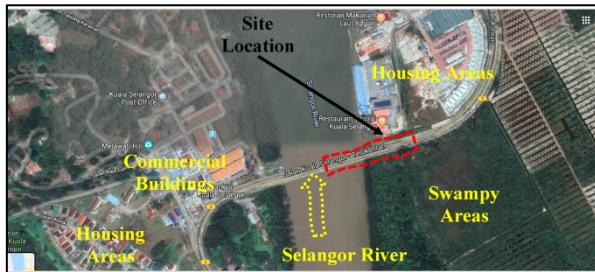
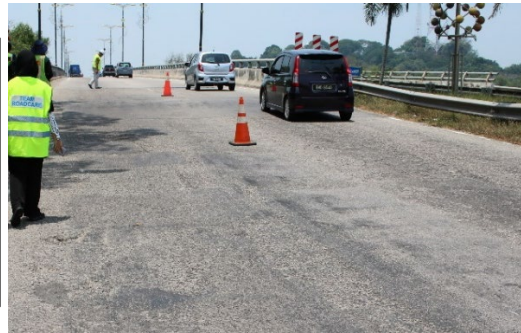
The site topography at the Sultan Salahuddin Abdul Aziz (SSAA) Bridge or known as Kuala Selangor Bridge consists of flat terrain surrounded by commercial building, housing areas and the most important thing is swampy near the bridge approach as shown in Figure 4. The swampy areas surrounded all over the bridge is

one of the main factor that contributes to the settlement process of the transition section underlain the road on the viaduct section (Zainuddin *et. al.*, 2021).

Figure 4. Site location of Kuala Selangor Bridge (a) Plan view of the bridge; and (b) Photo of the bridge from west bound to Klang view.

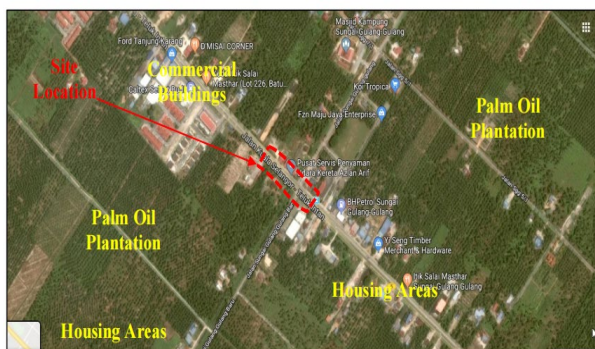
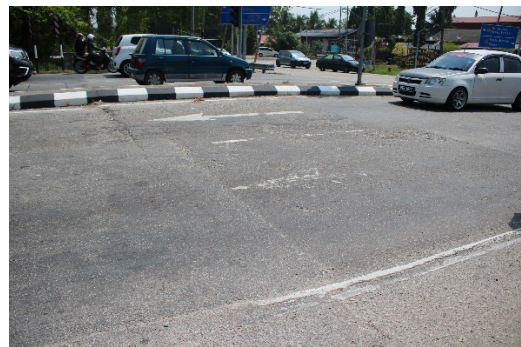
The topography at the Jalan Sungai Gulang-Gulang consists of flat terrain surrounded by commercial building, housing areas and agricultural land as shown in Figure 5. The settlement occurred on the left and right side of the box culvert causing undulation and discomfort to the traffic users.

Figure 5. Site location of a box culvert at Sg. Gulang-Gulang (a) Plan view of box culvert; and (b) View the carriageway from Klang to Sabak Bernam.

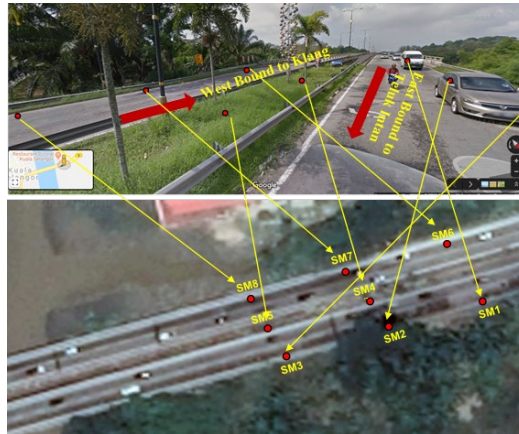
Figure 11. Location of the settlement markers at Kuala Selangor bridge approach.

Based on the eight (8) recorded data observed, it can be concluded that the settlement readings for all the settlement markers during the period of 14 months are considered within tolerable limits which is 250mm/5 year (total settlement) and 100 mm/5 years (differential settlement). After a year, at settlement markers SM 2 and SM 3 which is located on the compacted fill showed that the road experienced drastic settlement just after the PU foam injection location. PU foam expands and plug the edge of piled embankment and filled the cavities. At the same time, it densifies and increases the soil beneath the structures. The settlements at SM 4 and SM 5

are slowly increased because at median of the approach, there were no injection points located. All the data varied within 14 weeks due to uplifting since the buoyancy characteristic of the PU foam and rearrangement of soil particles to achieve a stable compaction condition. The deformation presented in Figure 13(a) and Figure 13(b) showed either settlement or uplifting due to buoyancy effect of the PU foam injected at Kuala Selangor Bridge.

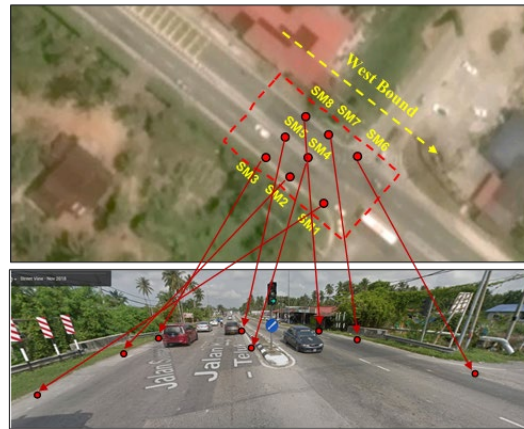
Figure 12. Location of the settlement markers at Sg. Gulang-gulang culvert approach.
