**TITLE
BUILDING CONDITION ASSESSMENT: DAMPNES**

**NURDIYANA BINTI MOHD SOBRI
2010357149
DIPLOMA IN BUILDING SURVEYING**

PRACTICAL TRAINING REPORT

AMAS FM Consultant Sdn. Bhd. (AFC) was engaged by Etiqa Insurance Bhd to conduct a Building Condition Assessment exercise at Akademi Etiqa. AMAS FM Consultant is a building surveying consultant that provides building surveying and asset management consultancy.

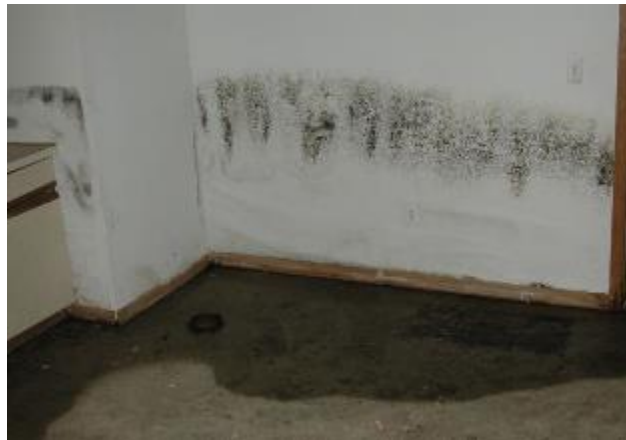
Figure 1.4 Dampness due to ground water

(a) Dampness due to Ground Water for all buildings are founded on soils. Soil holds water for a long time. Sometimes water level may rise and come in contact with foundation. Due to capillary action moisture from ground rises into foundation, floor and even in wall.

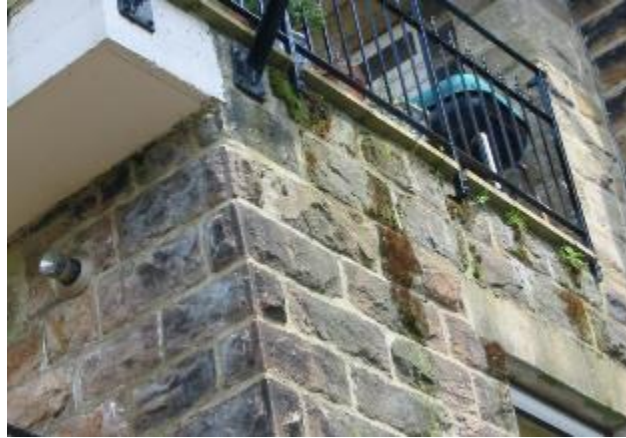
Figure 1.5 Dampness due to rain water

results into entry of rain water into roof and wall. Although, Improper slopes to roof in flat roofs, can cause for the dampness of roofs. If slope is not given properly, water ponds are formed on the flat roof, which results into entry of water into slab. Once water enters the slab it remains for long time creating dampness. Other than that are Leakage from Pipes: From over head tanks, pipes are taken over roof and along the wall. From bathrooms, toilets and kitchen water is drained out with different types of pipes. The pipes are joined to get required length and turns. Many times water leaks through joints resulting into moisture in building components.

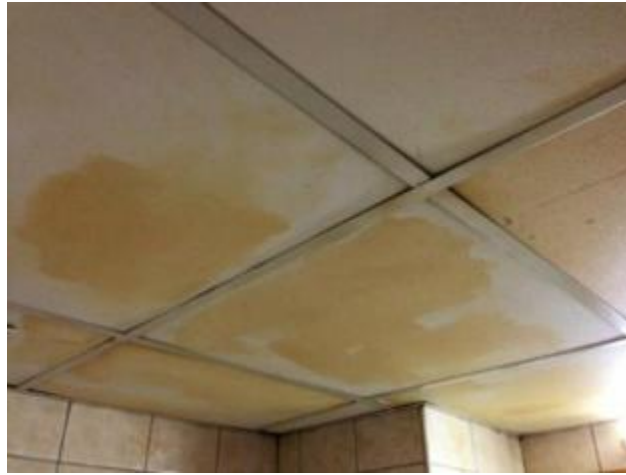
Figure 1.6 Stain on ceiling

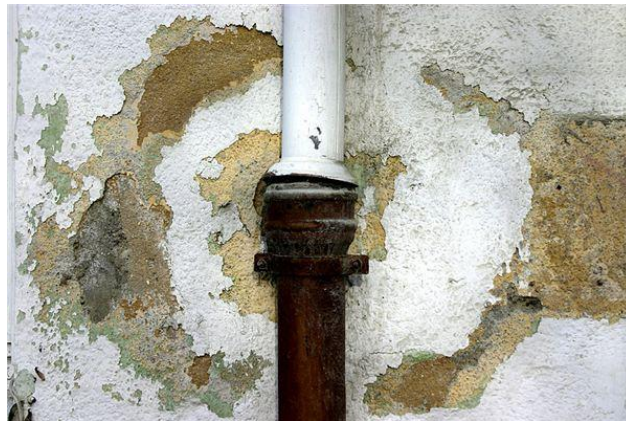
Figure 1.7 Stain on wall surface
