**THE WORK FLOW OF BUILDING INSPECTION AT TRAINING NURSE HOSTEL  
(BLOCK E)**

**NUR FARHANAH BINTI MA'ZIN  
2015881846  
DIPLOMA IN BUILDING SURVEYING**

**PRACTICAL TRAINING REPORT  
MARCH – JULY 2018**

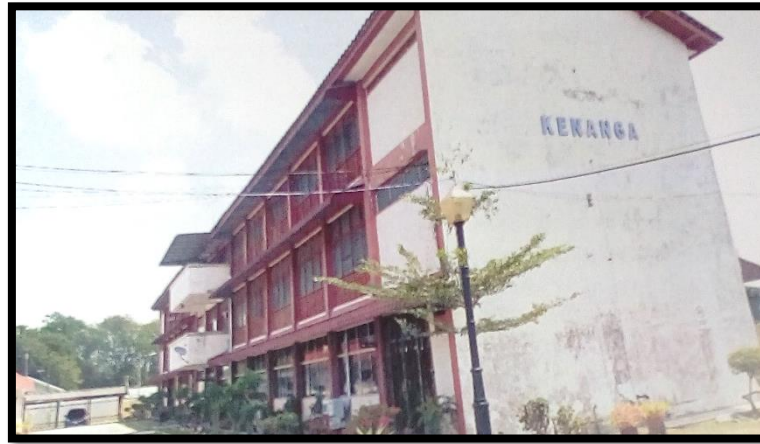
Figure 3.1: Training Nurse Hostel (Block E).

In this section the officer identifies the additional staircase in the critical condition which is they found a large crack on the parapet wall of the additional staircase. The additional staircase will be worse if the occupants on the building continue used it. For the safety aspect, the additional staircase is requested to close temporarily for detail inspection from the professional team.

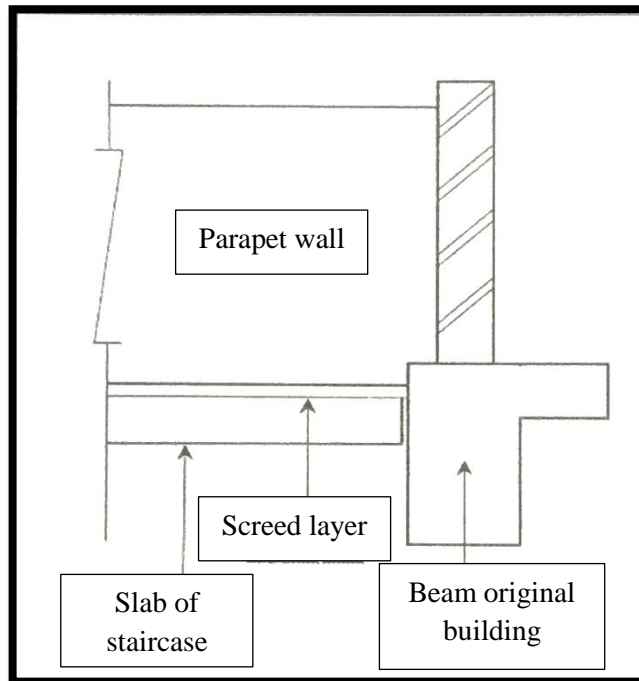
Figure 3.14: sketches existing connection on site

The visual observation found that the outside staircase structure was constructed separately from the original building structure. However, the parapet walls of the staircase and floor layers were constructed on the outside structure of staircase and the beam of the original building. From the observation, the parapet wall is attached to the wall in the original building through the mortar bond.

The cracking on the parapet wall and the floor layer may be due to the deposition of additional staircase structure where the suspended soil under the base of additional staircase has undergone secondary consolidation following the receipt of additional loads.

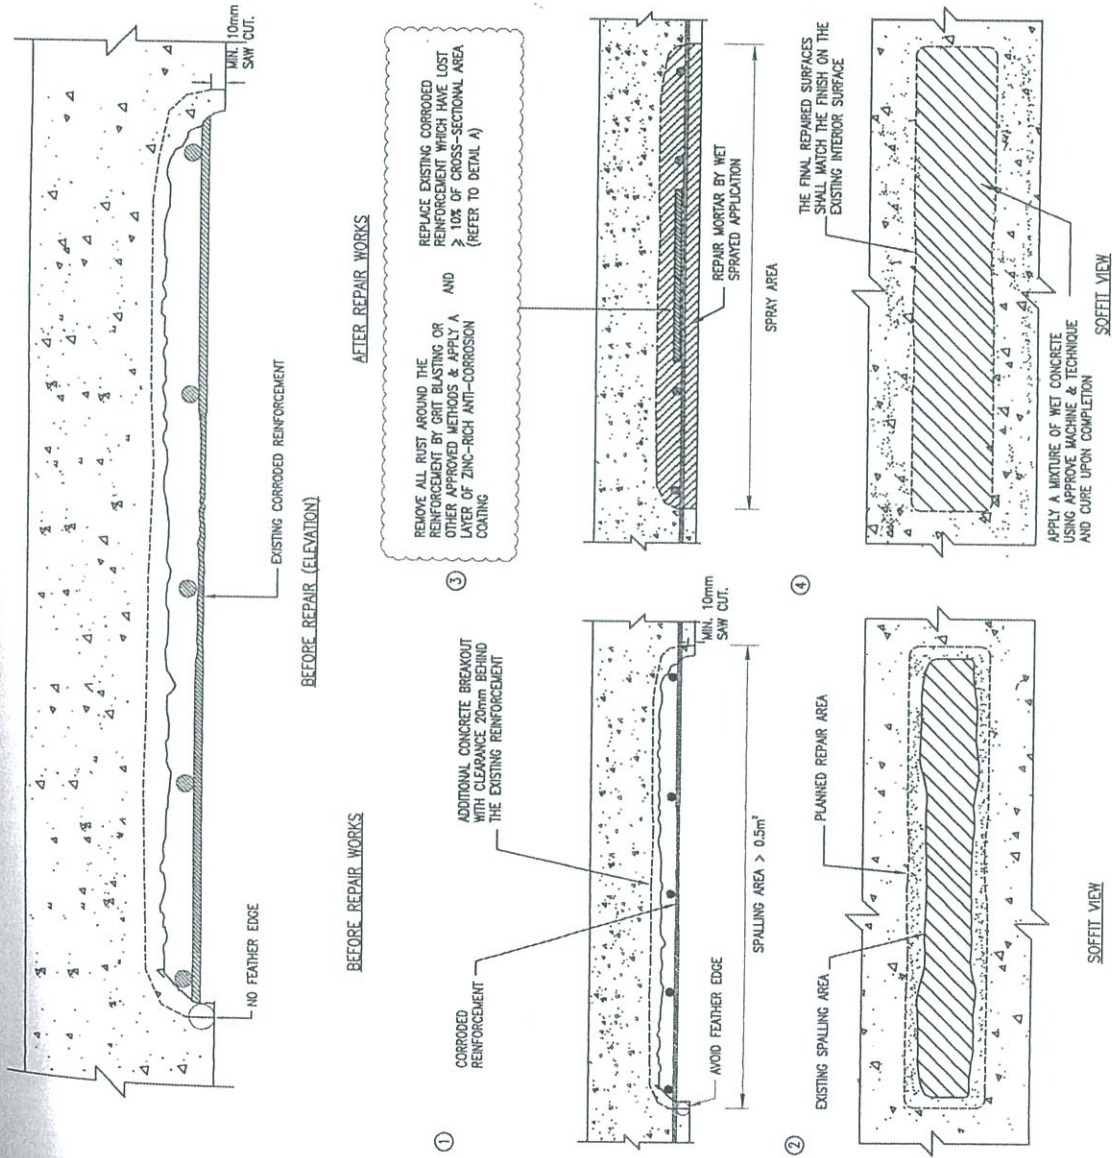
**CONCRETE REPAIR BY SPRAYED CONCRETE FOR CORRODED REINFORCEMENT**

Concrete spalling and concrete delamination on stairs soffit and slab stems from corrosion of steel reinforcement. the corrosion reinforcement of steel is due to the oxidation reaction of steel reinforcement with the presence of oxygen and water.

Typically, oxidation responses occur when a passive protective layer of steel reinforcement is destroyed by long carbon coating activity. In addition, inadequate concrete cover also contributes to increased carbonization rates
