**BUILDING FORENSIC INVESTIGATION OF COLLAPSE HALL
AT CURE & CARE REHABILITATION CENTER (CCRC),
PERLOP**

**PREPARED BY:
MUHAMMAD AIDIL QAYYUM BIN MOHAMMAD RUSLI
2019236012**

Practical Report

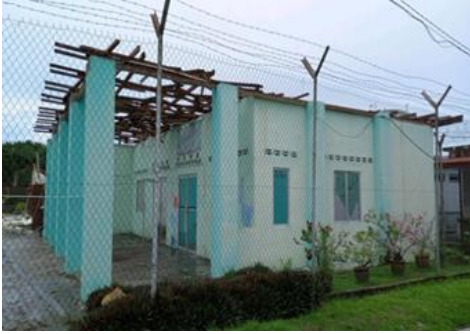
<p data-bbox="467 1070 826 1099"><i>Figure 10 Trusses replacement work</i></p>	<p data-bbox="927 696 1390 837">The roof has been dated in advance for trusses replacement work to be carried out by the contractor</p>
2

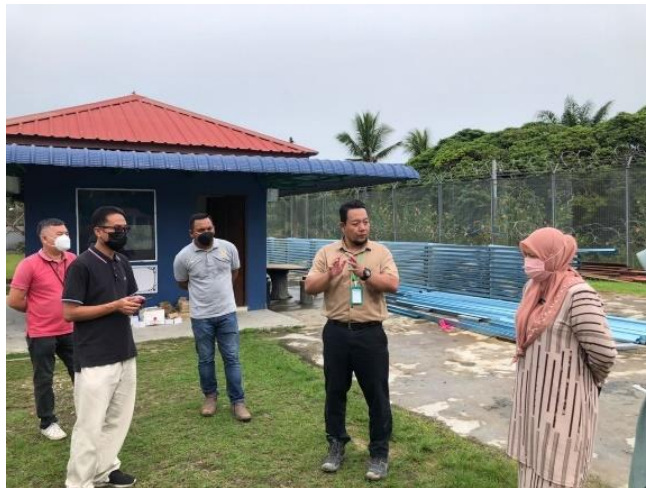
Figure 22 Discussion between PWD Engineer and CCRC Owners

Discussions with parties or representatives from the premises about the history, events before and after the damage occurred (as shown as figure 22). Based on all of the information gathered, the forensic investigator constructs, tests, documents and then provides a reasoned explanation of the cause, effect and possibly the recommended remedy for the building or building environment concern under investigation.
