DEFECT IN CONSTRUCTION SITE

**Prepared by:
MUHAMMAD HARITH HAZIQ BIN ABDUL AZIZ
2019435976**

**DEPARTMENT OF BUILDING
FACULTY OF ARCHITECTURE, PLANNING AND SURVEYING
UNIVERSITI TEKNOLOGI MARA
(PERAK)**

FEBRUARY 2022

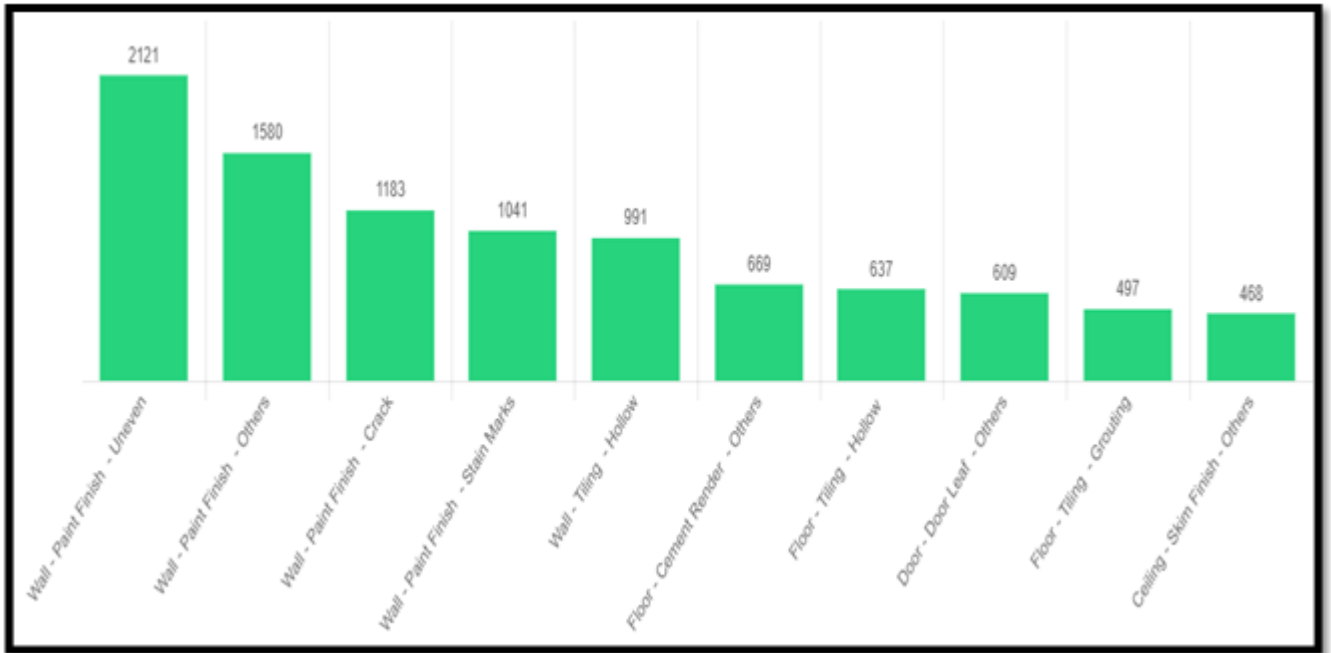
Figure 3.1: Common Defect Occurs in TA207 Obtained from DMS.

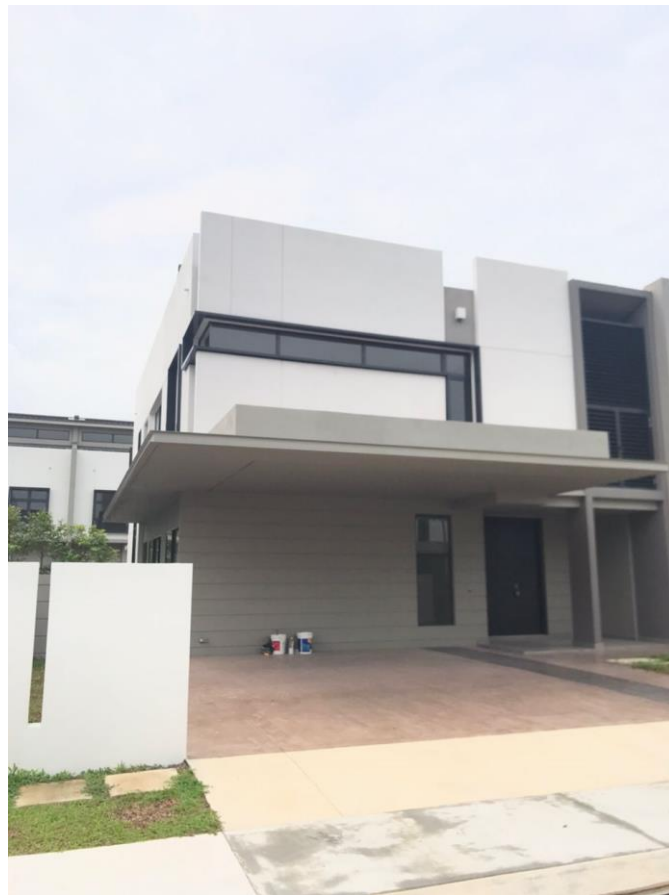
Figure 3.2: House unit 66.

221	Wall, Paint Finish, Crack	External Area	Crack line on wall surface, moss growing on roof drainage, sign of water ponding.	 	In Progress	2021-09-28 07:43:42 (Submit In Progress - Gunasegaran a/j S.Krishnasamy(Customer)) Remark: Crack line on wall surface, moss growing on roof drainage, sign of water ponding.
222	Floor, Cement Render, Others	External Area	damaged roof tile.	 	In Progress	2021-09-28 07:44:07 (Submit In Progress - Gunasegaran a/j S.Krishnasamy(Customer)) Remark: damaged roof tile.
223	Wall, Paint Finish, Crack	External Area	crack line on wall surface	 	In Progress	2021-09-28 07:44:32 (Submit In Progress - Gunasegaran a/j S.Krishnasamy(Customer)) Remark: crack line on wall surface
224	Wall, Paint Finish, Crack	External Area	Crack line & dented wall surface. Loosen roof tiles.	 	In Progress	2021-09-28 07:45:07 (Submit In Progress - Gunasegaran a/j S.Krishnasamy(Customer)) Remark: Crack line & dented wall surface. Loosen roof tiles.

225	Floor, Cement Render, Others	External Area	missing roof ceiling.	 	In Progress	2021-09-28 07:45:35 (Submit In Progress - Gunasegaran a/j S.Krishnasamy(Customer)) Remark: missing roof ceiling.
226	Wall, Paint Finish, Crack	External Area	crack lines on wall surface.	 	In Progress	2021-09-28 07:45:57 (Submit In Progress - Gunasegaran a/j S.Krishnasamy(Customer)) Remark: crack lines on wall surface.
227	Wall, Paint Finish, Crack	External Area	crack lines on wall surface.	 	In Progress	2021-09-28 07:46:20 (Submit In Progress - Gunasegaran a/j S.Krishnasamy(Customer)) Remark: crack lines on wall surface.

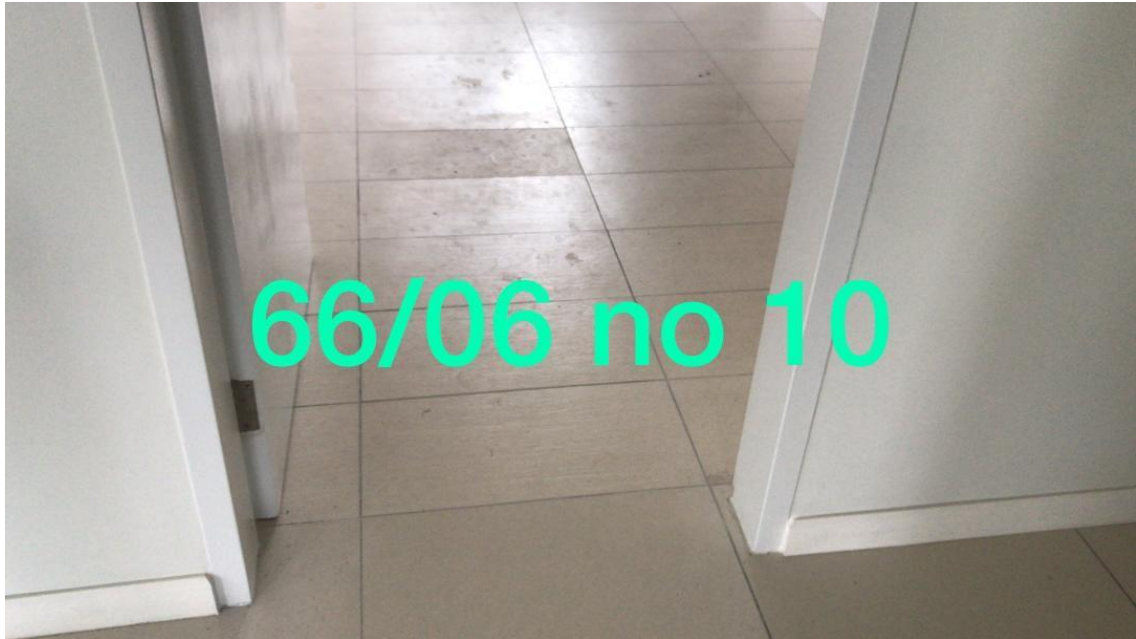
Figure 3.5: Defect Closing Picture.

When the rectification works is done, the site supervisor will take a pictures of defect that has been fixed refer to the defect list and do an inspection and closing the defect. After that, the site supervisor need to close the defects in Defect Management System (DMS) produced by developer.

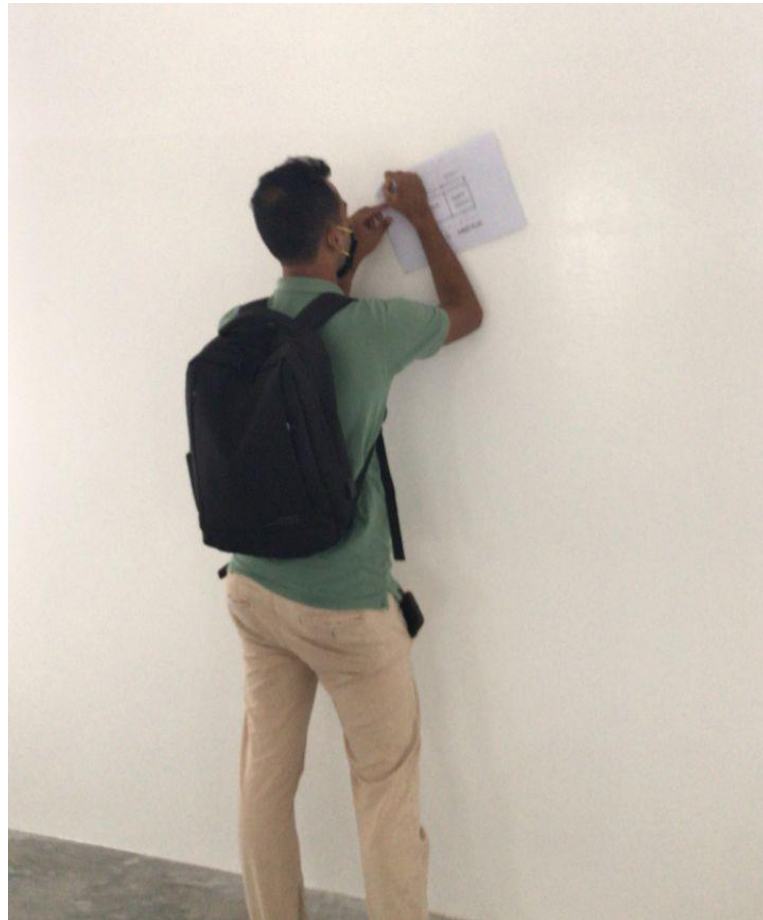
Figure 3.6: Verification Works at Site.

Submit the closing defect in DMS list. The Clerk of Work (COW) or Vacant Possession team will receive the closing defect and they will verify the defects either the defect is done or not at site.
