**FACULTY OF ARCHITECTURE, PLANNING AND
SURVEYING**

DIPLOMA IN BUILDING

**PRE-CONSTRUCTION DILAPIDATION SURVEY ON
BUILDING AND ROAD INFRASTRUCTURE AT SUNGAI ARA
PENANG**

FEBRUARY 2022

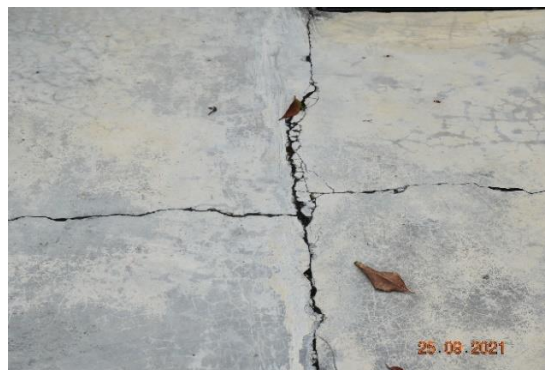
Figure 3.12: Inspection survey.

After getting the permission and appointment date from the property owner, an inspection of the building will be started. Lastly, taking all the defects photo that existed in the property houses by using a camera.
