**PERIODICAL BUILDING INSPECTION UNDER
ACT 133 AT SUMMIT SUBANG USJ**

PRACTICAL TRAINING REPORT

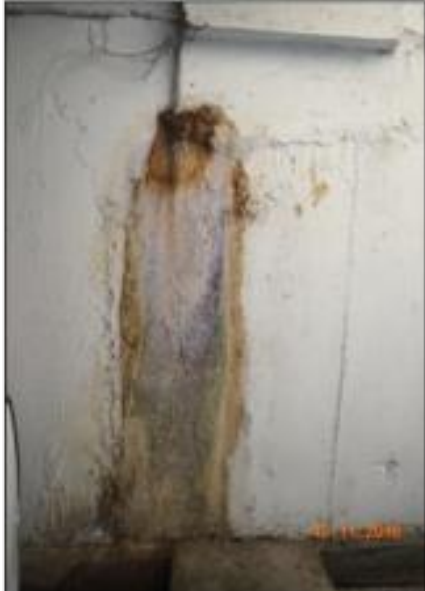
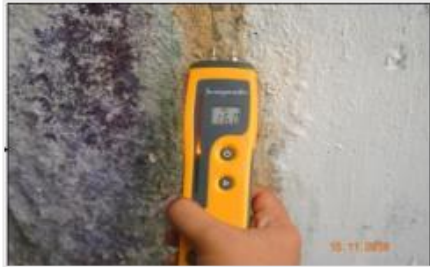
No. Helaian Kecacatan	L-02	Aras		Tingkat Bawah		
	Lokasi			Parkir			
	Elemen/komponen			Dinding Bawah Tanah			
	BARIS						
	Kondisi	Keutamaan	Matriks	Warna			
	4	3	12				
	Keterangan Kecacatan						
	Kesan resapan air, lembab, berkarat dan <i>time leaching</i>						
	Punca Kecacatan						
	Disebabkan oleh pengaliran air bawah tanah secara berterusan dan menyebabkan berlakunya tindak balas pada bahan konkrit.

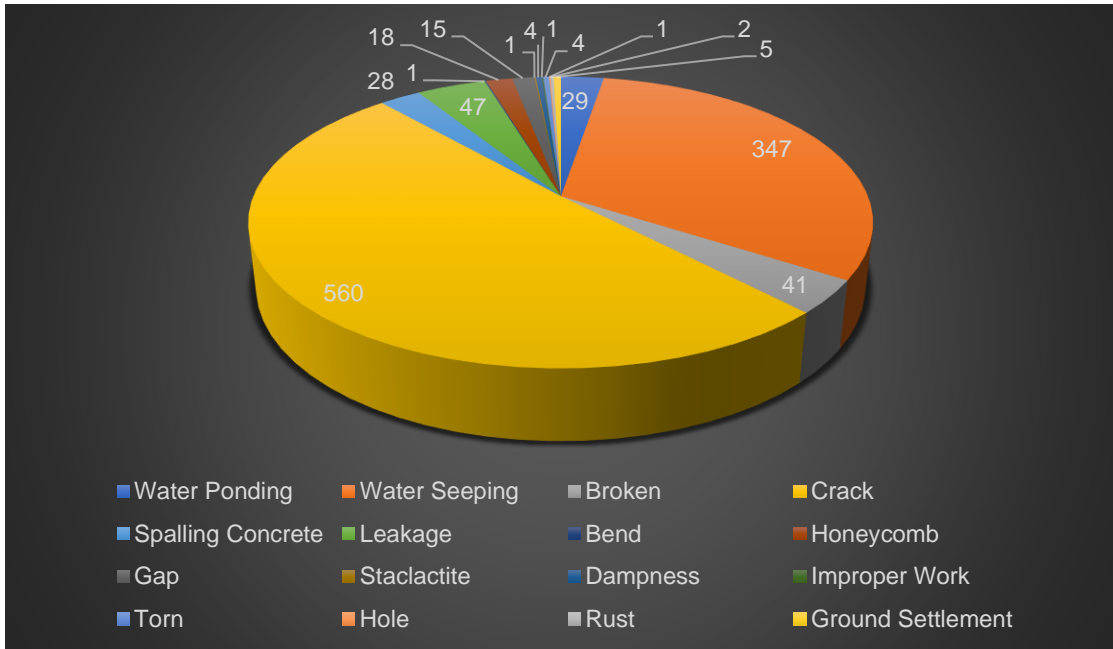
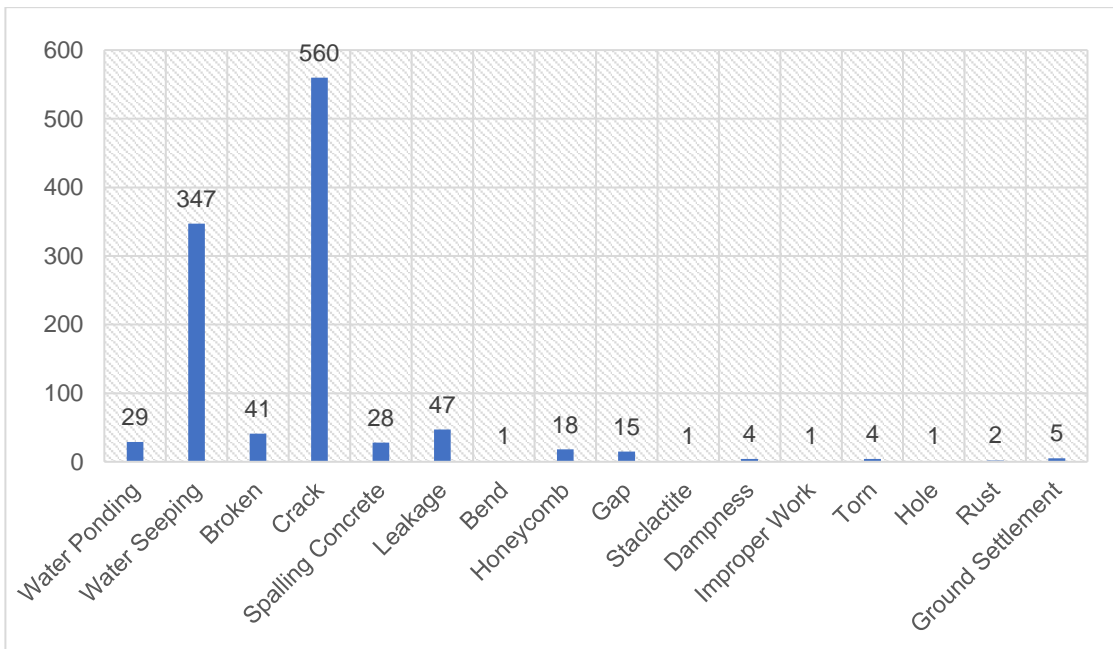
Figure 3.2 (a) and (b): Defects Analysis by Category

Based in figure 3.2 (a) and (b), the highest number of defect type are crack with 50.72% (560) cracks detected in the building. This may be due to ground settlement and load issue. There are three types of defects can be classified within the building. These types of defects can be categorised as major, medium and fair crack. Majority of major crack found on wall elements, while medium and fair crack have been found on every elements of the building which includes concrete ceiling, wall, column, and floor structure.

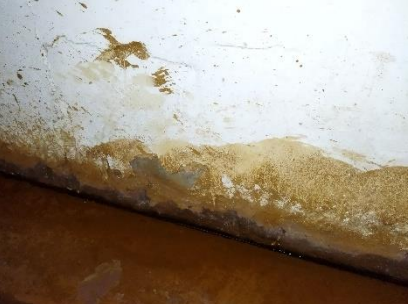
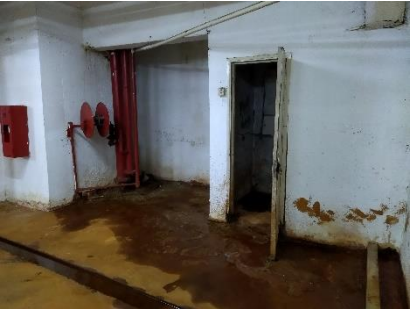
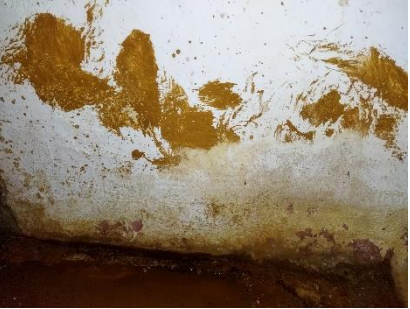
No. of Defect Sheet	A-265	Level	Basement 3

Location	Hotel Parking		
		Element / Component	Wall

BARIS			
		Condition	Priority	Matrix	Color
		4	3	12	
Defect Description					
Water seeping					
Possible Causes					
Due to continuous flow of groundwater and causing the reaction on the concrete material.
