**BUILDING DEFECT MANAGEMENT : A CASE STUDY AT THE
HAVRE BUKIT JALIL**

PREPARED BY :
MUHAMAD AFIQ HAKIM BIN SHAMSUL ANUAR
2016614386

**HIGH-RISE BUILDING UNIT DEFECTS MANGEMENT PHASE 2A, THE HAVRE
BUKIT JALIL**

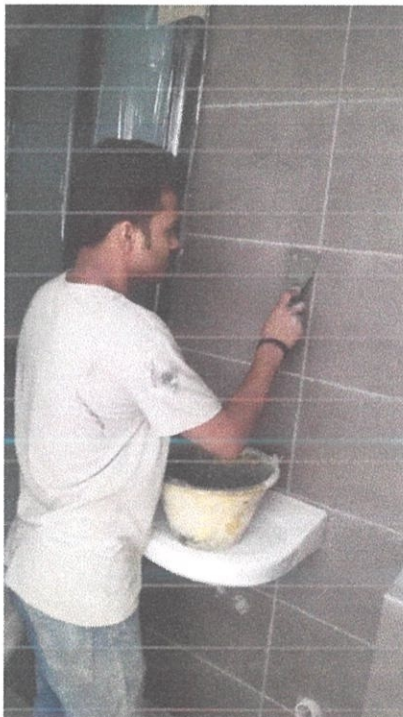
The bathroom defects are grouting, chipping of tiles and holes on the ceiling. For grouting and chipping of tiles, the sub-con needs to immediately come to the bathroom to see the defects. After a few discussion was made, all of us came up with the solution which are grout for grouting defects and welding for chipping tiles defect.

Figure 3.24 : Grouting works

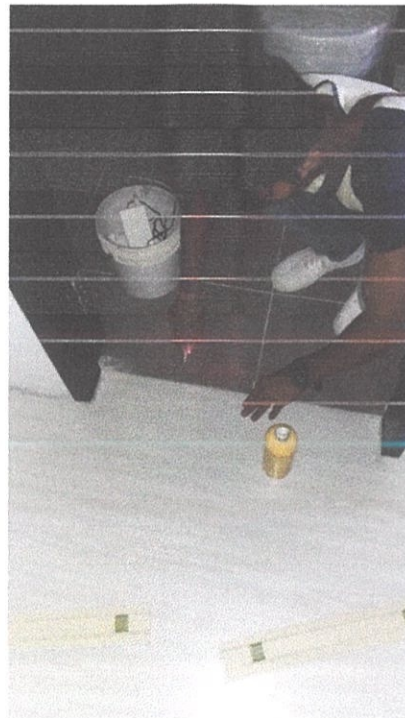
Figure 3.25 : Welding works

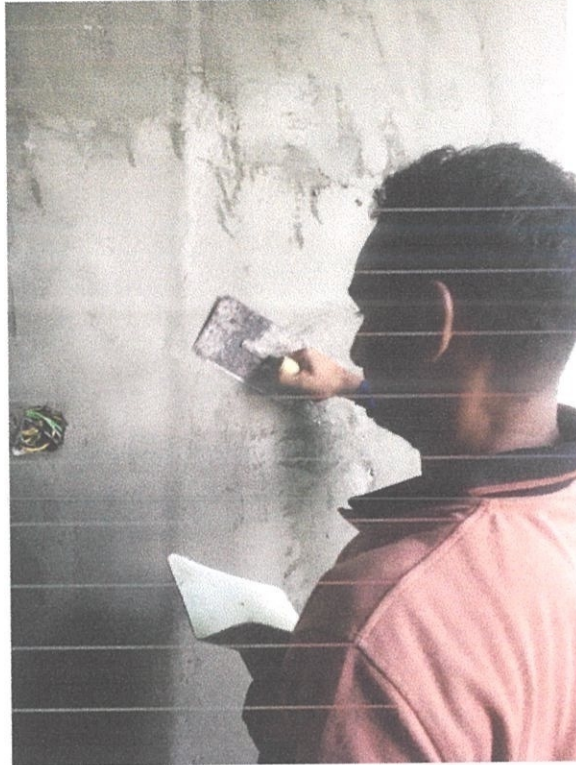
Figure 3.26 : Render works

Yard defects are rectified by apply back the cement render to the defect. That is the only way to rectify it.
