DEPARTMENT OF BUILDING
FACULTY OF ARCHITECTURE, PLANNING AND SURVEYING
UNIVERSITI TEKNOLOGI MARA
(PERAK)

DECEMBER 2019

Slope Stabilization

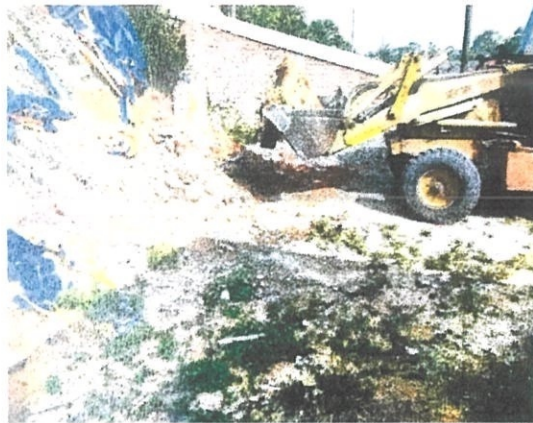
Figure 3.1 : Site clearing works (Source: Courtesy of JKRKT)

- i. Site access road was constructed while also making use of the existing public road for the access to the site. All trees inside the area was uprooted by using the excavator as the condition of the existing ground was good as shown in **Figure 3.1**. Branches and stumps of the trees were transferred to the dumpsite later. Holes from the uprooted tree were cleansed out using backhoe and the workers.

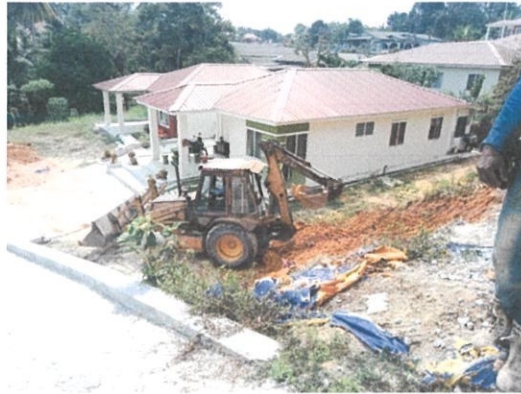
Figure 3.5 : Trench excavation for footing

- i. Firstly, the ground were excavated to make a trench by using excavator as shown in **Figure 3.5** which took around a day while other materials like aggregates and granite stones had arrived to prepare for the next step.

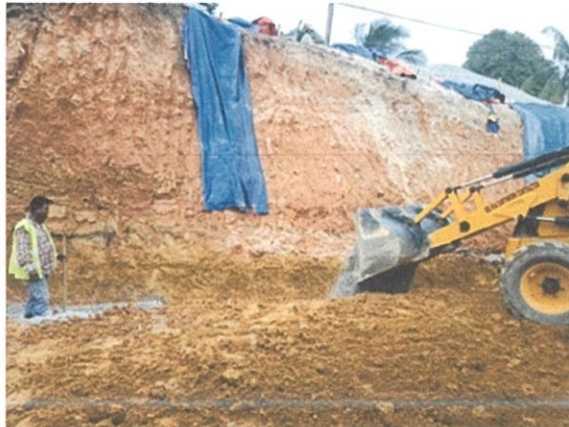
Figure 3.6 : Hardcore with the thickness of 300mm being poured

- ii. After the trench were dug and prepared, a layer of hardcore with the depth of 300 mm were poured as shown in **Figure 3.6**. After the hardcore have been laid, 50 mm thickness of lean concrete were laid before laying the plastic sheeting material of damp proof course (DPC) which works as to prevent rising damp and in some situations to prevent from any penetrating damp.

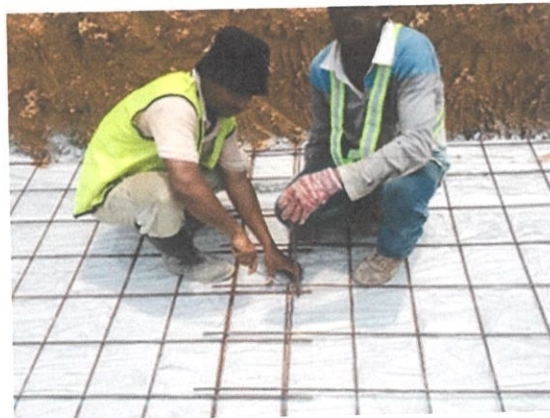
Figure 3.8 : Dowel bars being installed

- iv. To lock the footing with the rubble wall, dowel bars were installed as shown in **Figure 3.8** with the size of T12 and spacing at 200 c/c from one another. Later on, grade JKR 30 concrete were poured with thickness of 300 mm. As this project were monitored by JKR, most of the materials specification were required to follow JKR specification especially for the concrete grade as standard grade 30 concrete were quite different compared to grade JKR 30 concrete.

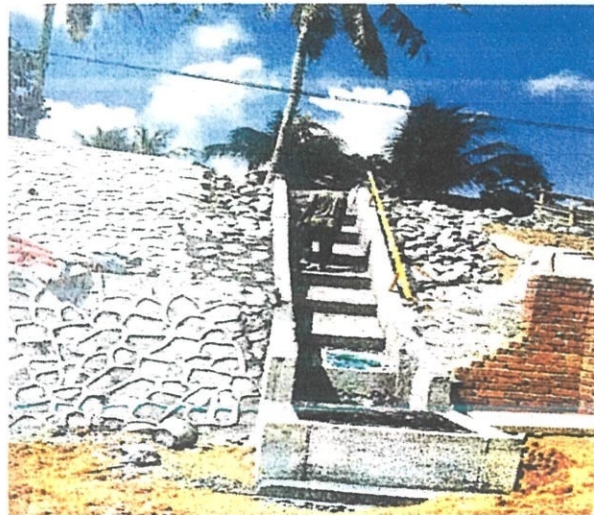
Figure 3.13 : Cascade drain construction in progress (Source: Courtesy of JKRKT)

- i. After the construction of stone pitching was completed, the drainage work started. Point and space for the drain and sump were excavated as shown in **Figure 3.12** to the required depth to invert level as the drain were also excavated besides shoulder drain. The type of drains used were cascade drain as shown in **Figure 3.13** and interceptor or toe drain.

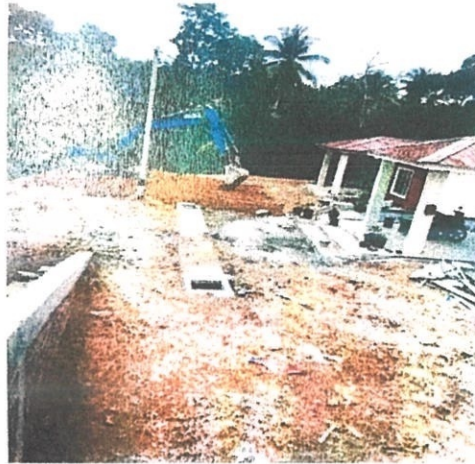
Figure 3.16 : Backfilling soil onto covered drains (Source: Courtesy of JKRKT)

- vi. Afterward, sumps were constructed which later works to facilitate the changes of level and flow within a drainage system. The sumps were covered by galvanized steel grating hinged as for safety and preventing from any big debris from entering the sumps. Last but not least, bedding was done consisting of grade 20 P concrete and backfilling of soil onto drains as shown in **Figure 3.16** after finishing the concrete slab installation for the drains. Completed works photos were attached in **Appendix III**.

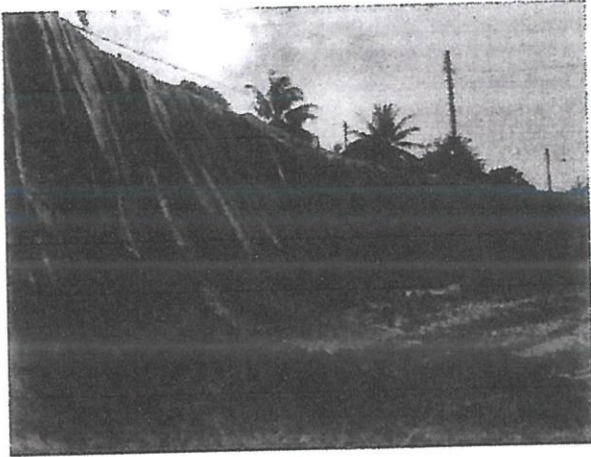
Site condition before start work

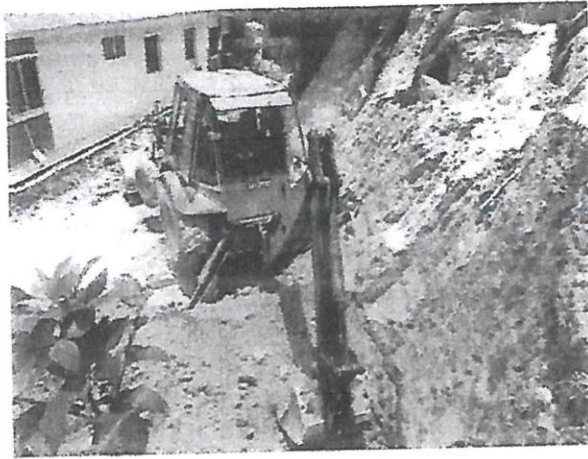
Site condition at excavation in progress

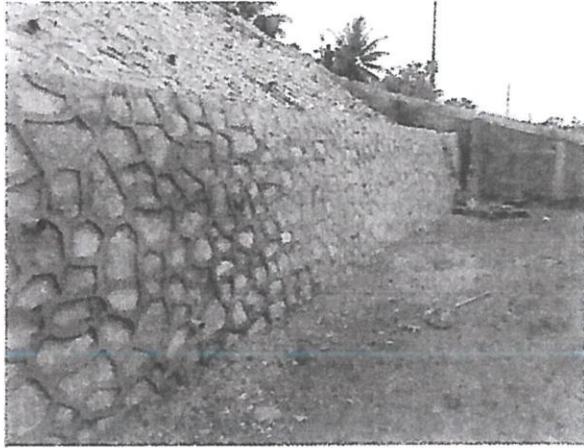
Stone Pitching works in progress

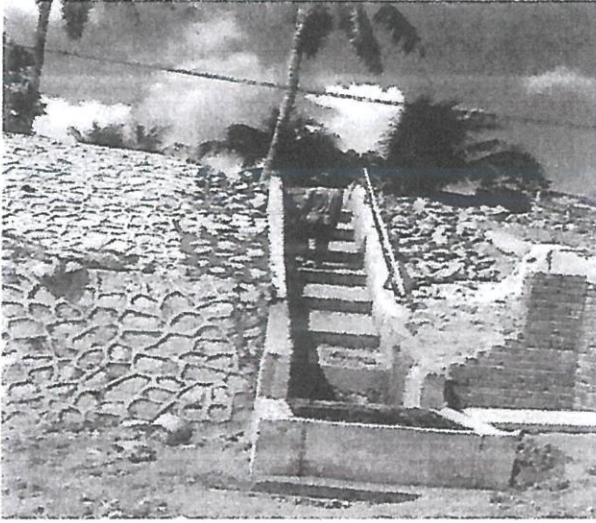
Stone Pitching works in progress

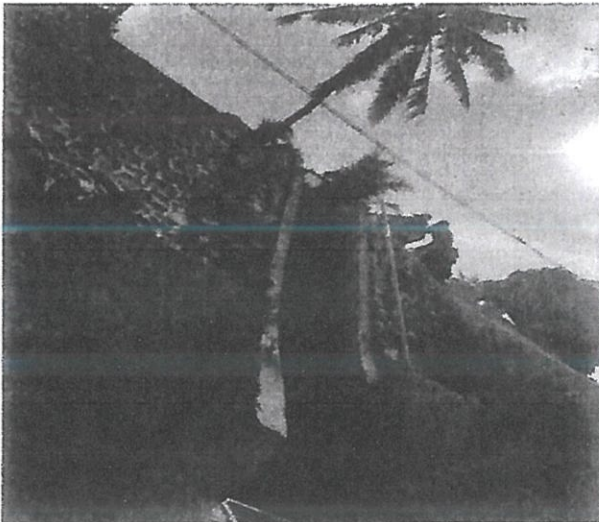
Stone Pitching works in progress

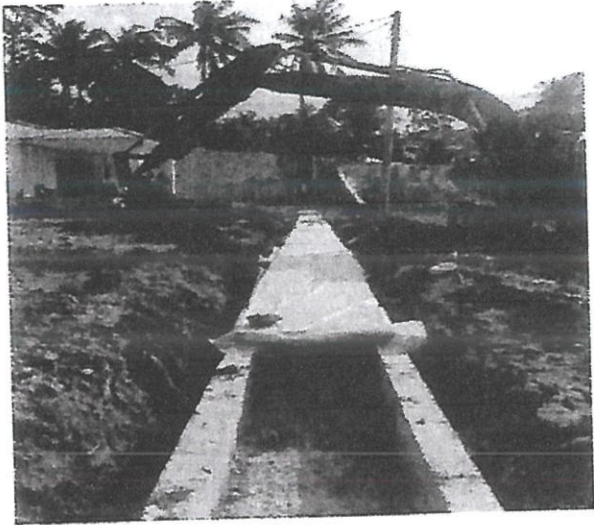
Toe drain works in progress, geotextile installation

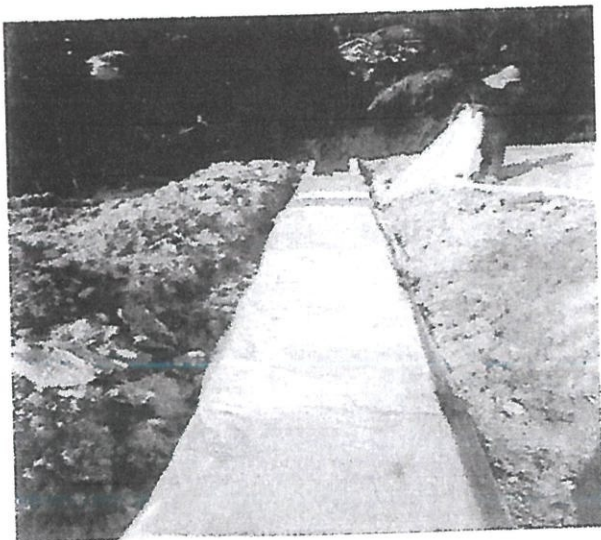
Geotextile installation works in progress

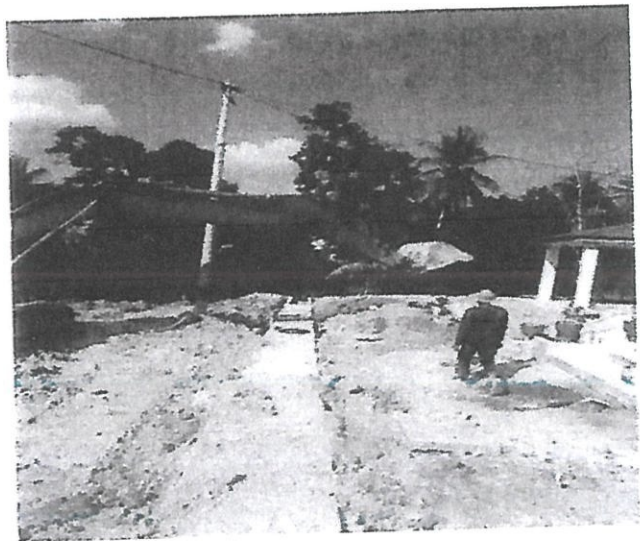
Backfilling works for toe drain

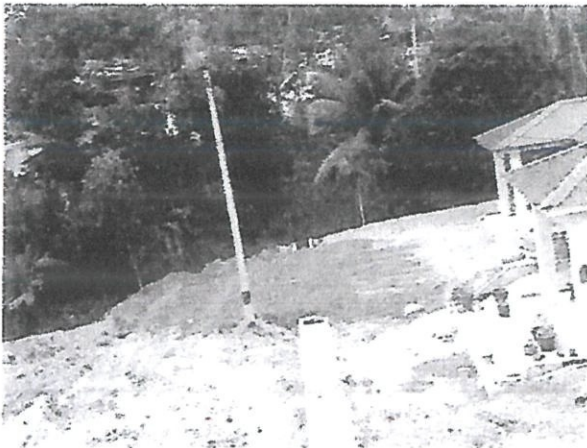
Toe drainage works completed

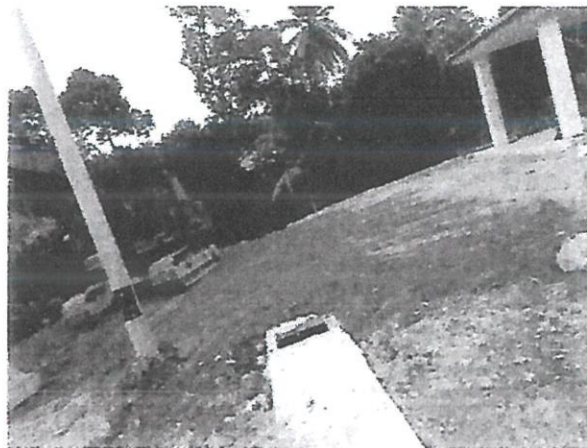
Toe drainage works completed

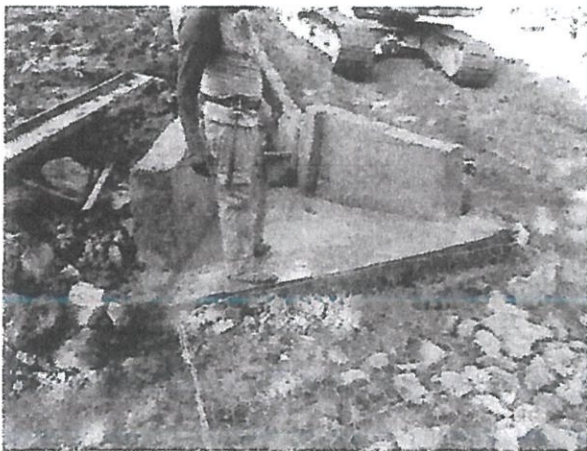
Gabion mattress installation

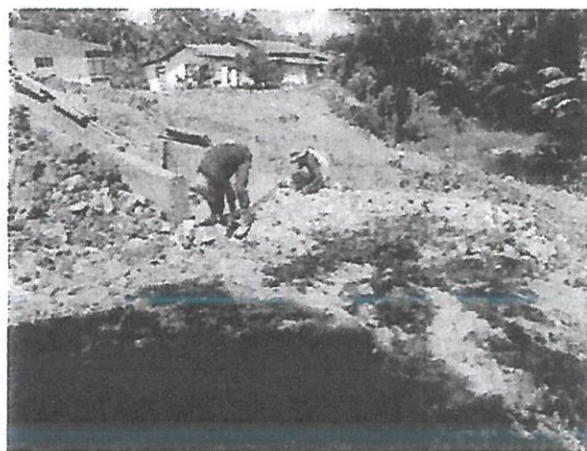
Gabion mattress installation

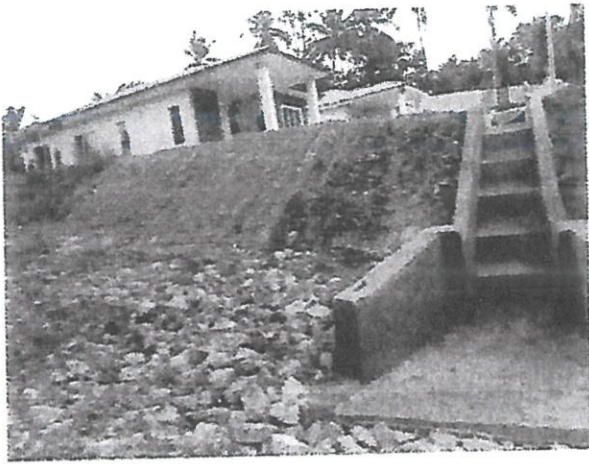
Cascade Drain and wingwall works in progress

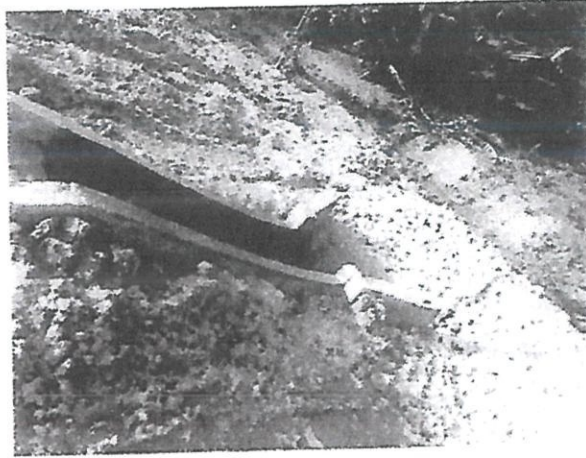
Cascade Drain and wingwall works in progress

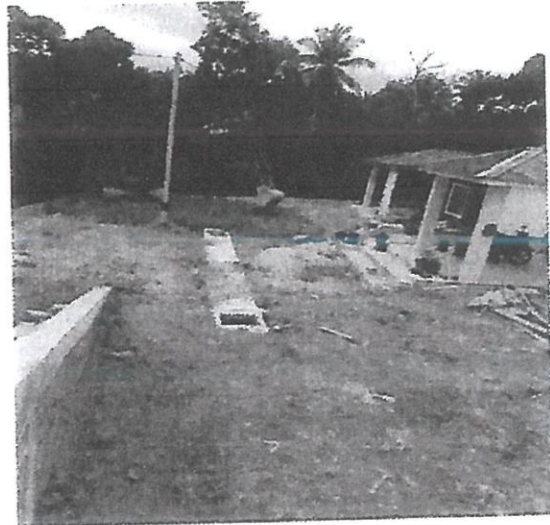
Backfilling works in progress

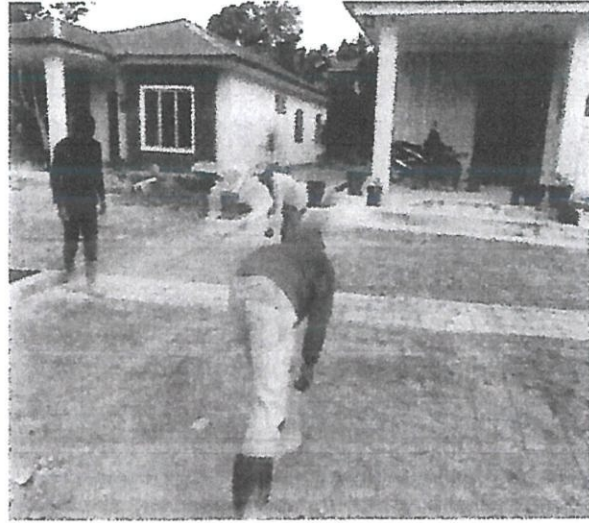
Base slab under progress

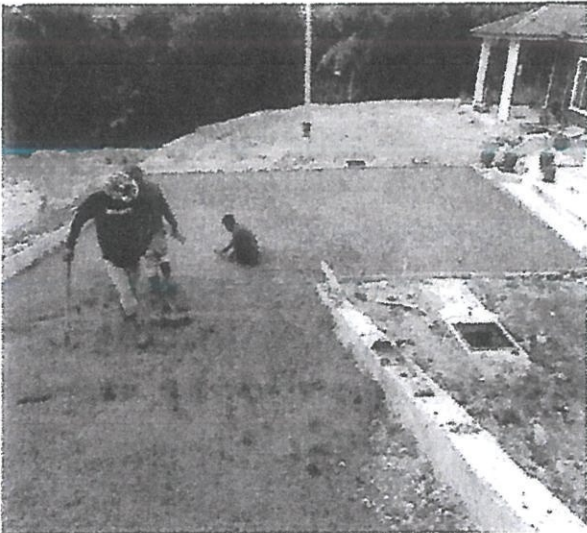
Base slab under progress

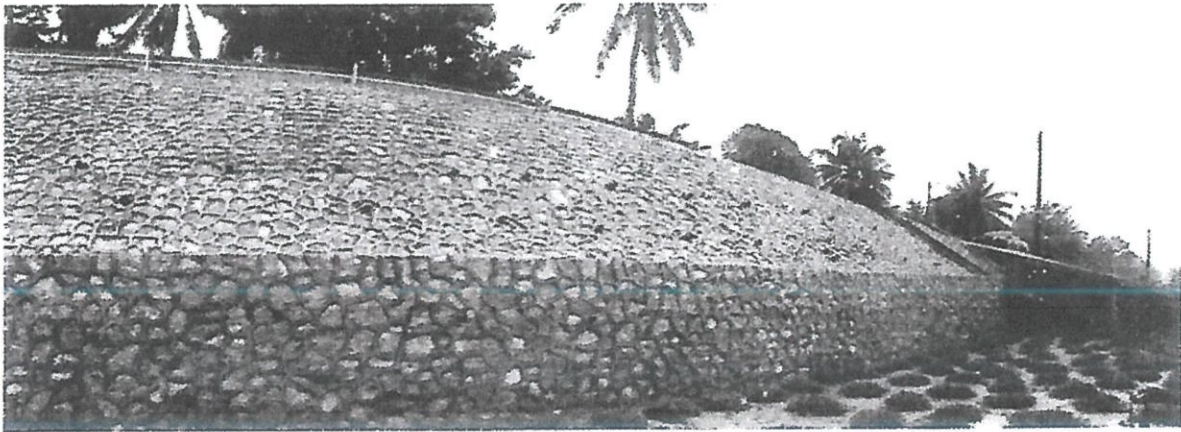
Stone Pitching and Rubble Wall 100% complete
