NATIONAL SEMINAR ON

30-31 May 2006

Swiss Garden Resort & Spa
Kuantan, Pahang

Failure Investigation of GFRP Water Storage Tank: A Case study at IKBN Jitra, Kedah

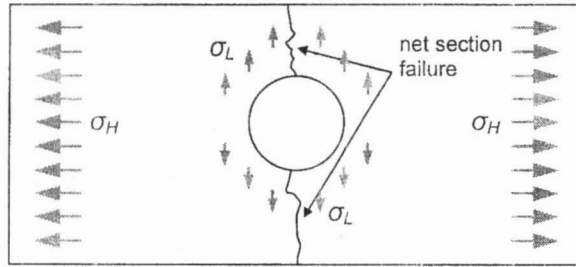
Fig. 4: Net Section Failure

The wall experienced a massive crash and cracked the inner wall of the tank. This is due to its rounded shape, plus the weight on the whole tank wall. Net Section Failure refers to tensile failure of a holed material. Crack until disconnected on the tangent hole occurred in the direction perpendicular to the tensile stress on the material. This phenomenon is shown in Figure 4.

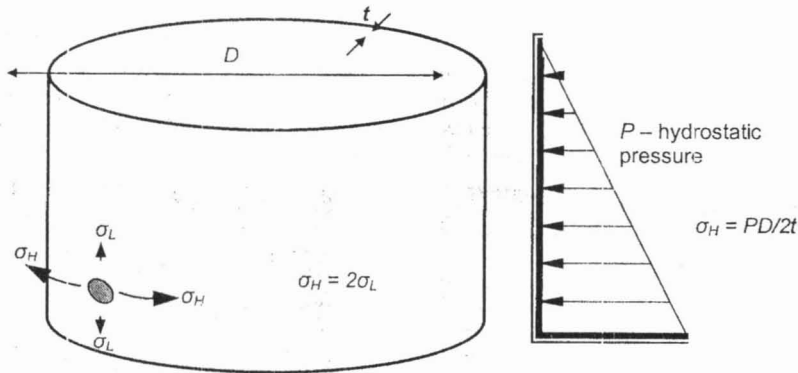
Fig. 5: (a) Tension inside Tank Wall, and (b) Hydrostatic Pressure of the Water produced Tension on the Wall

In the case of this tank failure, the hole on the tank wall that was used as a outlet flange hole was the caused of the overall failure of the tank structure. Generally, stresses that exist in a water tank is shown in Figure 5. Tension in circular direction, σ_H is two times the tension in vertical direction, σ_L . Thus, only stress in circular direction will be given attention in tank failure analysis discussed further on.

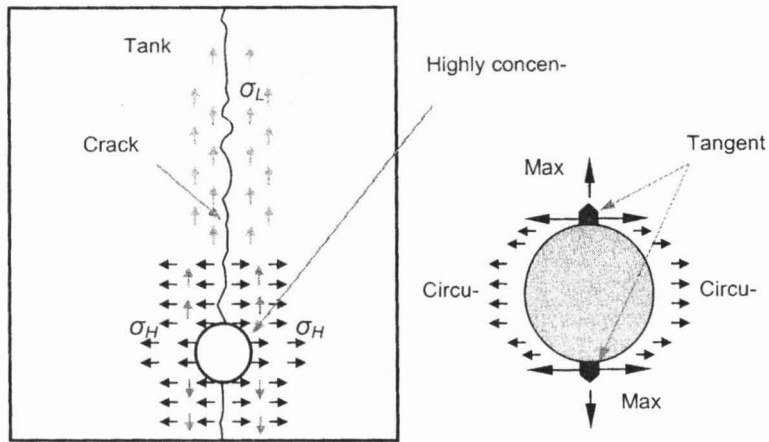
Fig. 6: Stress on the Tank Hole

Maximum stress tangent existed on outlet flange hole tangent as shown on Figure 6. The stress on this tangent was maximum because both tension from the circular and vertical direction concentrated here. Thus, any crack on the hole's tangent can spread quickly because of the concentration of these stresses. In composite structure design, loss of a part of a body that holds load must be bond with several layers that has the same strength as the discarded part. The tank did not have any bonded layer around the hole on neither outer nor inner side. This caused the concentrated stress on the tangent hole was withstand only by the original thickness of the tank.

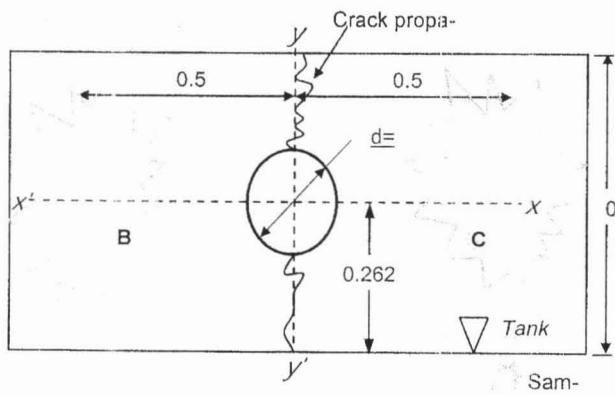
Fig. 9: The Location of Samples from the failed 13,200 gallon GFRP Tank

The location of samples for all tests is around outlet flange hole, as illustrated in Figure 9. Samples taken must be closest to the cause of failure, which was outlet flange hole to attain actual depiction of the condition of laminate on that area. Other than that, the position of the thickest is 0.5 m from the tank base to the floor. This position suffered highest hydrostatic pressure, thus the most critical area. Samples were divided into four parts which are A, B, C and D. B and C were the areas closest to the outlet flange hole.

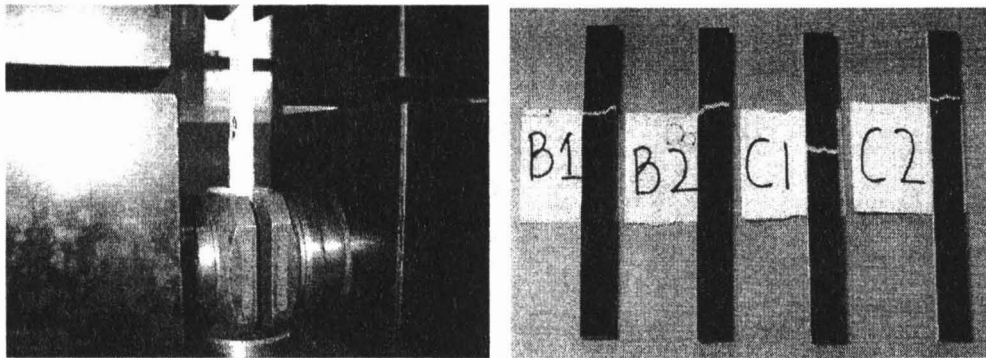
Fig.10: Tensile Test using DARTEC Universal Testing Machine

Tensile testis was done to acquire the value of maximum stress strength for tank wall laminate. To perform the tensile test, ASTM D 3039 standard was applied byusing DARTEC Universal Testing Machine. Figure 10 shows the tensile test.

From the tensile test conducted, pure tensile failure was seen on specimens B1, B2 and C1. Specimen C2 showed not only tensile failure but also shear failure. Shear failure occurred on WR and CSM laminate, which already has low shear force. However, the tensile strength of this laminate was high which was 94.36 MPa and exceeded the minimum value specified by SIRIM's tensile test which is 63 MPa. Thus overall, laminate for tank wall was safer than the benchmark minimum level.

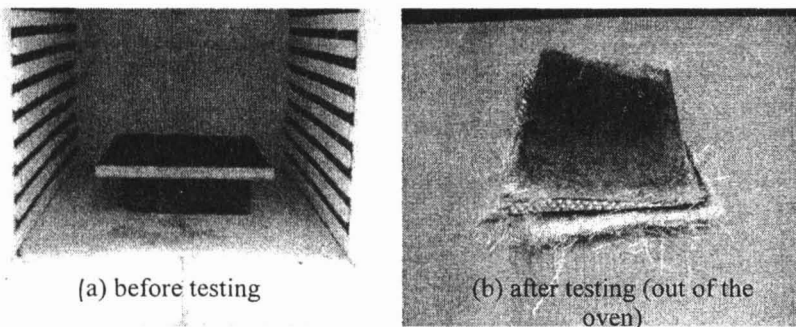
Fig.13: Burn-out Test Procedures

This test was conducted according to the MS1390 testing standard (Appendix D) with sample size 200mm x 143mm. The burn-out test procedures are using burning temperature up to 600°C with duration about 30 minutes. The specimen was burnt in CARBOLITE furnace with maximum temperature of 1200°C. Figure 13 shows the test procedure and sample condition.

From the burn-out test conducted, the composition of matrix and resin was identified. More over, the arrangement of woven roving (WR) and chopped strand mat (CSM) type glass fibre layers can be observed. After comparing it with original laminate arrangement from the manufacturer, the total amount of laminate are the same, which are 10 layers. However, from calculation based on BS 4994: 1981, the amount of laminate needed is 13 layers. Therefore, reducing the amount of laminate is risky as the safety factor is lower than the ideal safety design.
