**TRAINING MODULE FOR HOUSE DEFECT INSPECTION FOR  
RESIDENTIAL BUILDING: CASE STUDY AT TAMAN KOTA SERIBONG**

PRACTICAL TRAINING REPORT

(TRAINING MODULE FOR HOUSE DEFECT INSPECTION FOR  
RESIDENTIAL BUILDING: CASE STUDY AT TAMAN KOTA SERIBONG)

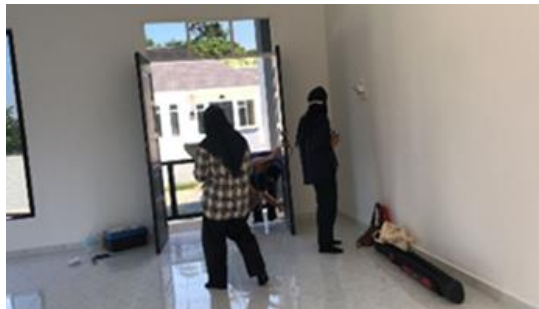
Figure 3. 4: Activities of HDI

The defect assessment at Kota Seribong take two days to complete. It depends on the area of the building. All the element and component in this building was inspected by using tools and equipment. The building element such as floor, wall, ceiling, door, window and other components include M&E fittings and permanent fixtures such as bath tubs, basins and kitchen cabinet. The defects were assessed by area or room for example master bedroom, guest room, bathroom 1, bathroom 2, kitchen and family area.

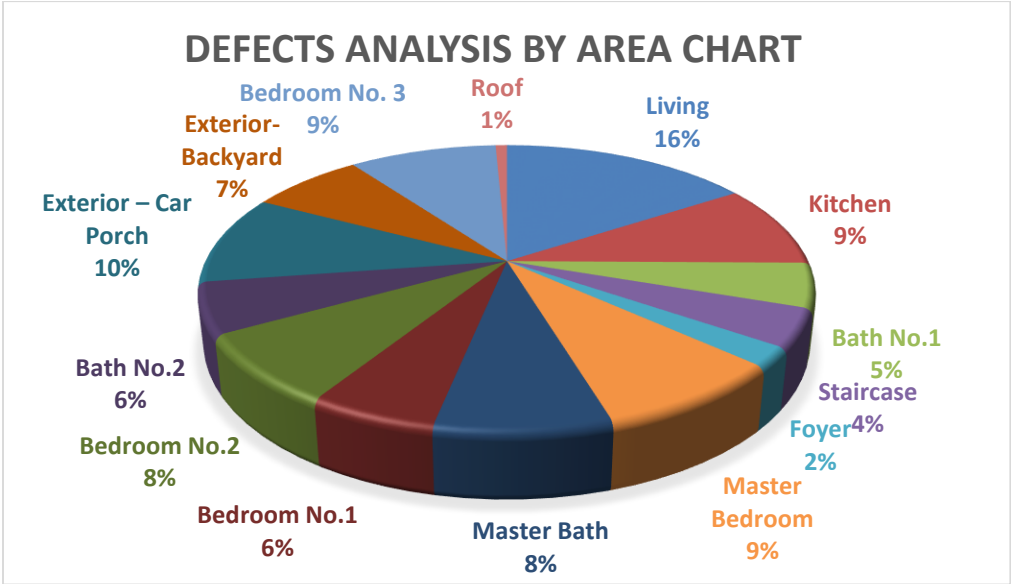
Defects Analysis by Item Table

NO	AREA	NO. OF DEFECTS
1	Living	22
2	Kitchen	13
3	Bath No.1	7
4	Staircase	6
5	Foyer	3
6	Master Bedroom	12
7	Master Bath	11
8	Bedroom No.1	8
9	Bedroom No.2	11
10	Bath No.2	8
11	Exterior – Car Porch	14
12	Exterior- Backyard	10
13	Bedroom No. 3	13
14	Roof	1
	TOTAL	<b>139</b>

In defect analysis by area, the Exterior contributes the most at 16% and for most defect by items will be for Wall with 43% of overall contribution. Clearly we can see the Walling issue will be the most concern defect in the house.

In conclusion, we can see the Living and Wall in the house must be taken extra attention for verification & rectification.
