RECOMMENDATIONS FOR IMPROVEMENT BASED ON FIRE INCIDENT CASE AT LOT NO. 4.18B (*RELYSIS COMPUTER*), LEVEL 4, PLAZA PELANGI, TAMAN PELANGI, JOHOR BAHRU, JOHOR

PRACTICAL TRAINING REPORT

FEBRUARY 2022

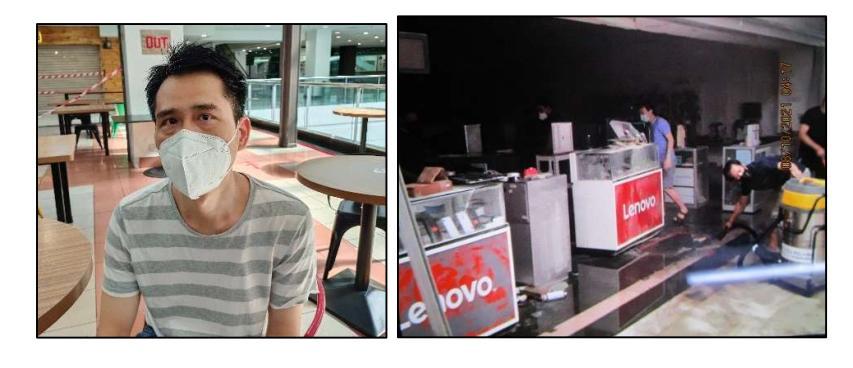
Figure 3.10: (Left) Owner of the premise that was contacted after fire was extinguished, (Right) Premise's staffs checking the condition of the premise lot after incident

Right after the fire was extinguished, the owner of the premise was contacted to come to the premise right away. Several other owners for the shop premises were also contacted as to inform them regarding the occurrence of the fire incident and requesting them to check and inspect on their premises' lot on whether they are affected by the incident or not.

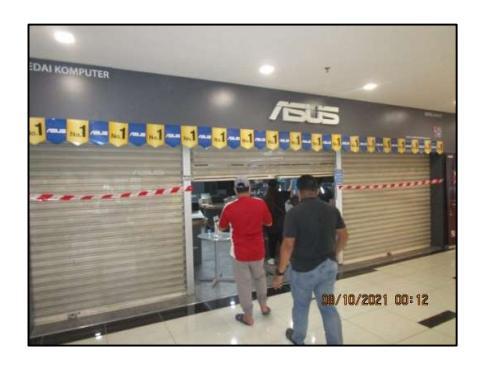
Figure 3.11: Owner and staffs of other premises came to check on their premise lots.
