**BUILDING INSPECTION FOR DEFECT LIABILITY PERIOD AT SETIA  
ECO GLADES CYBERJAYA**

PRACTICAL TRAINING REPORT

(BUILDING INSPECTION FOR DEFECT LIABILITY PERIOD AT SETIA  
ECO GLADES CYBERJAYA)

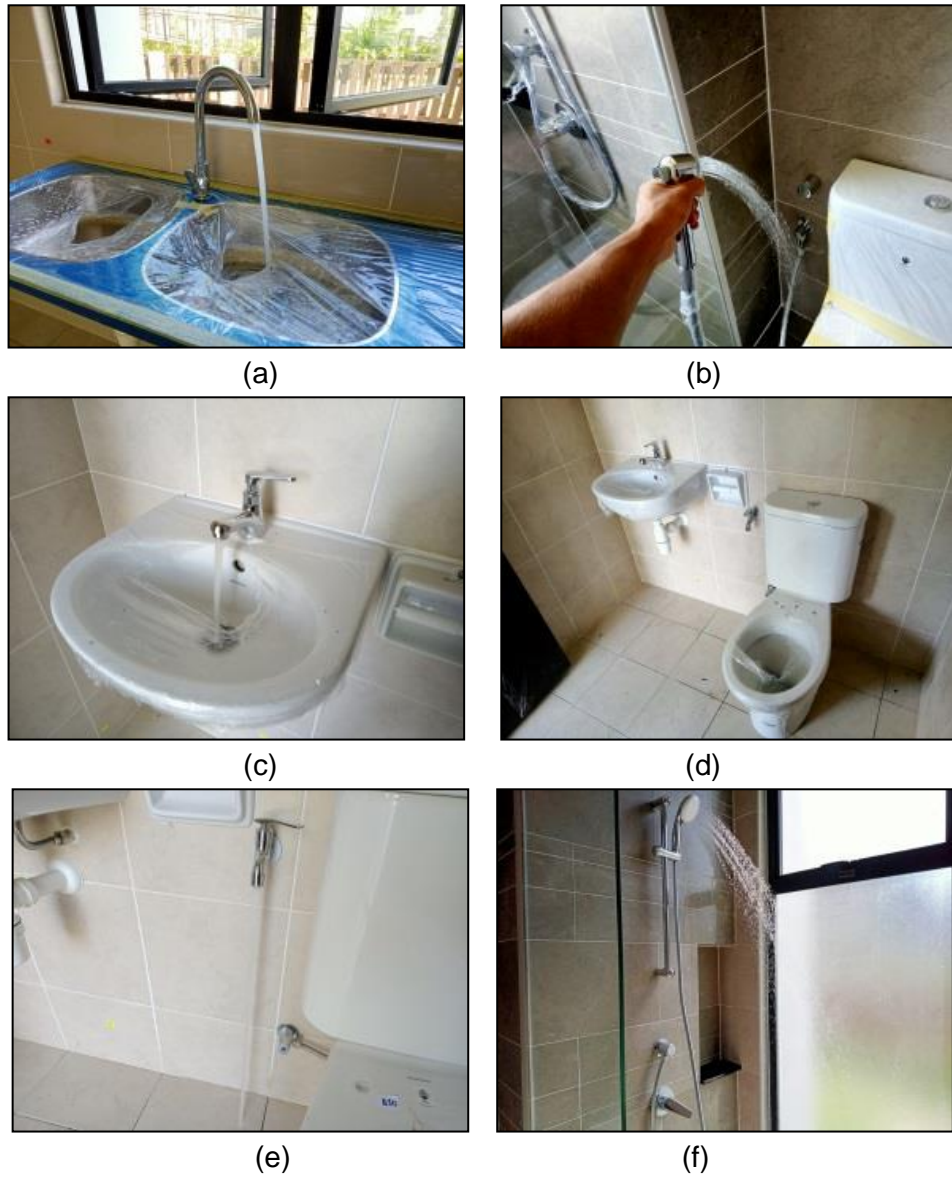
*Figure 3.46 (a), (b) (c), (d), (e), (f): Sanitary and plumbing testing*

Photographs below showed the tests that being conducted for sanitary and plumbing equipment at the case study.
