DEPARTMENT OF BUILDING UNIVERSITI TEKNOLOGI MARA (PERAK)

DEFECTS WORKS AT KL TRADERS SQUARE GOMBAK

Prepared by:
NOR NAJWA BINTI ABD RAHMAN
2016458592

DECEMBER 2018

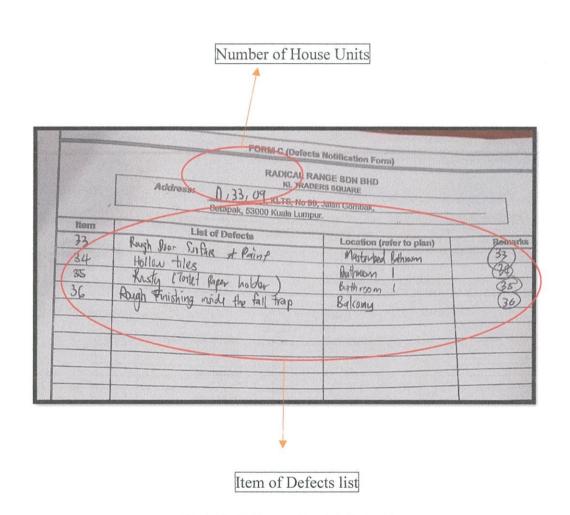
Photo 3. 7: Example of defect list

For example, on how the site supervisor to identify which parties need to rectify the defect work, based on the photo 3.6 above, like item no.34, the defects is hollow tiles. For Hollow Tiles defects, the site supervisor will check first based on the location of the tiles defects by referring from the layout floor plan whether the tiles is truly hollow or not, if hollow sound was found more 15%, the tiles will immediately mark for rectifying work. Then site supervisor will call the tiling worker to start the works.

This process will repeat with other hollow tiles as well. For item no. 35, the defect is rusty of toilet paper holder. For toilets materials, this defects will be doing by the NSC which is to the plumber. Site supervisor then will inform the High Speed company for changing the new one of paper holder.

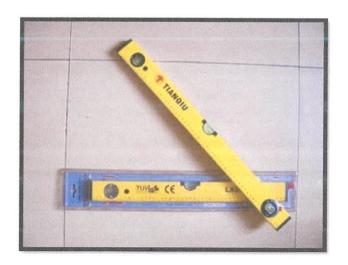
Figure 3. 5: Levelling instrument

Uneven tiles are the most major tiles defects for tiling works. This defects occur because of the poor workmanship and unbalance of levelling work during installation of the tiles. This defects can cause serious injury to the residence if the levelling tiles was not level based on the specific requirements.

Then the tiles area then will fill back with cement and install back carefully using levelling instrument. Then let it dry for about one day before doing the finishing for the tiles.
