**DEPARTMENT OF BUILDING
UNIVERSITI TEKNOLOGI MARA
(PERAK)**

PREPARATION OF DILAPIDATION REPORT

Preparation of Dilapidation Report

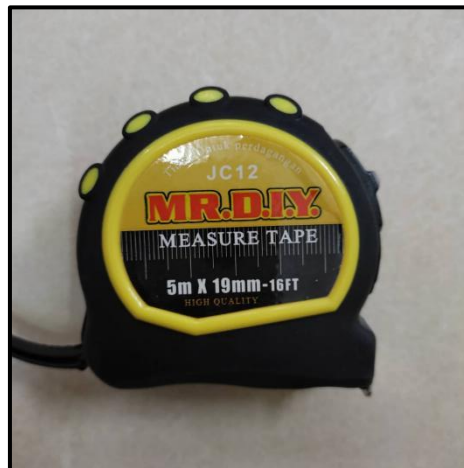
Figure 3.4 : Measuring Tape

Figure 3.4 shows a measuring tape that will be used by the inspector to measure the length or an area of the defect. This is important to get an accurate data because if the data is not taken correctly then it will affect the report and also can give confusion to the contractor.

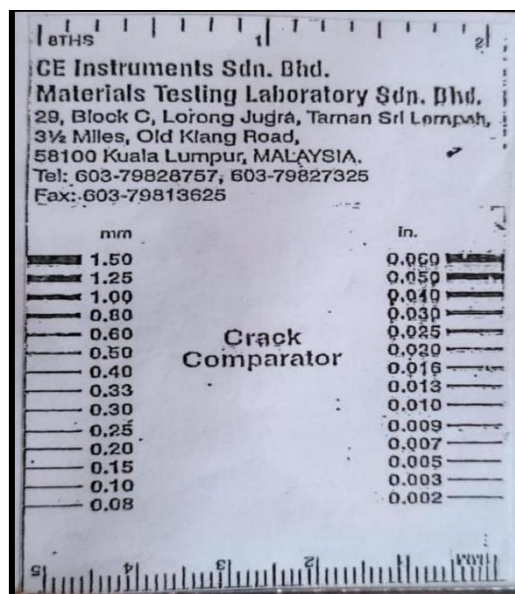
Figure 3.5 : Crack Comparator

Based on the figure above, this is a crack comparator where each of the inspector must have this scale. It is very helpful as it can fasten the process of measuring. Other than that, we could also use this scale even the size is more than 1.50mm as at the bottom of the scale there were a ruler that is specially made for bigger size of crack and gap.

Figure above is how the size and length of the defect is taken. Usually, size and defect are taken only for gap defect and crack defect where the size will be taken by using crack comparator and the length will be taken by using measuring tape. For other defect, the area of the effected area will be taken.

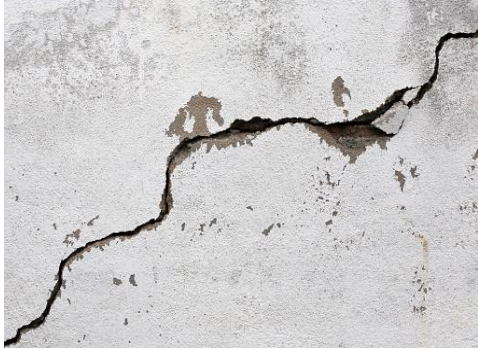
<p data-bbox="930 786 1166 819">Figure 3.8 : Crack</p>
Peeling off Paint

Defect	Figure
Crack line, crazing crack, vertical crack and horizontal crack

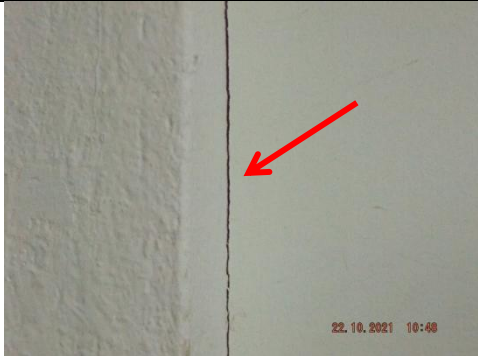
<p data-bbox="930 1659 1166 1693">Figure 3.10 : Gap</p>

<p data-bbox="855 1227 1241 1261">Figure 3.9 : Peeling Off Paint</p>
Gap between wall and column, gap at adjoining wall

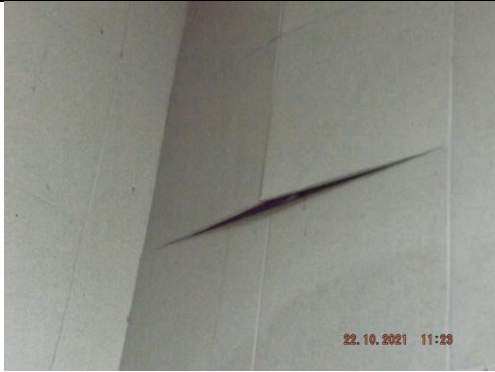
<p>Figure 3.11 : Detached</p>
<p>Missing</p>

<p>Detached</p>

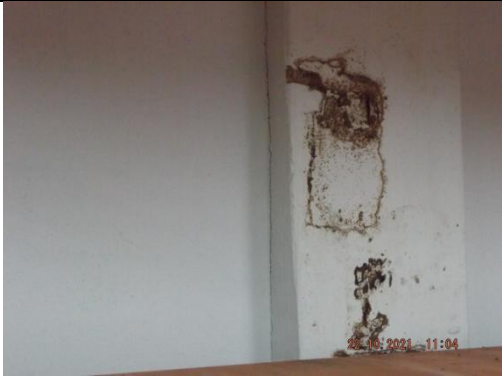
<p data-bbox="860 589 1235 622">Figure 3.15 : Termite Attack</p>
----------------	---

Termite Attack

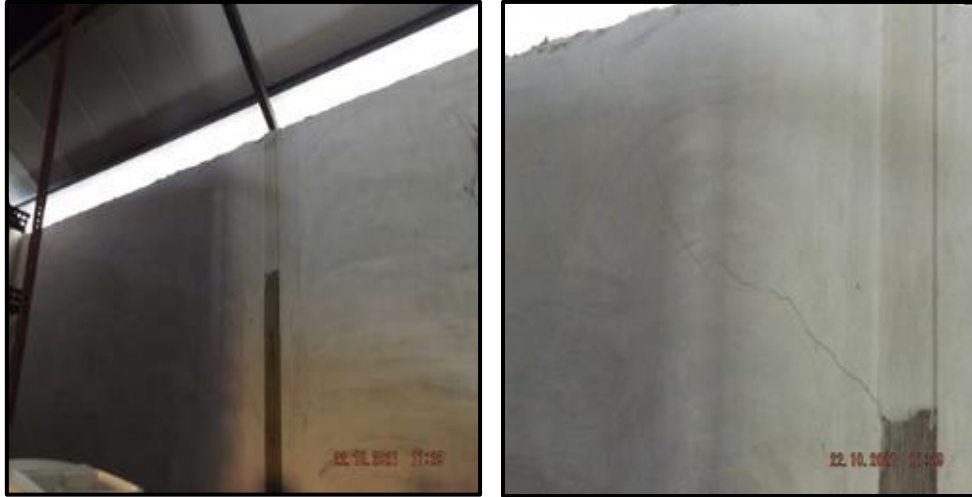
Figure 3.17 : Example of Picture Taken for The Defect

Based on the figure above, there were two types of picture that need to be taken for one defects which is the zoom one and not zoomed. Both of this picture must be taken clearly as it will be inserted in the report afterwards. Other than that, every picture taken must have the time and date of the inspection is done at the bottom of the picture as it will be used as a references in making a report.

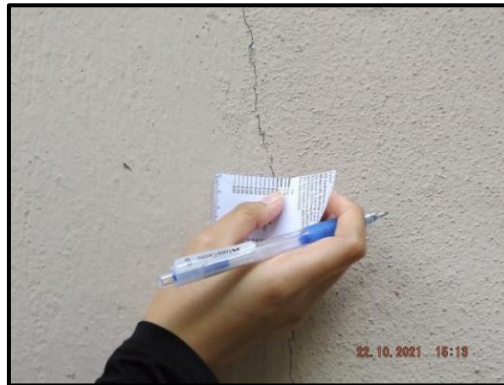
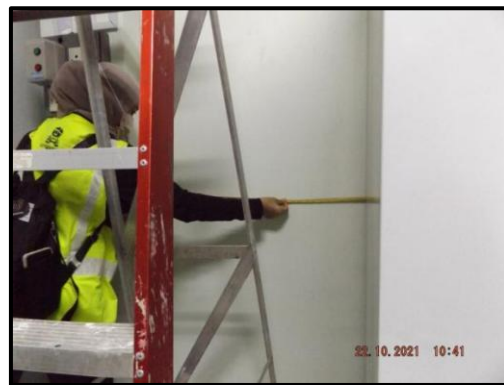
Figure 3.20 : Measuring The Defect Size

Figure 3.21 : Measuring The Defect Length

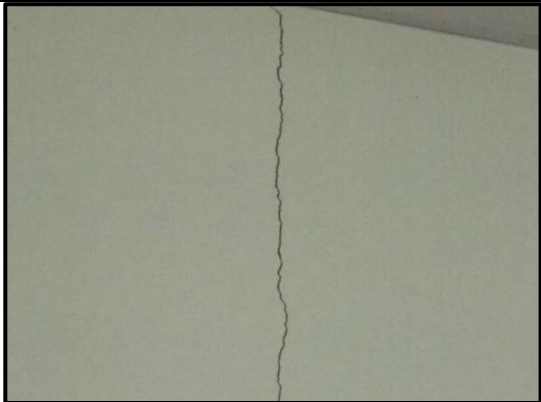
<p>Figure 3.22 : Example of Crack</p>	Ground Floor	Stationery Store	Wall (Plaster)	Vertical Crack	0.06mm	3.00m
2

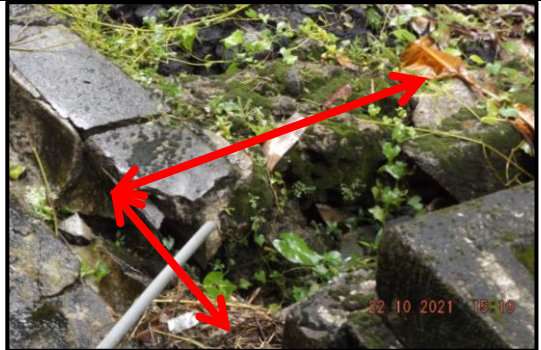
<p>Figure 3.23 : Example of Broken</p>	Ground Floor	Rear part of The Building	Drain (Concrete)	Broken	-	0.30m x 0.20m (take its area)

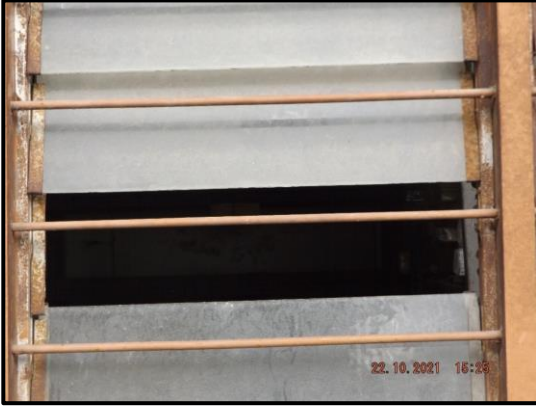
<p>Figure 3.24 : Example of Missing</p>	Ground Floor	Front Part of The Building	Window (Glass)	Missing	-	1 Unit
4

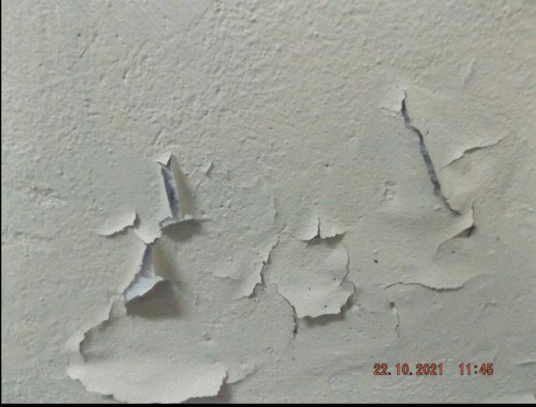
<p>Figure 3.25 : Example of Peeling Off Paint</p>	Ground Floor	Balcony	Wall (Plaster)	Peeling Off Paint	-	1.00m x 0.80m (area of effected area)

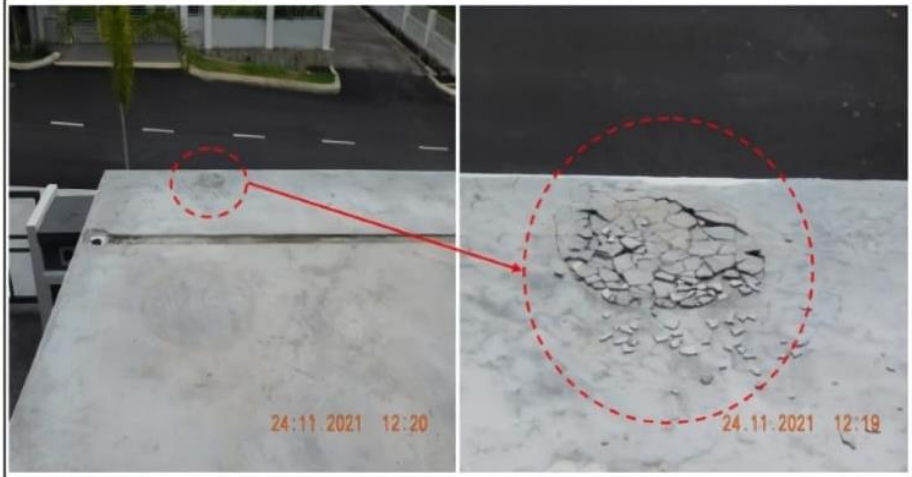
Figure 3.35 : Example of Defect Form

Building Level:	Building / Construction Part:	Defect Location:	Element:	Component:																																	
First Floor	External	Front Part of the Building	Flat Roof	Concrete Slab																																	
Type of Defect:	Size of Defect:	Length / Reading:	Defect Level:	Remedy Priority:	Cause of Defect:																																
Broken	-	0.40m x 0.40m	3.Poor	2.Repair & Monitor	Contraction & Expansion of Surface Layer / External Forces																																
Defect Scale:	Severity Scale:	Matrix Analysis:	Score:	Colour Code (Severity Level)	Defect Condition: (On The Average / Whole)	Maintenance Type Building Care:																															
3	2	6	5-9		Quite Good / Small Damaged / Maintainable	Preventive Superficial repair / Make Good

Above is the example of the defect form that will be included in the report where everything that is related to the defect will be stated and one page is only for one defect therefore if there was 54 defects then there will be 54 pages of defect form. Below are the explanation for each of the spaces in the defect form.
