# DEPARTMENT OF BUILDING UNIVERSITI TEKNOLOGI MARA (PERAK)

# CONSTRUCTION OF PILE CAP

CADANGAN MEMBINA DAN MENYIAPKAN SEBUAH KOMPLEKS PLAZA TOL DAN KERIA BERKAITAN DI KAWASAN BUKIT TERATAI (TP2) BAGI PROJEK PENSWASTAAN LEBUHRAYA SUNGAI BESI-ULU KELANG (SUKE): NO. CONTRACT - TURNPIKE-SUKE-C-TP2-B-026 PROJECT ORGANIZATION CHART (REV 04)

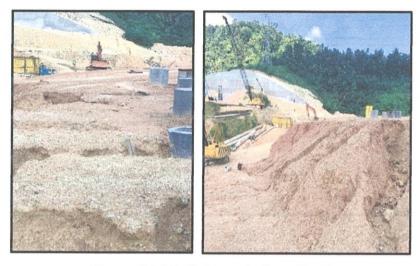
Figure 3.3(a): Sedimentation of soil

Sedimentation of soil occurred due to rainy weather. It has caused delay of work on site as it is dangerous to start excavating on a loose soil.

| | Project Signboard | 9 |
|---|---|---|
| Figure 3.3(a) | Sedimentation of soil | 21 |
