# Hydrostatic Pressure Analysis of Yarn Composites Patch for PVC Pipes

## ABSTRACT

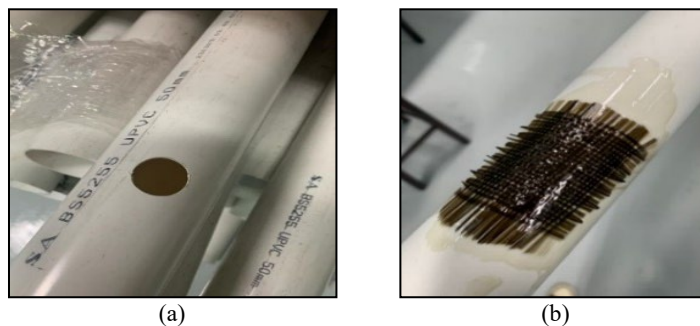
Fig. 3. (a) Defect pipe and (b) PVC pipe patching with woven basalt fiber.

A hole was introduced into the PVC pipe to replicate a defect that is commonly encountered in real life situations that necessitate repair. A 20 mm diameter hole was drilled into the pipe's surface to create this defect. The pipe was subsequently patched with a size of 50 x 50 mm WB. Fig 3 shows the PVC pipe with the drilled hole and the patched specimen. This repair technique ensures that the wrapped material adheres firmly to a stable surface, thereby improving the overall effectiveness of the repair.

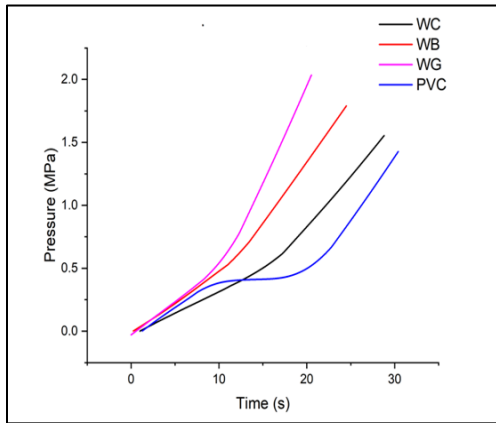
Fig. 6. Pressure failure of woven fiber wrapped PVC.

Fig 6 and Fig 7 show the experimental results of the burst test of wrapping PVC pipe with woven types of fiber. Fig 6 shows the pressure failure of woven fiber over time. It was observed that the burst pressure of solid PVC pipes gave different results with different types of woven wrapped materials. PVC pipes wrapped with WG fiber show the highest burst pressure value, reaching 2 MPa, while solid unwrapped PVC pipes have a maximum pressure of 1.51 MPa. This represents a 29.2% increase as compared to solid unwrapped PVC pipe. These results indicate that the properties of woven glass fiber are recognized for its strong mechanical properties that may contribute effectively to pipe repairs (Gao & Li, 2016). However, while the WG wrapped fiber pipe shows the highest burst pressure value, it has a shorter burst time to failure compared to solid PVC pipe. This reduction in the pipe's flexibility is due to WG wrap, resulting in quicker failure time (Al-Mahfooz & Mahdi, 2020).
