# DIAGNOSING TIMBER DEFECTS IN TRADITIONAL MALAY HOUSE: A CASE STUDY OF TOK ABU BAKAR ALANG KETAK (TABAK) Nature of Building Defects in Tok Abu Bakar Alang Ketak House (TABAK)

Haryati Mohd Isa<sup>1\*</sup>, Mohd Nurfaizal Baharuddin<sup>2</sup>, Othman Mohd Nor<sup>3</sup>,  
Mohd Sabriza Ab Rashid<sup>4</sup>, Daljeet Singh Sedhu<sup>5</sup>,  
Muhammad Daniel Abdul Manap<sup>6</sup> & Najat Affendy Dzulkifly<sup>7</sup>  
*<sup>1,2,3,4,5,6</sup>Faculty of Architecture, Planning and Surveying, UiTM Perak Branch,  
Seri Iskandar Campus, <sup>7</sup>Planet Hijau Sdn Bhd, Kajang, Selangor*

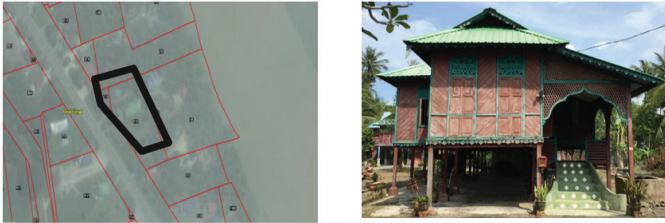
**Figure 1. Location Plan and Front Elevation of TABAK House**

Tok Abu Bakar Alang Ketak House is located on the banks of the Perak River in Bota Kiri, Perak. It was built by Tok Abu Bakar Alang Ketak together with several other craftsmen in the 1920s. This house was built based on the architectural style of Rumah Limas Bumbung Perak and the front of the house faces the Perak River. The structure of TABAK's house such as pillars and beams were originally built using Cengal timber. The floorboard used Kempas and the walls are from Meranti timber.
