**DEPARTMENT OF BUILDING**  
**UNIVERSITI TEKNOLOGI MARA**  
**(PERAK)**

**CONSTRUCTION METHOD OF SUPERSTRUCTURE FOR  
TERRACE HOUSE**

**DECEMBER 2019**

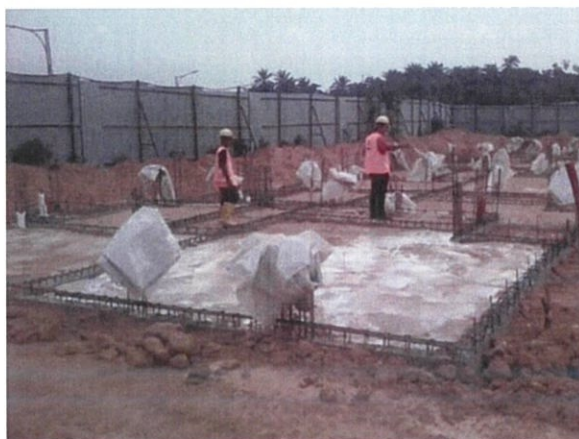
For ground slab, blinding like Damp Proof Course (DPC) and anti-termite solution were applied underneath lean concrete beforehand. The application of anti-termite solution was shown as in Figure 3.6. Laminated plywoods and woods were deposited near each related house and appropriately covered when not in used.

Figure 3.6: Application of anti-termite on soil.

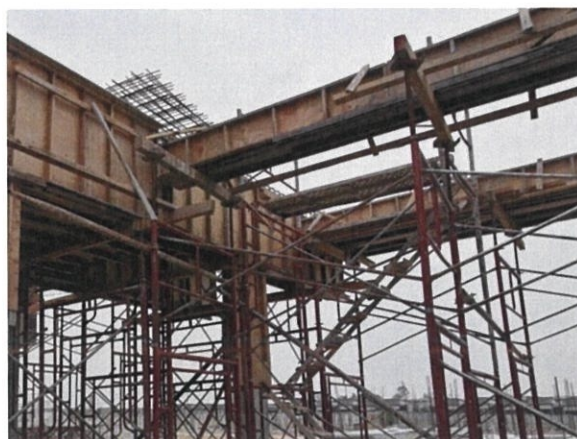
Formwork and supports were installed properly and accurately to avoid any distortion. The installation of formwork and support as shown in Figure 3.7 were for roof beam and slab.

Figure 3.7: Installation of formwork and supports at roof beam and slab.

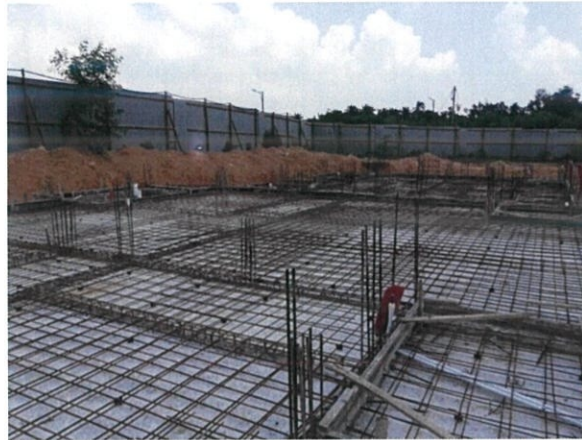
Approved drawings by Engineer were used to start reinforcement bars installation. Installation of reinforcement bars for ground slab was as shown in Figure 3.8. The reinforcement bar layouts, sections, dimensions and schedules were followed to fix the bars. The bars were properly bound and any loose binders were rejected in the reinforcement bars. The free ends of the binding wire were bended inward.

Figure 3.8: Installation of reinforcement bars at ground slab.

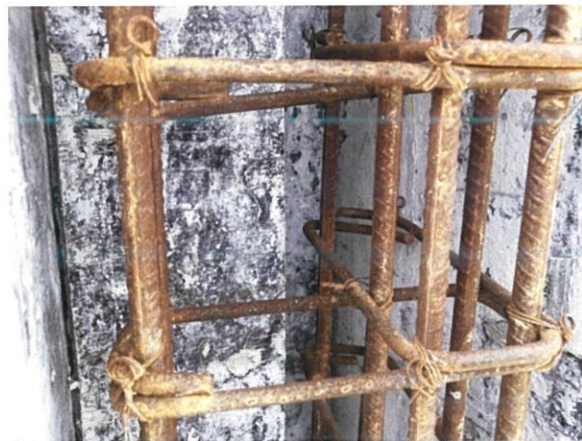
Stirrups or links as in Figure 3.9 were used to tight the reinforcement bars properly and they were fixed straighten and aligned. Any loose stirrups or links were discarded and they were ensured fixed as per approved drawings.

Figure 3.9: Fixation of links at column.

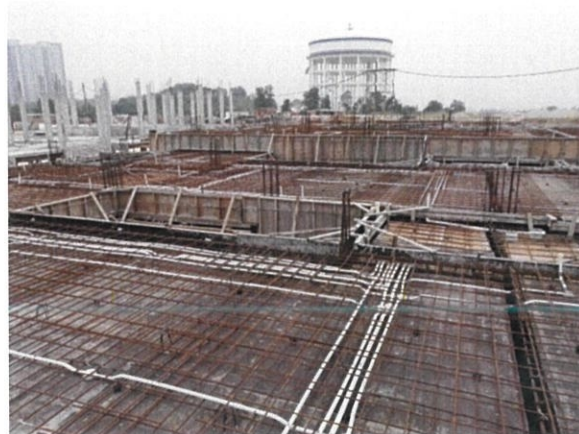
Figure 3.11: Usage of tips coated metal chairs and circular spacers as concrete cover.

Compressible filler board or aluminium strip were used as in Figure 3.10. The usage was according to the thickness stated in the approved drawings for expansion joints. Tips coated metal chairs and circular spacers were used for the horizontal bars and verticals bars respectively as a concrete cover. The application was shown in Figure 3.11.

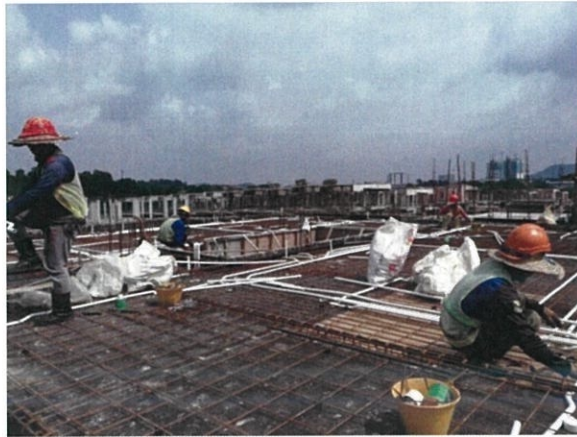
Mechanical and Electrical (M&E) works were installed according to approved M&E drawings. The installation of M&E works was shown in Figure 3.12. Proper fixing, alignment and levelling were conducted by fixing the required concrete level at the formwork as per approved drawings.

Figure 3.12: Installation of M&E works.

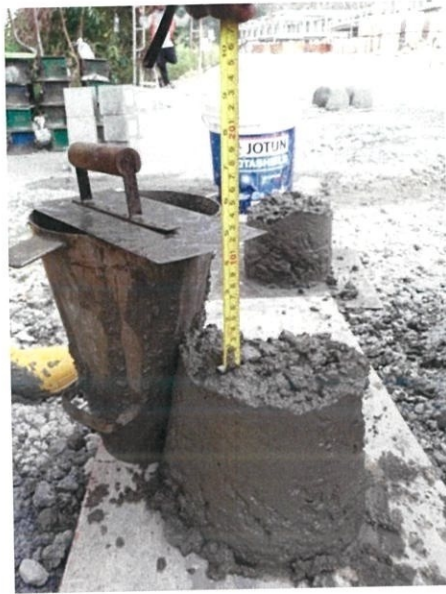
A sketch to display the casting areas, pump location, pump and trucks access and concrete trucks checkpoints were drawn by contractor, which were submitted to the engineer. The concrete trucks first stopped at the entrance for inspection. Slump Test as shown in Figure 3.15 was handled. Cubes for Cube Compression Test were also made. The making of the cubes were shown as in Figure 3.16. The slump was ensured to follow the pre-approved mix design while a set of nine cubes were made for every concrete trucks. Three cubes will be tested at the age of 7 days, three cubes will be tested at the age of 28 days and the remaining will be given to the concrete supplier for their own reference. The concrete was ensured to be unloaded from the concrete truck within two hours from the batching plant.

Figure 3.15: Reading of slump test was measured.

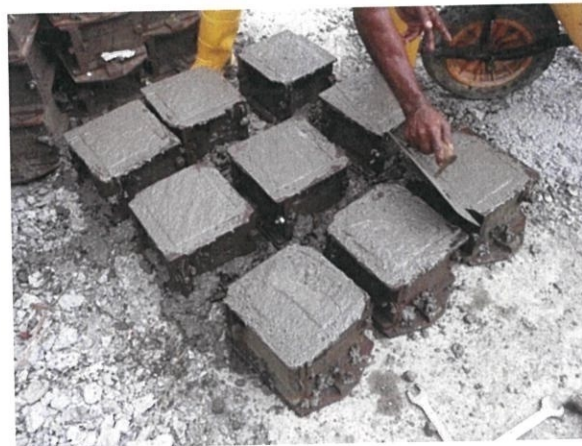
Figure 3.16: Making of the nine cubes.

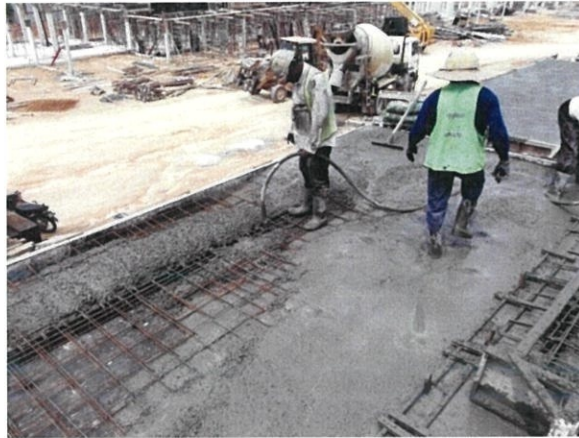
During concreting work, the concrete was properly compacted using mechanical vibrator as shown in Figure 3.17.

Figure 3.17: Concreting work which vibrator was used to compact the concrete.

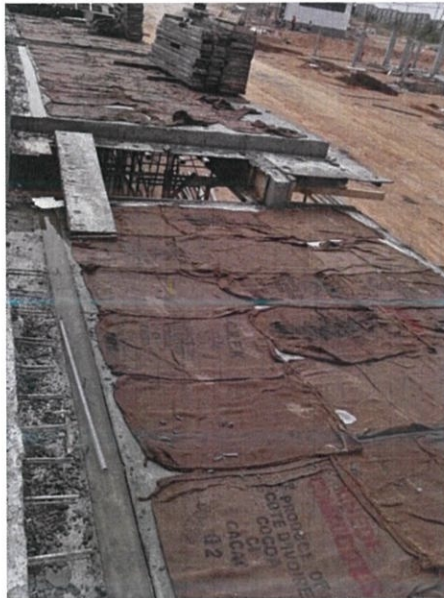
The casted area was properly cured by covering the concrete using wet hessian cloth. Curing process was shown as in Figure 3.18. Clean and clear water was used for the curing process.

Figure 3.18: Wet hessian cloth was used for curing process.

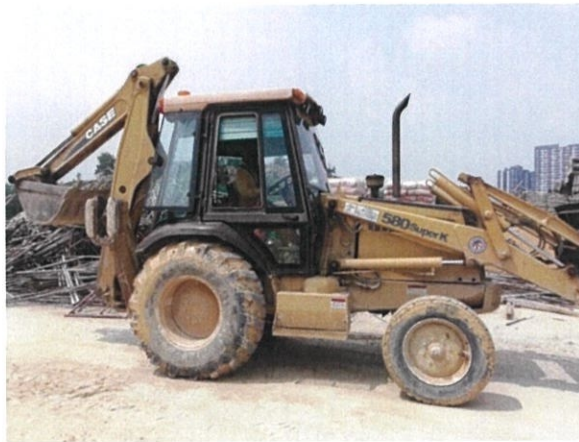
Backhoe as in Figure 3.21 is an excavating equipment or digger, consisting of a digging bucket at the end of an articulated arm. Articulated arm is mounted on the back of a tractor or front loader. The arm closest to the vehicle is known as the boom, while the arm which carries the bucket is known as the dipper stick. The boom is attached to the vehicle through a pivot known as king-post, which allows the arm to pivot left and right, through 180 to 200 degrees.

Figure 3.21: Backhoe with a digging bucket.

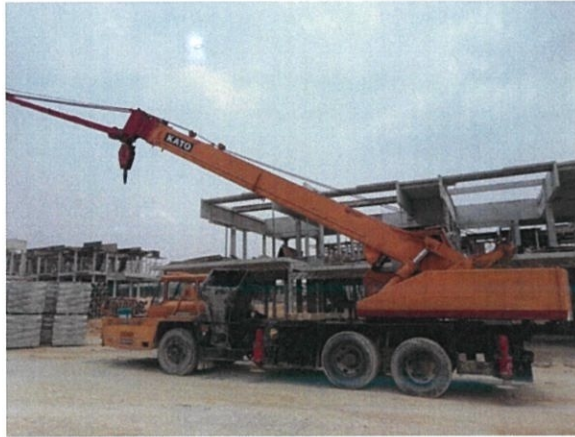
Mobile crane as shown in Figure 3.22 is a machine equipped with a hoist rope, wire ropes or chains, and sheaves that can be used to lift and lower materials and to move them horizontally. It is mainly used for lifting heavy things and transporting them to other places.

Figure 3.22: Crane on site.

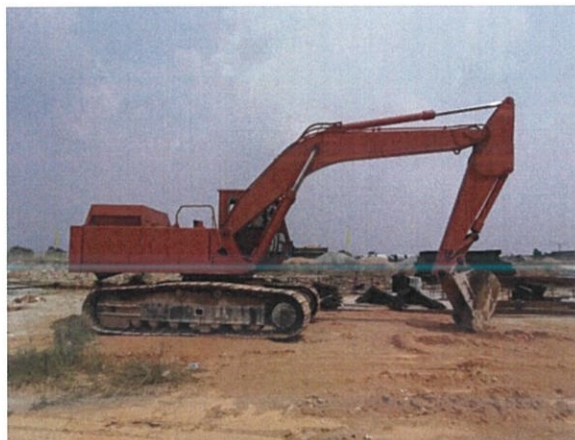
Excavator as in Figure 3.23 is a heavy construction equipment consisting of a boom, stick, bucket and cab on a rotating platform. The cab sits on top of an undercarriage with tracks or wheels. All movement and functions are accomplished through the use of hydraulic fluid, with hydraulic cylinders.

Figure 3.23: Excavator on site.

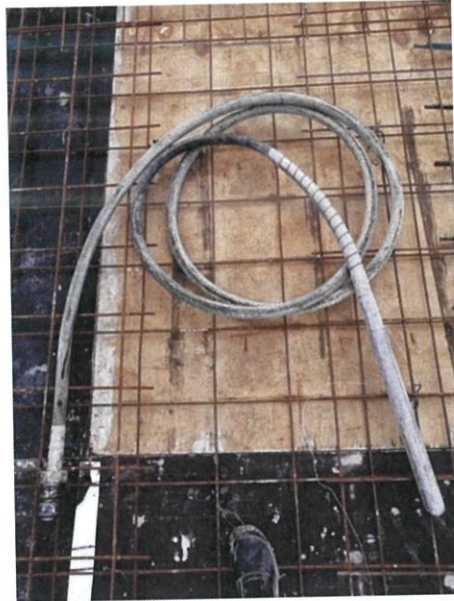
Vibrator poker as shown in Figure 3.24 is a tool used during concreting works. It ensures that the concrete pour is free of air bubbles and are even so that the concrete remains strong and has a smooth finish even after removal of the form work. It consists of an electric weight encased in a housing and driven by a diesel engine. Poker diameters range from 25 to 75 mm.

Figure 3.24: Vibrator poker to compact concrete.

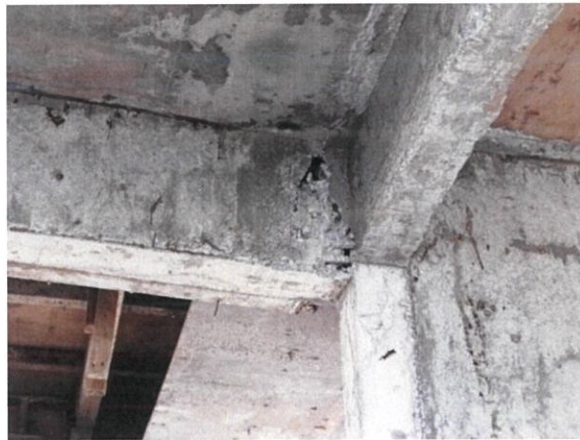
Figure 3.26: Honeycomb at first floor beam.

3.	<b>Honeycombing</b> Honeycomb shown in Figure 3.26 is a rough, pitted surface or voids in concrete.	Insufficient vibration, segregation, improper placement, leakage of grout through joints.	Proper vibration, prevent pouring concrete mix from height, ensure no leakage at joints.

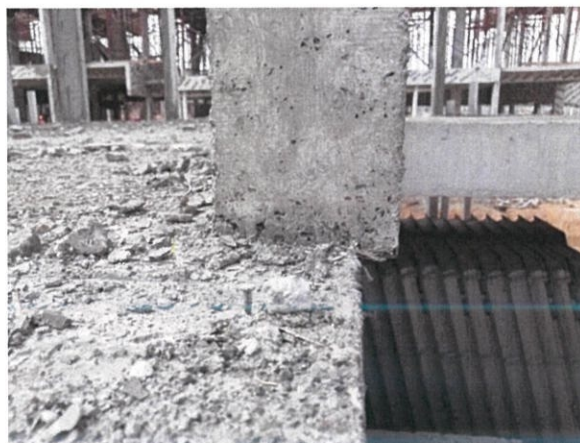
Figure 3.27: Inaccurate dimension or placing of column at first floor.

5.	<b>Dimension Inaccuracy</b> Inaccurate dimension of concrete structure was shown in Figure 3.27.	Defective workmanship, bad detailing.	Proper detailing, handle pre-concreting inspection.

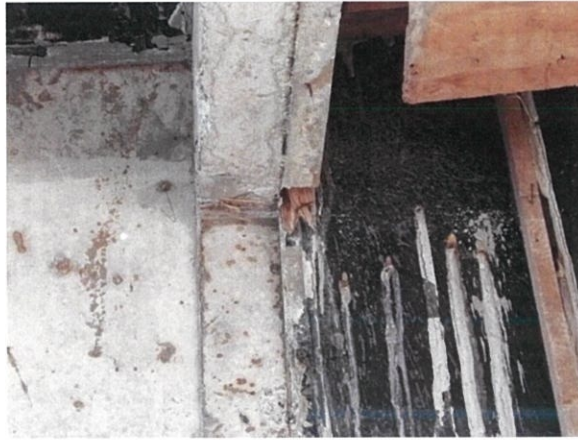
Figure 3.28: Left over formwork which got stuck in the concrete due to inaccurate installation of formwork.
