**6th UNDERGRADUATE  
SEMINAR ON BUILT  
ENVIRONMENT  
AND TECHNOLOGY  
(USBET) 2023**

# DAMPNESS DEFECTS ON WALL USING INFRARED THERMOGRAPHY AT PASAR BESAR SITI KHADIJAH, KOTA BHARU KELANTAN

*Using infrared thermography for the analysis of buildings and structures is reliable and accurate. To measure the extent of dampness to a structure or building, an infrared scanner detects energy and maps the temperature contours over the surface of a target object. There is consideration of the application of infrared thermography in two specific situations - the delamination of external/ internal wall finishes and the assessment building's physical condition. However, this study will focus on dampness on the building surface as well as the causes that affect this problem through the use of infrared thermography. Accordingly, a samples test (imager pictures) was taken to find the cause and effect of the occurrence of the defect dampness in the case study. From the research done, it can be concluded that there is indeed an effect of humidity on the walls of Pasar Besar Siti Khadijah, that is from an average temperature of 30 degrees Celsius, the colour from the observation of the thermograp

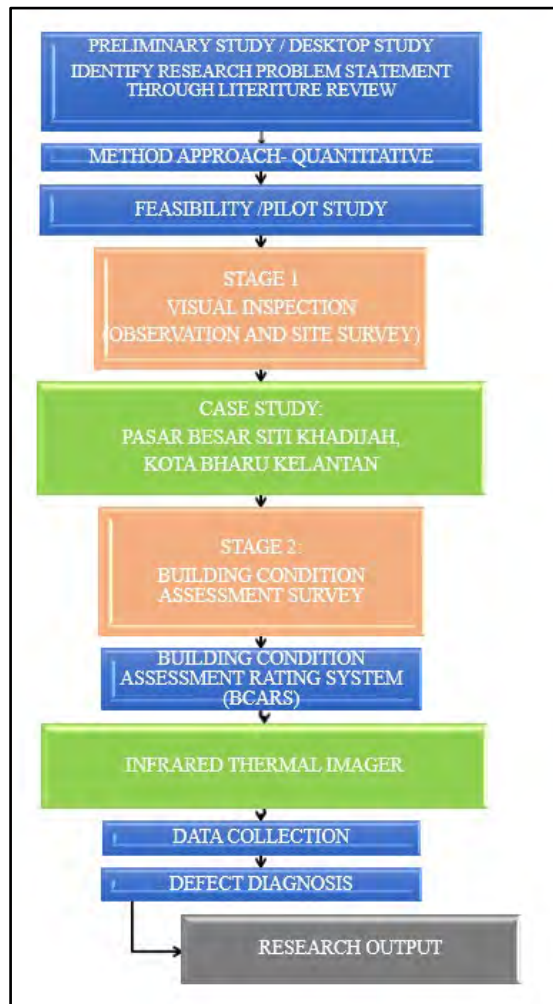
Figure 1: Research Design Work Process.

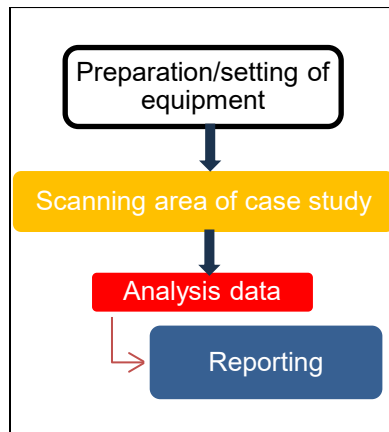
**Figure 2: Procedure of Infrared Thermograph.**

**Table 1: Infrared Thermograph setting.**

IR Fusion	Dew Point (°C)	Transmission (T)	Temperature (°C)	Emissivity
<b>Mid IR Fusion Level</b>	Auto setting (in IRT) follow by surround dewpoint future.	100%	-21 -150 c	0.95% (Concrete)
<b>Colour palette:</b>			<b>ironbow</b>

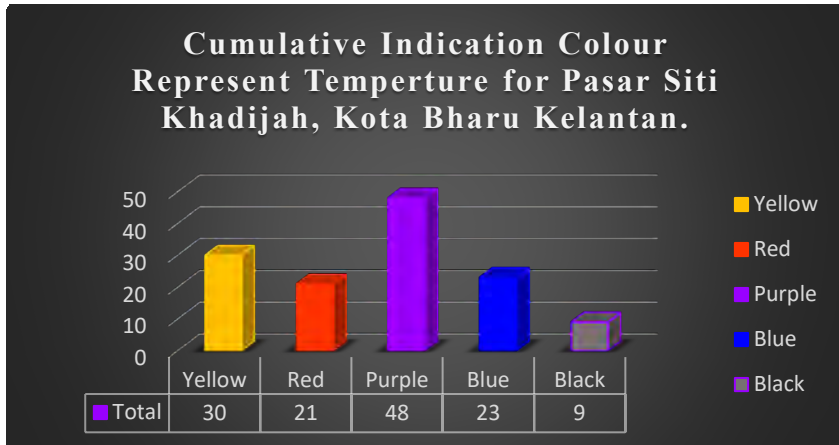
**Figure 3: Cumulative indicator colour.**

Bar chart Cumulative indication colour represents temperature for Pasar Siti Khadijah, where it can be seen that the maximum value for the entire structure is purple, the second highest is yellow, the third highest is blue, the fourth highest is red, and the lowest value is black.
