# Hot Corrosion Behaviour of Austenitic Steel-308 in Chloride Salts

Mohd. Misbahul Amin Che Mohd. Ruzaidi Ghazali Neelofar Amin

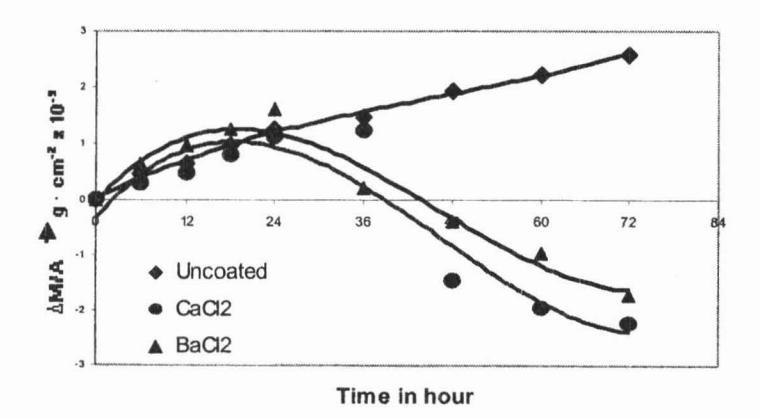
Figure 1 shows the curve of weight changes verses exposure time of austenitic steel-308 coated with calcium- and barium- chlorides, oxidized at 950°C in air. The graph showing the weight changes increase while the exposure times increase up to 48h, followed there is decrease with time. The highest corrosion rate was recorded by alloy that coated with CaCl<sub>2</sub> and follow by alloy coated with BaCl<sub>2</sub>. The greater corrosion rate was recorded at the first 48 hours, followed the trend showing the corrosion rate decreased with the increased of exposure times.

Figure 1. Curve of Weight Change versus Exposure Time of Austenitic Steel-308 Coated with CaCl<sub>2</sub> and BaCl<sub>2</sub>, Oxidized at 950°C in Air.

The corrosion rate of each test was decrease with the increasing of exposure times. It is because the decrease of the concentration of the chloride ions with times, most of the chloride ions that leads to corrosion has reacted to breakdown of the chromium film protecting the surface of the steel and activates the unprotected surface [7]. This determined the concentrations of chloride solution would affect the corrosion rate. The chemical reactions of chloride ions are:

The corrosion rate was highly affected by the concentration of chloride ions and temperature. The trend showing the corrosion rate decreased with the increased of exposure times. This is because the concentration of the chloride ions decreases with times. Besides that, temperatures also affect the corrosion rate.

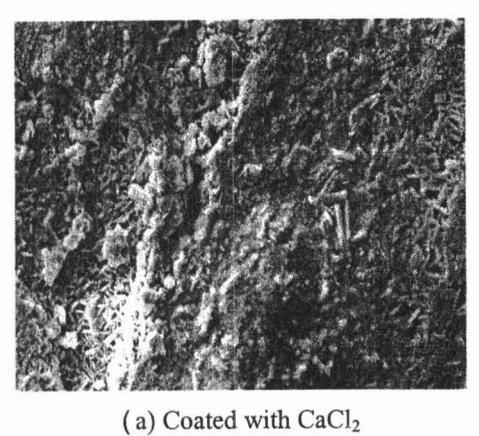
The spotted area shown in Figure 2 (a) & (b), indicated pitting corrosion seems to be took their place on the metal surface coated with  $CaCl_2$  &  $BaCl_2$ . The SEM micrograph of specimen coated with calcium chloride that exposed at 950°C for 72 hours showing the presence of intergranular corrosion and pitting corrosion and badly deterioration is observed, exhibiting the breaking of scales.

(b) Coated with BaCl<sub>2</sub> Figure 2: SEM Micrograph of Austenitic Steel-308 Coated with CaCl<sub>2</sub> and BaCl<sub>2</sub>, Oxidized at 950°C for 72 Hours in Air.

From the SEM micrographs analyses, the alloy coated with  $CaCl_2$  that exposed to 950°C undergone a seriously corrosion than the alloy coated with  $BaCl_2$ . It determined ionic salts also affect the corrosion rate. Increasing the time and high temperature, exhibiting the susceptibility to both pitting and active dissolution. Higher temperatures resulted in increased corrosion current densities and peak current densities [10].

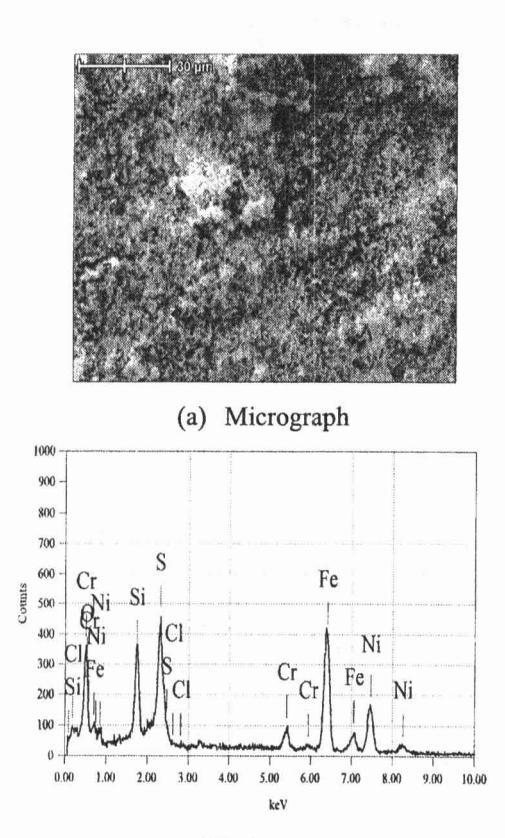
As shown in Figure. 3 and 4, the micrographs and EDAX spectra had verified the content of the elements of the specimen coated with  $BaCl_2$  and  $CaCl_2$  that exposed at 950°C for 72 hours. The results showed that the surface was mainly composed of chromium (Cr), Nickel (Ni), iron (Fe) and oxygen (O). The results were logically acceptable because austenitic-308 containing Cr-19.50%; Ni-11.00% and remaining. The oxygen occurs from the air.

(b) Spectra Figure 3: Micrograph and EDAX Spectra of the Elements and Compounds of the Specimen Coated with CaCl<sub>2</sub>, Oxidized at 950°C for 72 Hours.

Table1: Elemental Analysis Results of Specimen Coated with CaCl2	Oxidized at 950°C for 72
Hours from EDAX.

Element	Mass ( % )	Compound	Mass ( % )
0	30.63		
Si	5.46	SiO <sub>2</sub>	9.68
S	4.79	SO3	11.96
Cl	0.36	Cl	0.36
Mn	1.57	MnO	2.10
Cr	3.63	Cr <sub>2</sub> O <sub>3</sub>	5.31
Fe	37.50	FeO	50.10
Ni	16.10	NiO	20.49
Total	100		100

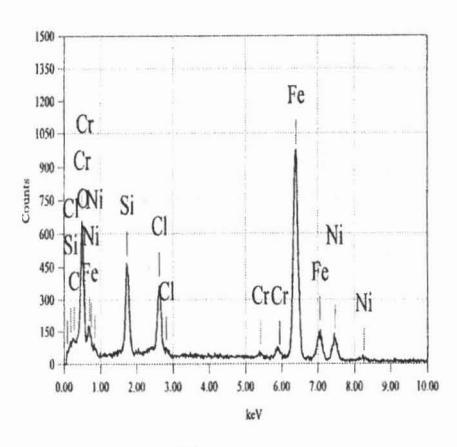
(a) Micrograph

(b) Spectra

Figure 4: Micrograph and EDAX Spectra of the Elements and Compounds of the Specimen Coated with BaCl<sub>2</sub>, Oxidized at 950°C for 72 Hours.

Table 2. Elemental Analysis Results of Specimen Coated with BaCl<sub>2.</sub> Oxidized at 950°C for 72 Hours from EDAX.

Element	Mass ( % )	Compound	Mass ( % )
0	23.69		
Si	4.24	SiO <sub>2</sub>	7.08
S	1.96	SO3	2.20
C1	4.21	Cl	4.21
Mn	2.07	MnO	1.80
Cr	2.63	Cr <sub>2</sub> O <sub>3</sub>	2.31
Fe	52.50	FeO	47.10
Ni	9.39	NiO	11.94
Total	100		100
