EXPLORING ALTERNATIVE MATERIALS FOR BAMBOO PANEL WALLS IN THE CONSERVATION OF THE IHSANIAH ISKANDARIAH MOSQUE: A CONCEPT PAPER

The Ihsaniah Iskandariah Mosque, Kuala Dal, Perak, serves as a symbol of Malaysia's cultural identity, making its preservation crucial for future generations. Despite previous conservation efforts, sections of the mosque's bamboo panel walls have suffered deterioration. The climate and environmental conditions in Malaysia, including high humidity and rainfall, pose challenges to the longevity of traditional materials like bamboo. To address this challenge, there is a need to explore alternative materials that offer enhanced durability, weather resistance, and sustainability. Researching alternative materials represents a proactive step towards preserving our cultural heritage. It not only fortifies the structural integrity of iconic landmarks like the Ihsaniah Iskandariah Mosque but also mitigates the environmental footprint of conservation efforts. Moreover, this endeavour catalyses adaptation strategies for climate change, propelling us toward a future where heritage conservation seamlessly aligns with sustainable development goals. This paper emphasizes

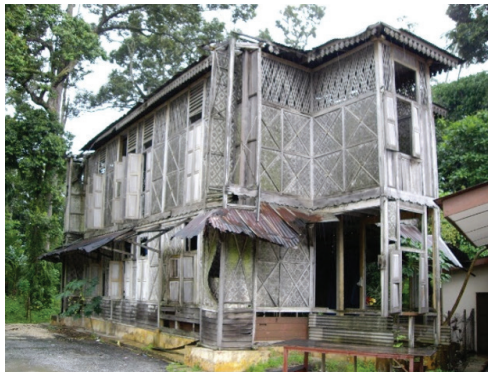
Figure 1. The Condition of the Mosque after being Vacated in 1976

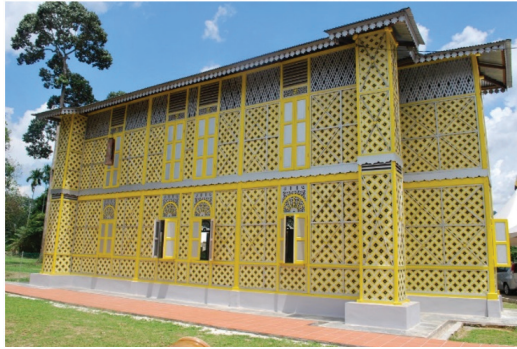
Recognizing the mosque's historical and architectural significance, the Department of National Heritage undertook extensive conservation work in December 2008. The conservation efforts included a wide range of activities to restore and preserve the mosque's structural and aesthetic integrity. During the 2008 conservation, efforts were made to replace these walls using materials identical to the originals, ensuring that the new bamboo panels matched the traditional weaving motifs, patterns, and dimensions precisely. Key aspects of the work included repairing the roof and structural framework, conducting termite prevention treatments, and restoring walls, panels, doors, and windows. These efforts were meticulously executed

to maintain the mosque's authenticity, architectural beauty, and intricate carvings as shown in Figure 2.

Figure 2. After conservation work in the year 2009

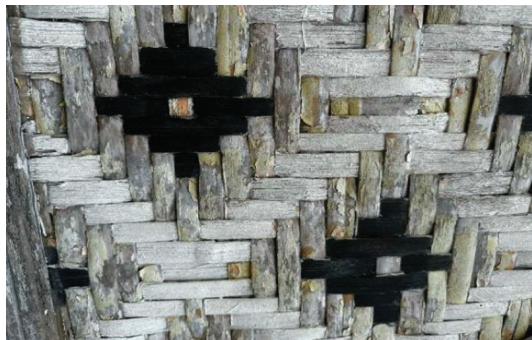
Despite these comprehensive conservation efforts, nearly 15 years later, as shown in Figure 3, it was discovered that the bamboo panel walls had deteriorated and required replacement. Bamboo, being an organic material, is particularly vulnerable to environmental factors such as humidity, rainfall, and temperature fluctuations, leading to its degradation over time. The Department of National Heritage, acknowledging the need for more durable materials, has initiated a search for suitable alternatives to replace the bamboo panels. This search aims to find materials that can withstand environmental challenges while preserving the mosque's historical and aesthetic values.

Figure 3. Current condition of the kelarai walls of Ihsaniah Iskandariah Mosque, Padang Rengas
