VOLUME 6 NO. 2  
DEC 2009

# SCIENTIFIC RESEARCH JOURNAL

# Influence of Retrogression and Re-Aging Heat Treatment to Stress Corrosion Cracking Resistance on Al-Zn-Mg-Cu Alloy

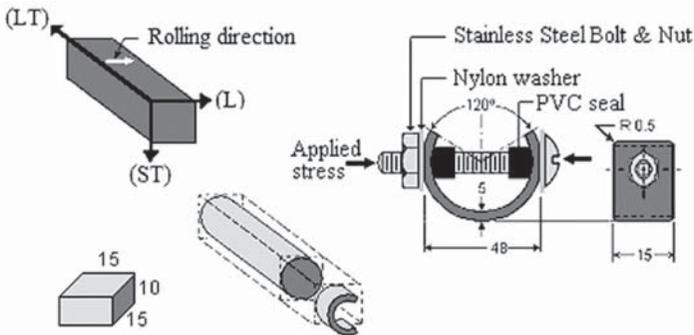
Figure 1: Sketches of the Orientation of Cube Shape and C-ring Specimens Employed (All dimensions are in millimeters)

In this investigation, two types of specimen were produced: the C-ring for stress corrosion cracking testing and cubes for hardness and microstructure testing. The cube shape was machined to 15 mm  $\times$  15 mm  $\times$  10 mm with a tolerance of  $\pm 0.05$  mm. The Vickers hardness was measured using a load of 20 kg and a loading time of 20 seconds at various locations on the cube shaped specimens. Six C-ring specimens were produced using a CNC turning machine according to the ASTM standard G 38, Figure 1.

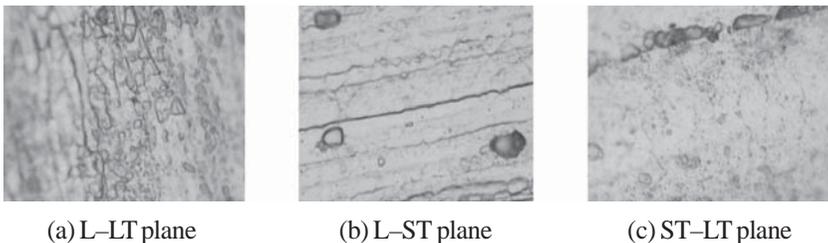
The orthographic micrographs of an Al-Zn-Mg-Cu alloy specimen, Figure 2, shows the grain structures of the specimen after RRA heat treatment. The figure clearly illustrates that these alloys have a highly directional grain structure. The directional effects relate to the rolling direction and based on the fragment grain flow it is evident that the Al-Zn-Mg-Cu alloy specimen derives from a flat rolled product. RRA treatment produces microstructures that closely match those found in the SCC resistant T7 specimens. Furthermore, dislocations which invariably develop during quenching from solution are annealed during the retrogression treatment, which contributes to better SCC performance [11]. The specimen was etched in order to enable distinction between the recrystallized grains (clear) and the unrecrystallized grain fragments, which appear dark due to the precipitation of fine subgrains at the boundaries.

Figure 2: Optical Microscope Pictures (magnification 500×) of Cube Shaped Specimen C4 Grains in Different Planes Retrogressed at 200 °C for 2 minutes followed by Re-aging at 120 °C for 24 hours

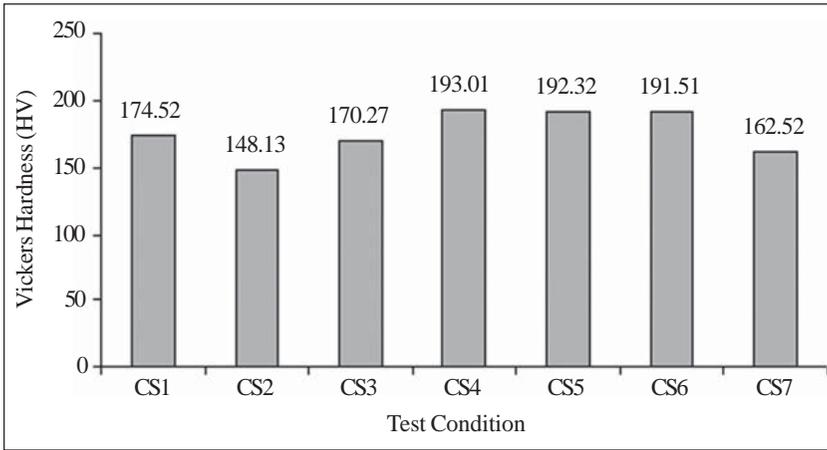
The average hardness values for the differently treated Al-Zn-Mg-Cu alloy are presented in Figure 3. The conventional treatment, which constitutes solution heat treatment followed by quenching (CS2), results in a significant drop in hardness compared to the untreated received specimen (CS1). The decrease in hardness is caused by the dissolution of  $MgZn_2$  particles ( $\eta$  phase), which provide greater strength to the Al-Zn-Mg-Cu alloy, and the formation of a single solid phase, which is relatively soft and weak.

Figure 3: Average Hardness of Different Heat Treated Al-Zn-Mg-Cu Alloys

After solution heat treatment the hardness of the T6 tempered specimen (CS3) has increased due to the effect of aging, whereby the solute particles diffuse into clusters that distort and strengthen the material. The formation of finely dispersed second phase particles in the alloy induce lattice strain in the aluminium matrix that restricts dislocation flow and is the same phenomenon which occurs during the RRA heat treatment (CS4, CS5 and CS6). It is of note that the hardness for the over-aging specimen (CS7) decreases, because the precipitates begin to coarsen and the average particle spacing gradually increases due to heating at a high temperature (175 °C) for about 5 hours. The conclusion is that the RRA heat treatment is the best hardening technique, because both the RRA specimens exhibit improved hardness compared to the specimens acquired using the conventional treatment method.

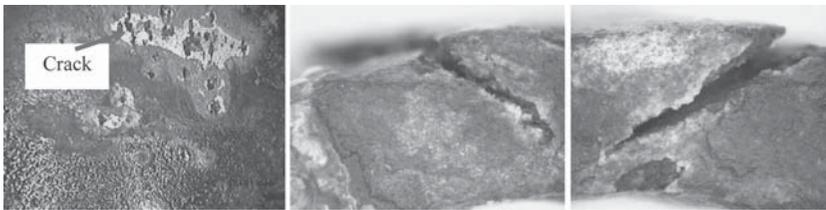
(a) Crack initiation on the toptop of the C-ring specimen CR1. Magnification 10×.

(b) Side view showed thecrack growth on thespecimen CR3. Magnification 7×

(c) Side view showed thecrack growth on thespecimen CR4. Magnification 7×

Figure 4: The Influence of Orientation and Grain Particles on the Cracking Propagation of the Alloy Specimens

The experimental results indicate that the RRA increases the SCC resistance of the alloy. Even though the initial applied stress is higher (for specimens C4, C5 and C6), the time of failure is longer (Table 6) than that for the T6 tempered specimen (CR3). Based on observation, cracking propagation for all specimens did not start at the centre of the C-ring, as shown in Figure 4. Theoretically, if the rectangular bar is bent to form a C-ring shape, the weak point may be located at the centre of the C-ring since it is the point of maximum bending and thus theoretical stress. However, in this investigation the C-ring was machined in the longitudinal and short transverse plane of the rolled bar direction, Figure 4. Thus, the orientation of grain particles will have an inherent effect on the strength of the C-ring, which is in accordance with the work of Bagab [10] who stated that the distribution of particles affects the hardness and yield strength. The short transverse grain orientation is far more susceptible to failure by SCC than the other two orientations, due to the flattening and elongation of the grain structure in the short transverse and longitudinal directions, respectively.

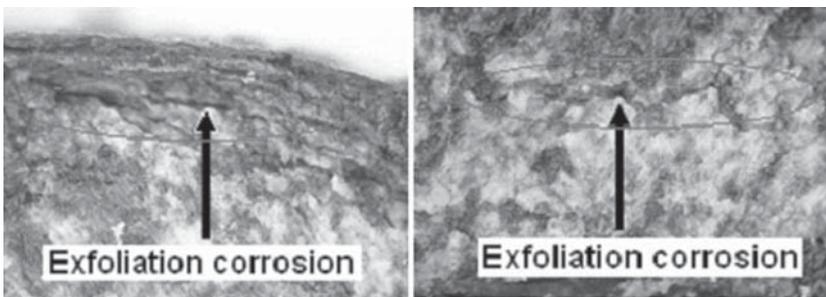
(a) Specimen CR6. Magnification 12×

(b) Specimen CR7. Magnification 12×

Figure 5: Exfoliation Corrosion (a) The T6 tempered/RRA Specimen (CR6) and (b) the Over-aged Specimen (CR7)

The T6 tempered specimen, which underwent RRA, (CR6) and the over-aged (CR7) specimen (CR7) did not fail for the duration of the test period (30 days). The specimens did however undergo exfoliation corrosion (Figure 5), whereby the surface alloy grains are lifted up by the force of expanding corrosion products occurring at the grain boundaries. Exfoliation

[12] is most likely to occur in wrought products such as extrusions, thick sheets and thin plates formed by rolling, because of the resultant highly elongated grain structure. Andreatta *et al.* [2] reported that over-aging distinctly improves resistance to intergranular corrosion, because the size of the  $MgZn_2$  particles at the grain boundaries increases their inter particle distance.
