Failure Analysis of Hybrid Fibre Reinforced Plastics for Bolted Joint under Thermal Effect

*D. Sivakumar**, L.F. Ng, J.W. Ng, M. Z. Selamat
Faculty of Mechanical Engineering,
Universiti Teknikal Malaysia Melaka,
76100 Durian Tunggal, Melaka, Malaysia.
*sivakumard@utem.edu.my

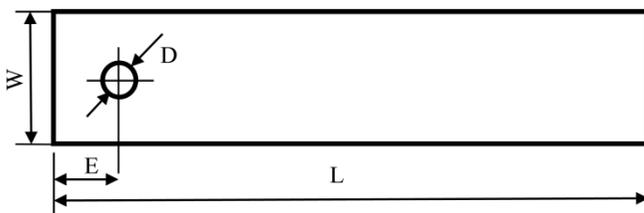
Figure 1: Composite specimen geometry

temperature 40°C for 24 hours to eliminate moisture content. The FRP panels were stacked in a 3mm thick picture frame mould with the stacking sequence of [PP/GF/PP/KF/PP/PP/GF/PP]. The picture frame mould was placed in a hydraulic hot press machine with a temperature of 180°C and pressure of 30kg/cm². Hybrid composite panels were cut into a dimension of 135mm x 36mm using Proxxon table saw in accordance to ASTM D5961. Specimens were then drilled with notch diameter of 6mm at a specific location using laboratory bench drill. Circular file was used to get a good surface finish on the drilled notch to eliminate stress concentration. The notch diameter shall be tight-fit with the M6 bolt. Figure 1 shows the schematic dimension of the specimens (L=135mm, W=36mm, E=18mm, D=6mm).

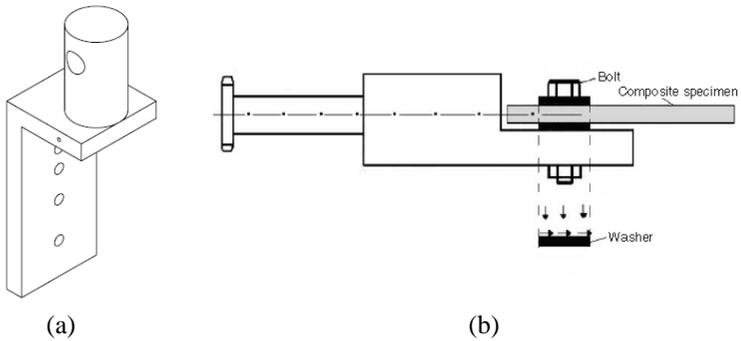
Figure 2: Experiment setup (a) jig design (b) specimen setup

The bearing test was conducted according to ASTM D5961 using INSTRON 5969 Universal Testing Machine (UTM) with a load capacity of 50kN. Specimens were attached and bolted to the special designed and fabricated jig and then placed in the heat chamber at room temperature, 40°C, 50°C and 60°C. The design of the jig and the experiment assembly of specimens are as shown in Figure 2. Specimens were loaded at crosshead displacement rate of 2mm/min until a maximum load has clearly been reached in order to observe and analyse the exact failure mode. The tests were terminated when a 30% load drop from maximum load was detected. The test was repeated three times for each setting. The result from different temperatures and preload moments were recorded and represented in load- extension curves. The result was then analysed and evaluated to deduce the effect of temperatures and preload moments on bearing strength. Figure 3 shows the setup of specimen inside the heat chamber.

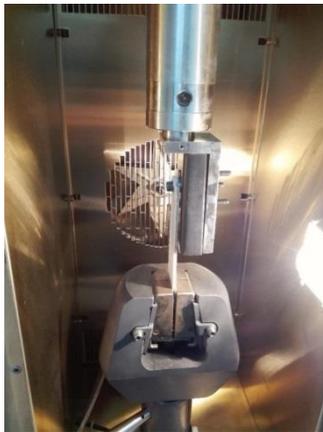
Figure 3: Setup of specimen inside heat chamber

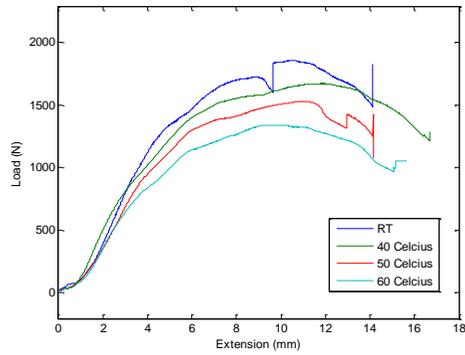
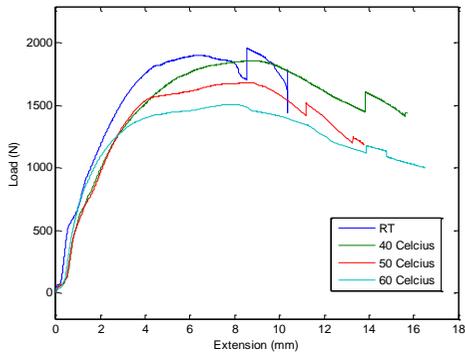
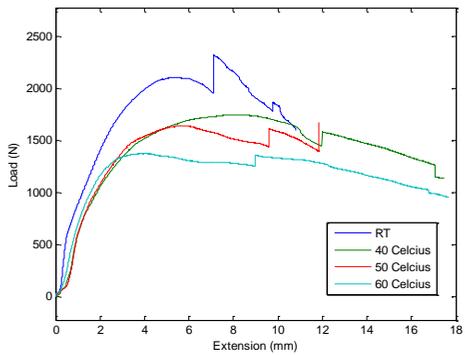
Figure 4: Effect of temperature on load-extension curve of hybrid composite at (a) 0Nm, (b) 5.2Nm and (c) 7.5Nm

Figure 4 shows the effect of temperature on load-extension curve of the hybrid composite under different preload moment of 0, 5.2 and 7.5Nm. As can be seen from the graphs, specimens at room temperature ($\approx 25^\circ\text{C}$) have the highest load carrying capability, followed by specimens at 40°C , 50°C , and 60°C for all preload moments. At room temperature, the structure of the PP polymer matrix was not affected by the heat and the PP polymer matrix was able to fully perform its function as a binding agent and hence it allows the applied load to be distributed more evenly to all reinforcing fibres. As a result, the load carrying capability of specimens at room temperature condition was the highest among all tested temperatures. At 60°C , the load carrying capability decreased by about 28% on average compared to at room temperature. This can be attributed to the structure of the PP polymer matrix had been damaged and its role as a binding agent had been adversely affected. This shows the significance of temperature effect on the load carrying capability of FRPs. Generally, the increase in temperature will decrease the load carrying capability of a specimen in a proportional manner, which means the higher the temperature, the lower the load that can withstand.

As for the load-extension relationship, all specimens showed typical behaviour of ductile materials, which is linear at the beginning followed by non-linear relationship. Linear relationship was observed for the first 4 to 5mm of extension and then followed by intensive non-linear load-extension curve. The specimens were able to have higher elongation if exposed to elevated temperature but with bearing carrying capability compromised

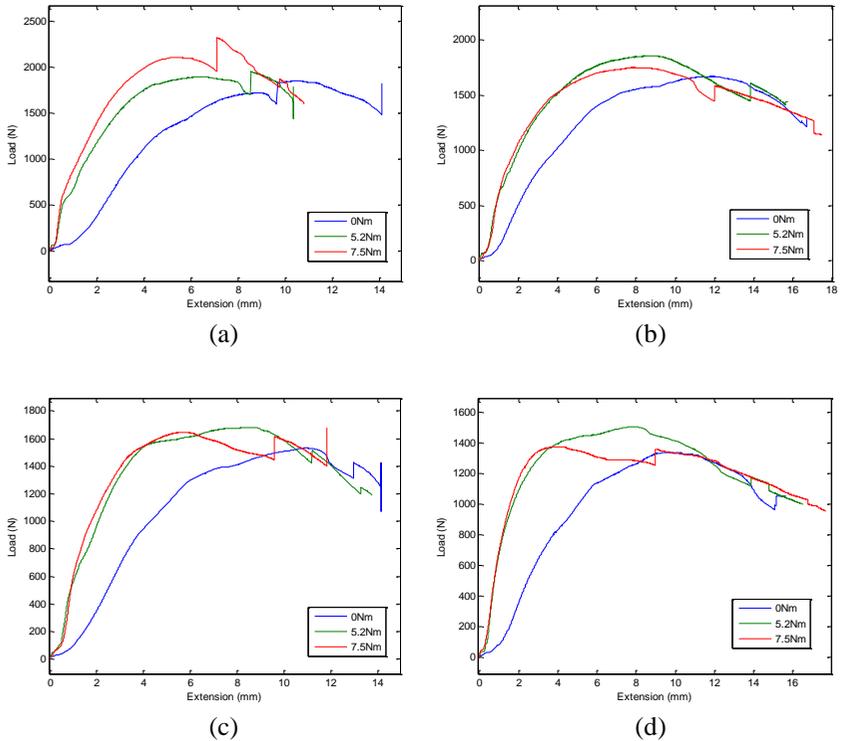
Figure 5: Effect of preload moment on load-extension curves at different temperature of (a) room ($\approx 25^{\circ}\text{C}$) (b) 40°C (c) 50°C (d) 60°C

Figure 5 shows the effect of preload moment on load-extension curve of the hybrid composite at different temperature (25, 40, 50 and 60°C). Figure 5(a) shows the effect of variation of preload moment at room temperature. From Figure 5(a), it can be seen that specimens with preload moment of 7.5Nm had the highest load carrying capacity, followed by 5.2Nm and 0Nm. This can be attributed to the clamping force produced by the tightening preload moments that prevent the delamination of fibre layers. The tightening preload moments held all the layers together at their original position, resulting in an increase in load carrying capacity. When delamination is avoided, the mechanical strength of specimens can be preserved, resulting in higher load carrying capacity. However, this phenomenon only happened in specimens at room temperature. For specimens exposed to temperature at 40, 50 and 60°C, preload moment at 5.2Nm showed the highest load carrying capacity, which was followed by 7.5Nm and 0Nm. Referring to Figure 5(b), (c) and (d), it can be noticed that the maximum loads were lower for specimens with 7.5Nm preload moment compared to specimens with 5.2Nm preload moment. Preload moment at 5.2Nm is the recommended tightening torque for M6 bolts [15]. This is because of the “plunging” effect of the washer that damaged the geometrical integrity of hole due to over-torque beyond recommended value. At elevated temperature, the PP matrix starts to soften due to the breaking of polymer chains. When the preload moment which is higher than the recommended value was applied, obvious engraving marks can be observed on the surfaces of the specimens. During bolted joint test, the washers “plunged” into the specimens, forming a cut-like opening around the hole that damaged both the PP matrix and fibres. As a consequence, the load carrying capability was undermined for over-torqued specimens at elevated temperatures.

In this experiment, preload moments do not have any impact on the extension of specimens. Except for the specimens at room temperature with 0Nm preload moment, all specimens at elevated temperature have a similar total extension before reaching the 30% peak load drop point. To exemplify the extension, from Figure 5(a), the specimens (except for specimens with 0Nm preload moment), reached the 30% peak load drop point at the extension of around 10mm. This also applies to other specimens at 40°C (around 12-14mm), 50°C (around 16-17mm) and 60°C (around 17-18mm). Therefore, this implied that preload moment does not affect the extension of specimens for the same temperature.

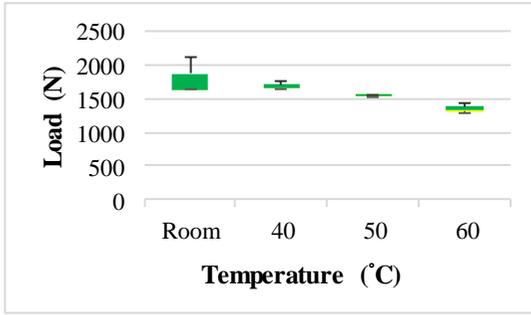
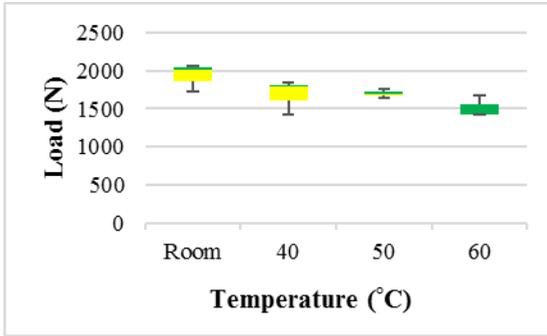
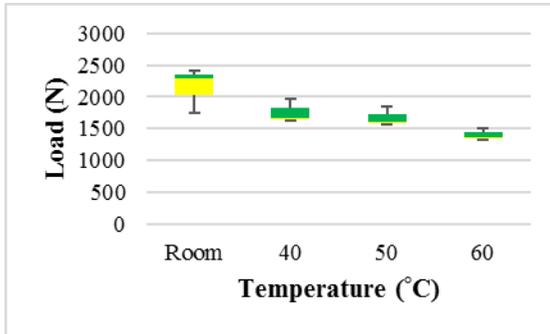
Figure 6: Box plots of maximum loads at various temperatures under (a) 0Nm, (b) 5.2Nm and (c) 7.5Nm preload moment.

Figure 6 shows the box plots for maximum loads at the temperature of room temperature, 40, 50 and 60°C and different preload moments (a) 0Nm, (b) 5.2Nm and (c) 7.5Nm. Generally, most of the test values were close to each other and average value. The deviation and spread in test results were probably due to minor specimen inconsistency since each FRP panels are unique in the way that each panel was fabricated individually using laboratory-level machines and tools. In order to reduce the deviation, precise temperature and preload moment control was executed during the experiment which theoretically reduces the spread of test values. Figure 7 shows the computed 95% confidence interval for the average maximum load at various temperatures under preload moment of (a) 0Nm, (b) 5.2Nm and (c) 7.5Nm. The small deviation of test values from the average values indicates that the obtained test results are in the acceptable range.

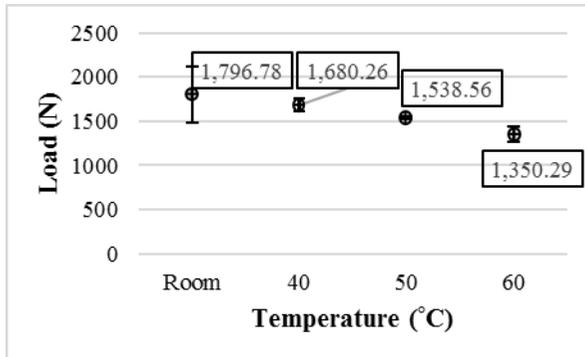
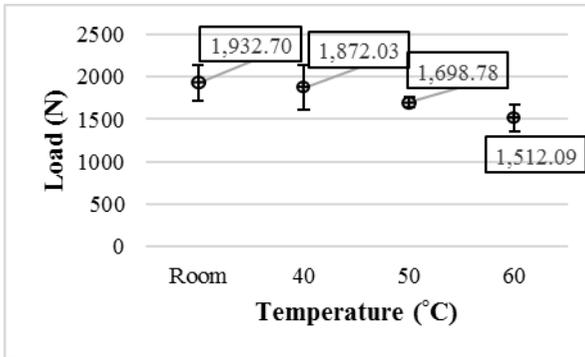
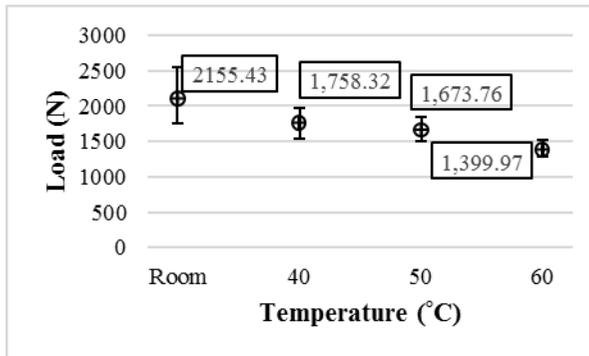
Figure 7: 95% confidence interval of average maximum loads at various temperatures under (a) 0Nm, (b) 5.2Nm and (c) 7.5Nm preload moment.

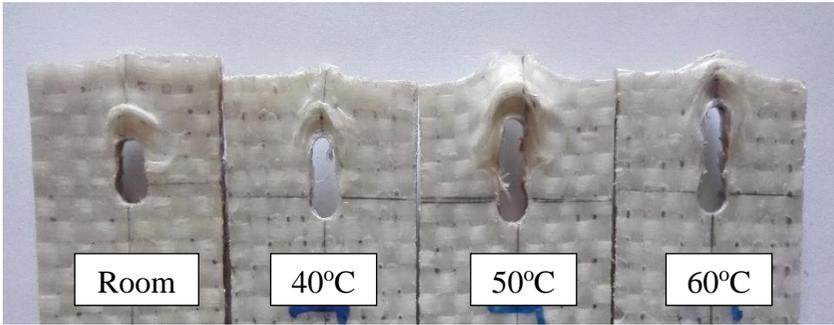
Figure 8: Photo of deformed specimens at various temperatures under 0Nm preload moment

Figure 8, 9 and 10 show the failure mode of the specimens after bolted joint test was performed. It can be seen that increasing the ambient temperature will lead to more damage in terms of notch deformation regardless the effect of preload moment. Figure 11 illustrates the “plunging” effect caused by the washers when specimens were torqued at 7.5Nm. The washer at the front side “sunk” into the specimen, forming a cut-like damage to the notch while the sunk washer forced the specimen to form a “bulge” at the back of the notch. Figure 12 presents the onset of net-tension failure mode at the two sides of the hole. The crack lines can be observed on the front and back of the specimen.

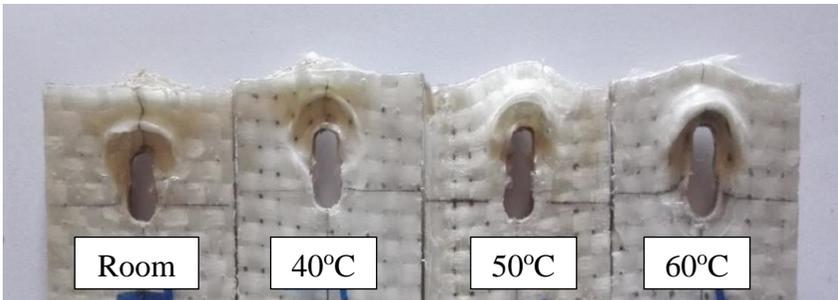
Figure 9: Photo of deformed specimens at various temperatures under 5.2Nm preload moment

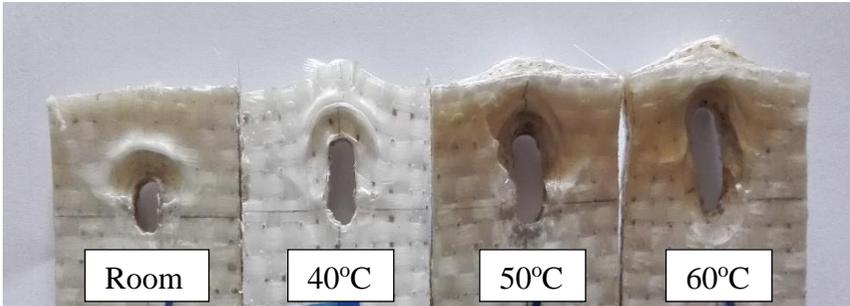
Figure 10: Photo of deformed specimens at various temperatures under 7.5Nm preload moment

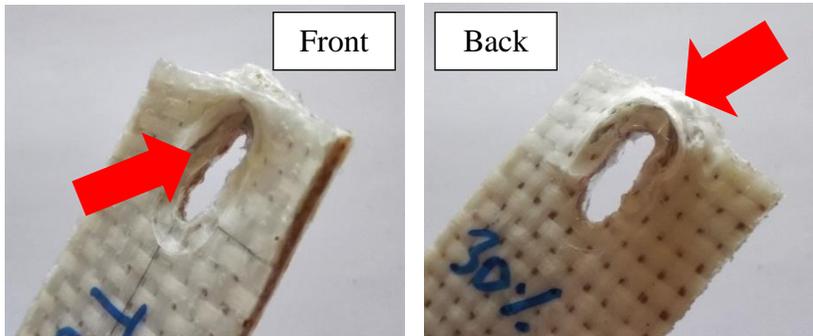
Figure 11: Photo showing “plunging” of washer into the specimen (Left: front side; Right: back side)

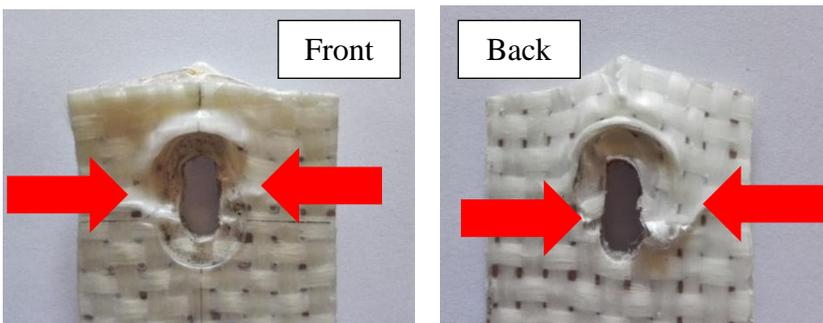
Figure 12: Photo showing the onset of net-tension failure mode (Left: front side; Right: back side)

All specimens showed the same failure mode which was bearing failure mode. This shows that the load was the highest at the contact point between the top side of the hole and the bolt. The bearing deformation continued to propagate and subsequently bearing failure mode was superseded by net-tension failure mode. During the experiment, small crack lines perpendicular to the length of the specimens were observed, the small

crack starts to propagate at the two sides of the holes. However, there was no large net-tension crack line observed due to the 30% peak load drop criterion was reached and the experiment was automatically stopped by the system. This is to comply with ASTM D5961 standard in order to observe the true failure mode and prevent the masking of true failure mode. Table 2, 3 and 4 summarise the test results at various temperatures under preload moment of 0, 5.2 and 7.5 Nm respectively.
