## **BUILDING RISK ANALYSIS AND INSURANCE**

PRACTICAL TRAINING REPORT

# AVENUE D'VOGUE

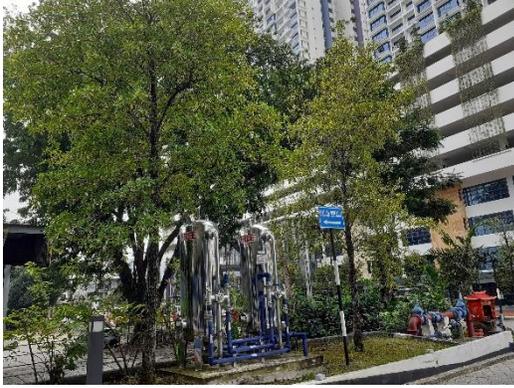
*Picture 3.4*

- The trees at the common area are advised to be trimmed accordingly as it may damaging the backwash & water filter.

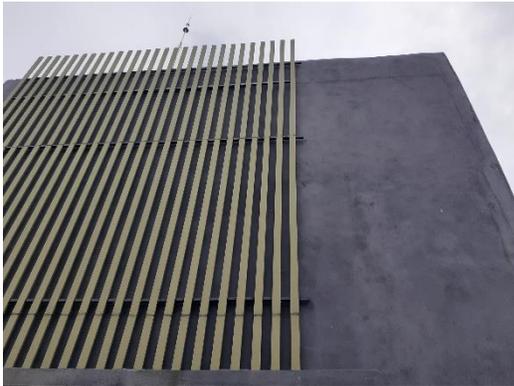
*Picture 3.5*

- The metal railing poses risks of falling off and causing harm to other property.

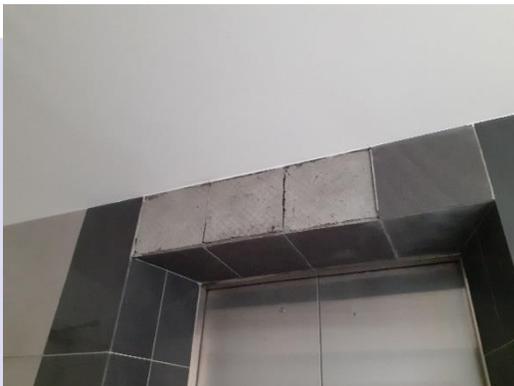
*Picture 3.6*

- Tiles at the lift hall broken due to the installation issue.

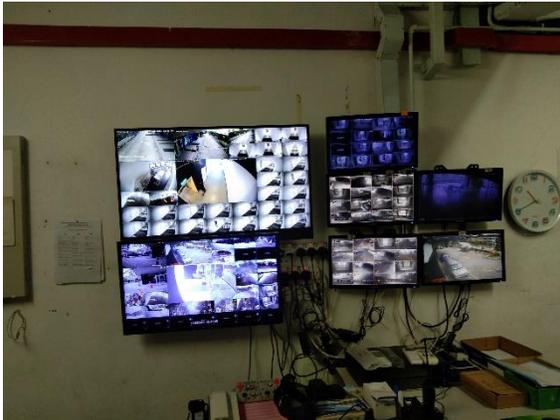
Picture 2.1

**1. CCTV function to acceptable standard and properly maintained.**

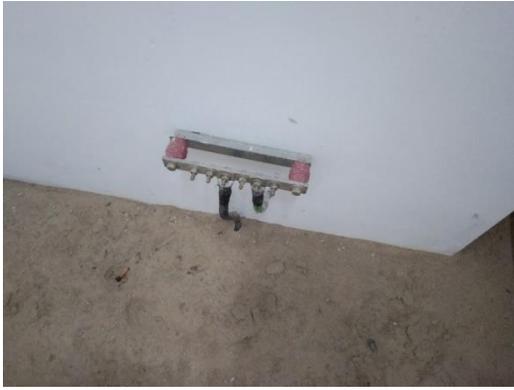
*Picture 3.4*

**4. Copper tape in place and serviceable repair.**

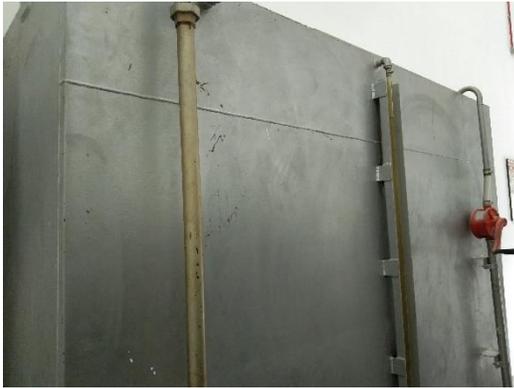
*Picture 3.5*

**5. Diesel tank in good condition and well-maintained.**

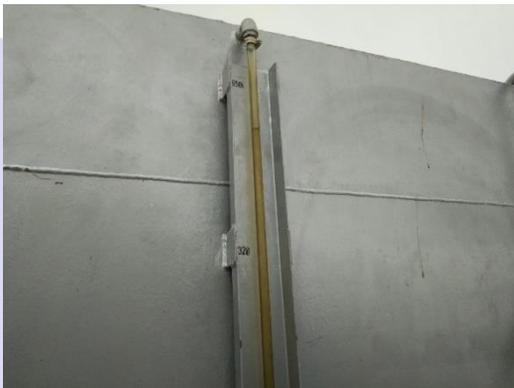
*Picture 3.6*

**6. Diesel level in satisfactory level and in good condition**

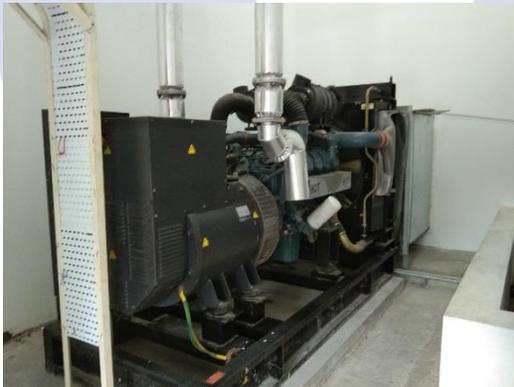
*Picture 3.7*

**7. Genset in good working condition and well-maintained.**

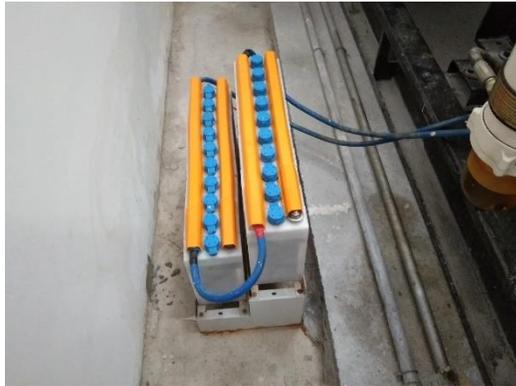
Picture 3.9

**9. Battery water level in good condition**

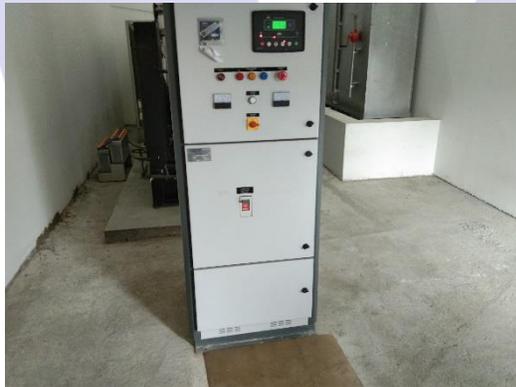
Picture 3.11

**11. Automated main failure board in good working condition with the rubber mat intact and in place.**

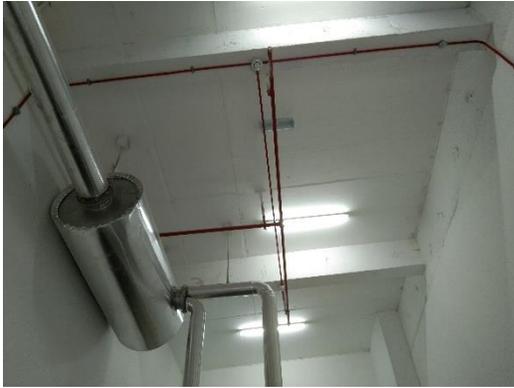
*Picture 3.12*

**12. Smoke detector, heat detector and CO<sub>2</sub> sprinkler were properly installed and in satisfactory condition**

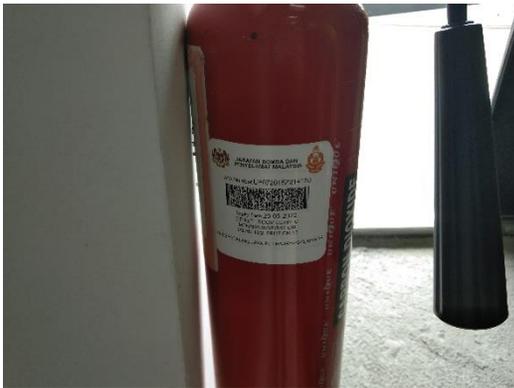
*Picture 3.13*

**13. Fire extinguisher available for genset room and valid until 20/05/2022**

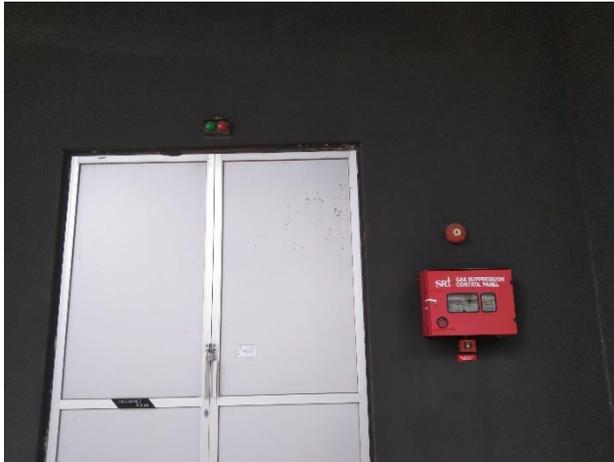
Picture 4.1

1. Fire alarm panel and light alarm indicator at TNB room does not function. It was informed by the technician; they cannot attend to the issues as it requires an authorised person to access the room.

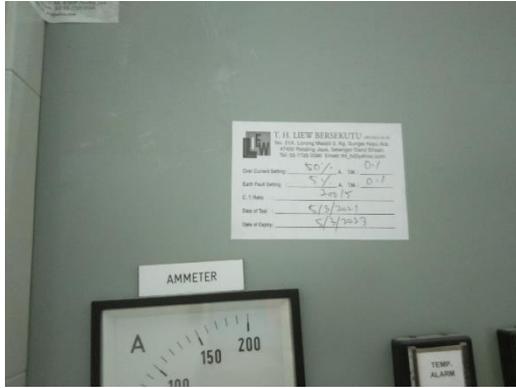
Picture 4.4

4. The calibration date of expiry is 5/03/2023

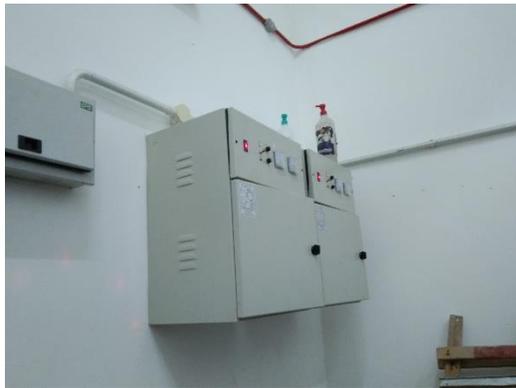
Picture 4.5

5. The control board in good working condition.

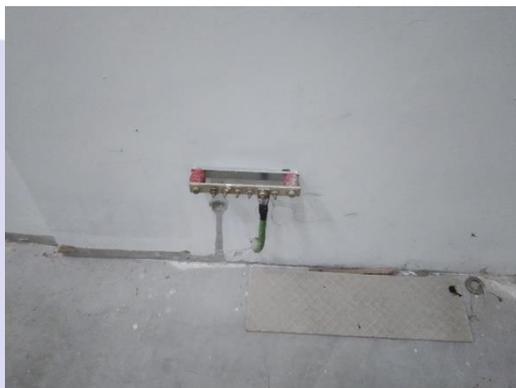
Picture 4.6

6. Copper tape available at the place and in good condition

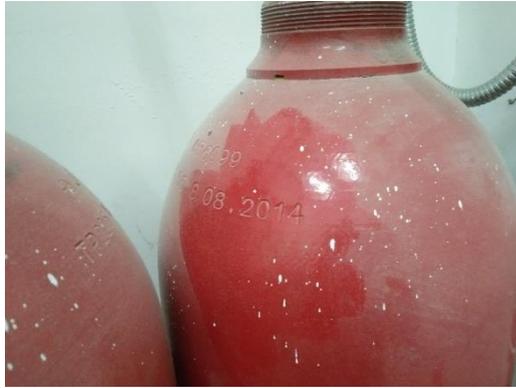
Picture 4.8

8. CO<sub>2</sub> cylinder stamping shows the manufacture year was in 2014

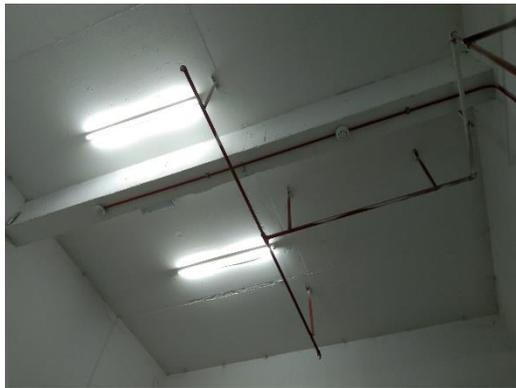
Picture 4.9

9. Smoke detector, heat detector and CO<sub>2</sub> sprinkler were properly installed and in satisfactory condition

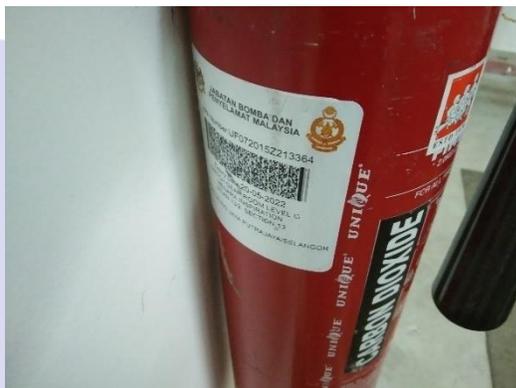
Picture 4.10

10. Fire extinguisher certificate valid until 20/05/2022

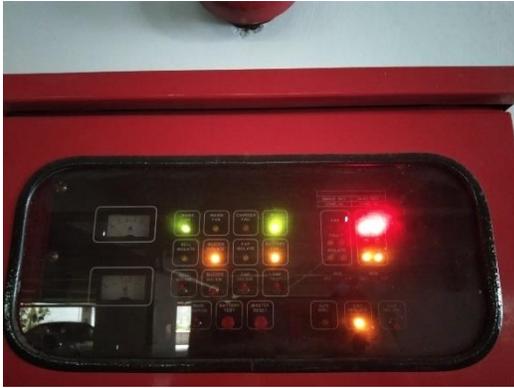
Picture 4.12

**12. The fire alarm triggered due to heat detector sensed excessive heat in the room due to ventilation problem.**

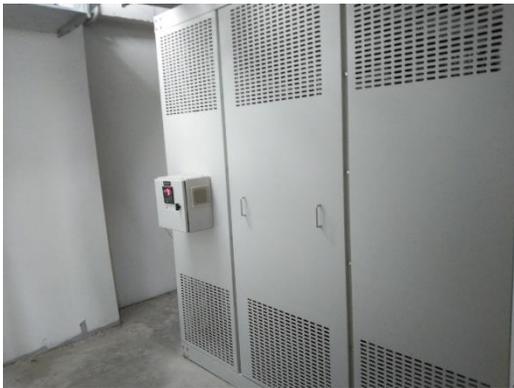
Picture 4.13

**13. The control board in good working order and serviceable condition.**

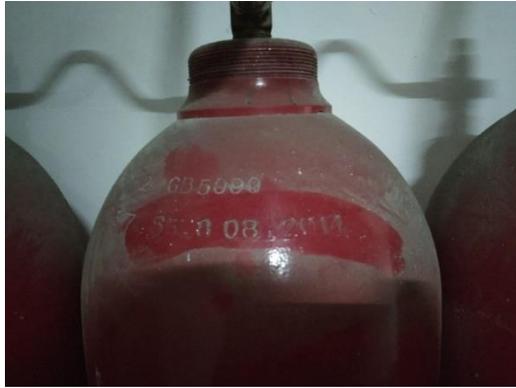
Picture 4.15

**15. CO<sub>2</sub> cylinder installed and placed in good condition.**

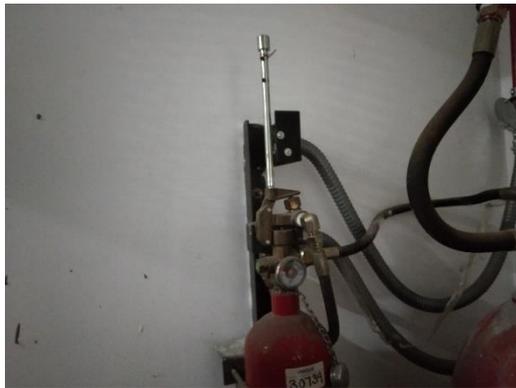
*Picture 4.16*

**16. CO<sub>2</sub> cylinder stamping shows the manufacture year was in 2014**

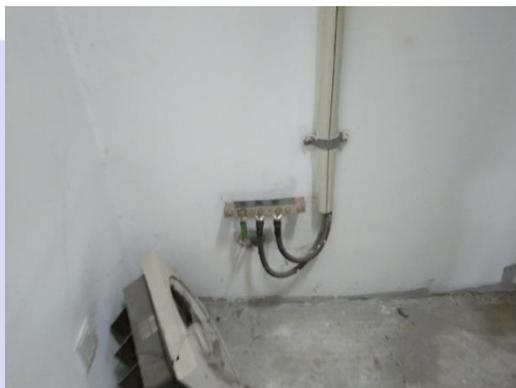
*Picture 4.17*

**17. Pilot cylinder it locked to avoid gas discharged**

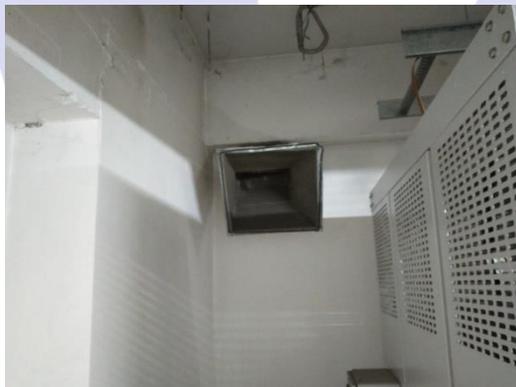
*Picture 4.18*

**18. Copper tape available at place and in good condition.**

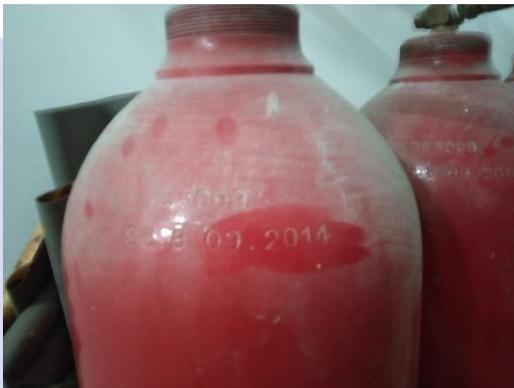
Picture 4.25

**25. CO<sub>2</sub> cylinder situated in good condition**

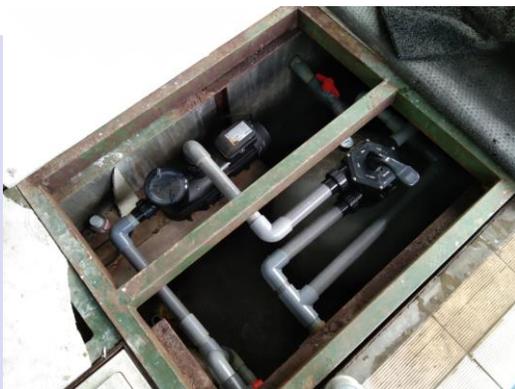
Picture 6.5

5. Swimming pool in good condition.

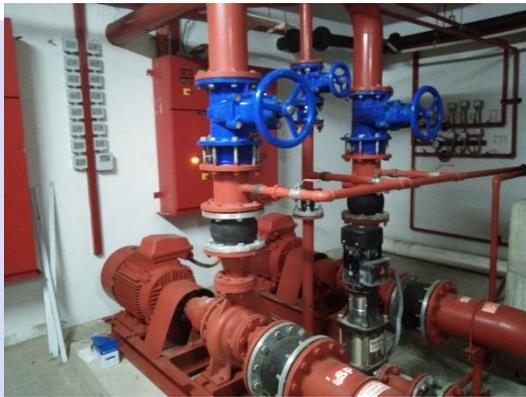
Picture 6.13

13. The pump in good working order and well-maintained.

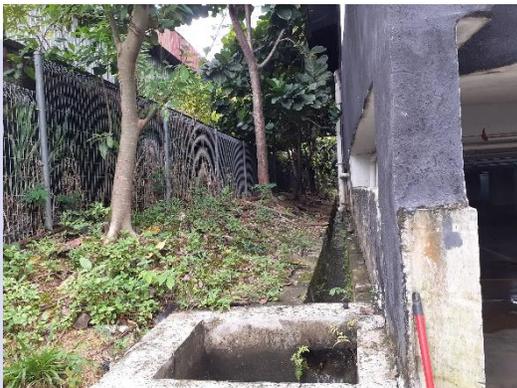
Picture 9.25

**25. Retaining wall install at the perimeter area in good condition.**

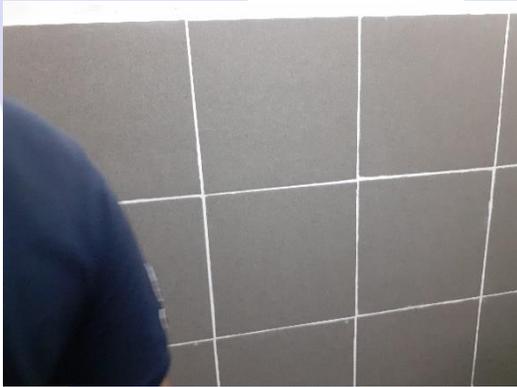
*Picture 9.38*

**38. The plastering work to cover the crack that occurred at the surau**
