DEPARTMENT OF BUILDING
FACULTY OF ARCHITECTURE, PLANNING AND SURVEYING
UNIVERSITI TEKNOLOGI MARA
(PERAK)

DECEMBER 2019

Slope Stabilization

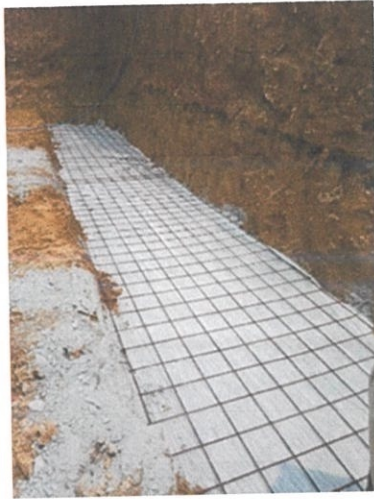
Figure 3.7 : BRC wire mesh steel

- iii. Before concreting works, two layers of BRC wire mesh steel as shown in **Figure 3.7** with the size of A10 were installed as to tighten the concrete slab.

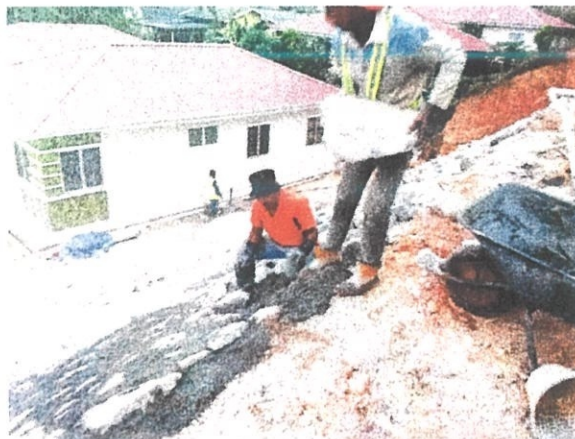
Figure 3.11 : Stone pitching works in process (Source: Courtesy of JKRKT)

- iv. The workers were making sure that the stones were perpendicular to the slope with the main point as the gradient is stable. A rough surface were left to retard any water flow in the drain and gullies. Other than planting grasses for strengthening the slope, this method used cement mortar instead although this method could impede drainage.

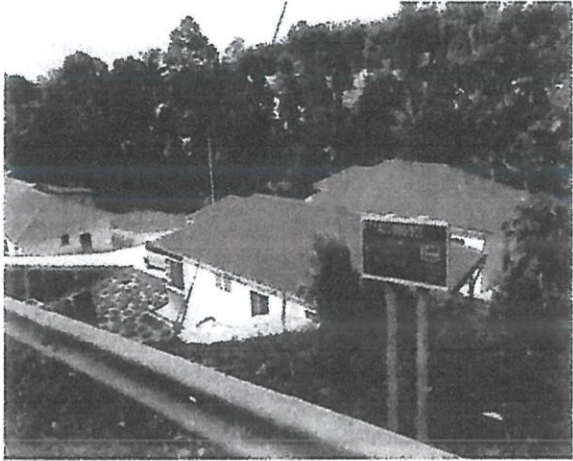
Signage installation
