**BUILDING QUALITY INSPECTION FOR VACANT POSSESSION  
(COMPLETE)**

**SYABIL ARISSA BINTI AZIZI  
(2015890332)  
DIPLOMA IN BUILDING SURVEYING**

**PRACTICAL TRAINING REPORT  
MARCH -JULY 2018**

### 3.1 INTRODUCTION TO CASE STUDY OF THE BUILDING QUALITY INSPECTION FOR VACANT POSSESSION

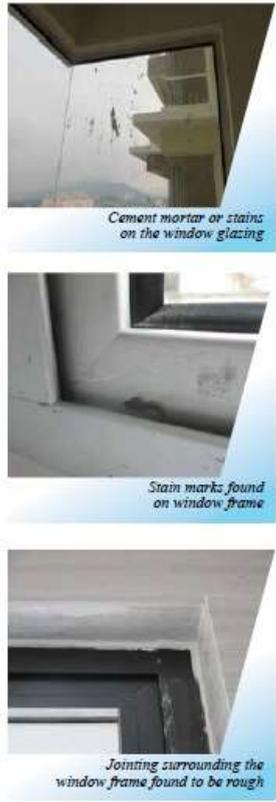
<p>Cement mortar or stains on the window glazing</p> <p>Stain marks found on window frame</p> <p>Jointing surrounding the window frame found to be rough</p> <p>Figure 2. 18 : Defects on wall</p>	<p style="text-align: center;"><b><u>Finishing</u></b></p> <ul style="list-style-type: none"> <li>➤ No stain marks on the wall and consistent colour tone and good paintwork with no paint drips and brush mark.</li> <li>➤ Good opacity, no rough/patchy surface from touch-up work.</li> </ul> <p style="text-align: center;"><b><u>Alignment and Evenness</u></b></p> <ul style="list-style-type: none"> <li>➤ Wall to be even with equal or not more than 3mm over 1.20m.</li> <li>➤ Walls meet at the right angle with equal or not more than 4mm over 300mm.</li> <li>➤ Vertically of wall should be equal or not more than 3mm over 1.20m.</li> </ul> <p style="text-align: center;"><b><u>Cracks and Damages</u></b></p> <ul style="list-style-type: none"> <li>➤ No visible damages/defects should be seen on the floor such as cracks, chipping, and peeling off should be seen on wall.</li> </ul> <p style="text-align: center;"><b><u>Hollowness and Delamination</u></b></p> <ul style="list-style-type: none"> <li>➤ No hollow sound when tapped with hard object/tapping rod and no sign of delamination, wallpaper peeling off.</li> </ul> <p style="text-align: center;"><b><u>Jointing</u></b></p> <ul style="list-style-type: none"> <li>➤ Jointing between wall tiles must be consistent, neat and aligned. Edges of walls to be straight, aligned and consistent.</li> <li>➤ No holes, over grout, under grout and stains on the jointing.</li> <li>➤ Lippage between 2 tiles should not be more than 1mm.</li> </ul>

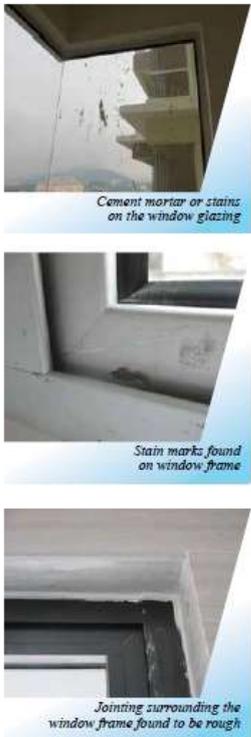
<p style="text-align: center;">Figure 2. 21 : Defects on window</p>	<p style="text-align: center;"><b><u>Joints and Gaps</u></b></p> <ul style="list-style-type: none"> <li>➤ No visible gap between window and wall.</li> <li>➤ Neat joints between window frame and wall internally and externally. Consistent and no visible gaps for joints at window leaf and frame.</li> </ul> <p style="text-align: center;"><b><u>Alignment and Evenness</u></b></p> <ul style="list-style-type: none"> <li>➤ Aligned and level with wall openings.</li> <li>➤ Window leaf and frame corners maintained at right angles.</li> </ul> <p style="text-align: center;"><b><u>Materials and Damages</u></b></p> <ul style="list-style-type: none"> <li>➤ No stain marks and any visible damages including paint drip, brush marks and such.</li> <li>➤ Louvered window with glass panels of correct length.</li> <li>➤ Good paintwork/coating with no patchy tough up mark. No sign of corrosion. Glazing clean and evenly sealed with putty or gasket for aluminium windows.</li> </ul> <p style="text-align: center;"><b><u>Functionality</u></b></p> <ul style="list-style-type: none"> <li>➤ Ease in opening, closing and locking.</li> <li>➤ No squeaky sound during opening and closing of the window. No sign of rain water seepage.</li> </ul> <p style="text-align: center;"><b><u>Accessories Defects</u></b></p> <ul style="list-style-type: none"> <li>➤ No sign of corrosion or missing or defective accessories. Screws levelled and flushed. Screws should be fastened properly.</li> </ul>

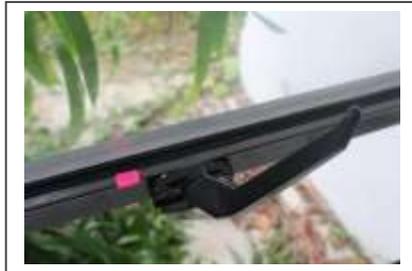
Window handle found loosened

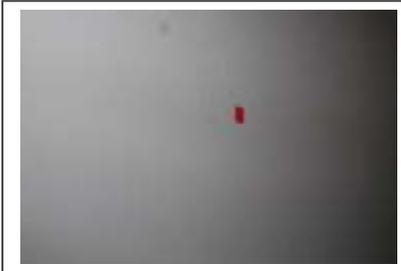
Paint dripping sighted on wall

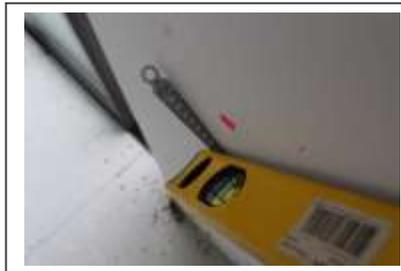
Wall found uneven and exceeded the tolerance of 3mm over 1.2m

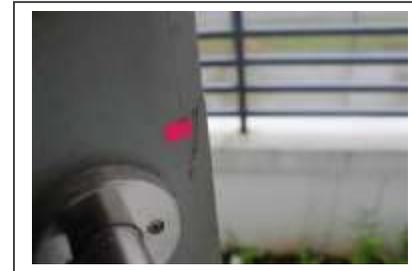
Damages sighted on door panel

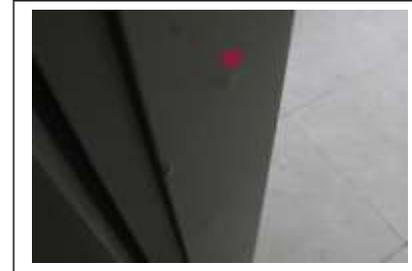
Damage sighted on door

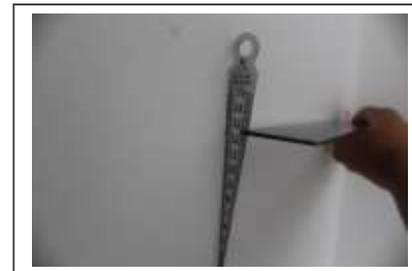
Wall squareness found misaligned and exceeded the tolerance of over 300mm

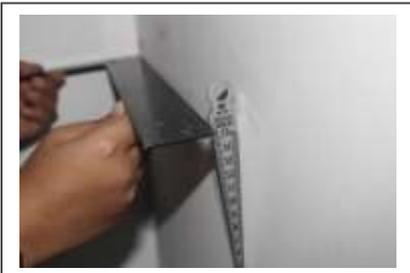
Wall squareness found misaligned and exceeded the tolerance of 4mm over 300mm (more than 15.0mm)

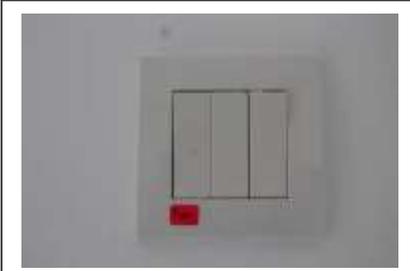
Gap sighted at switch buttons

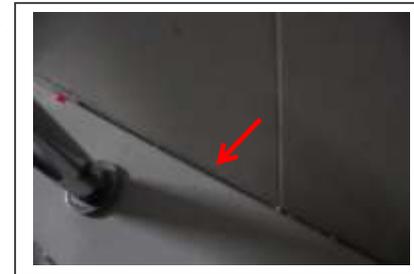
Gap sighted at wash basin

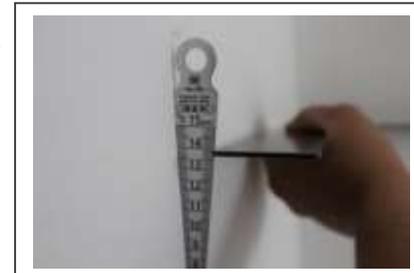
Wall squareness found misaligned and exceeded the tolerance of 4mm over 300mm (approximately 13.9mm)

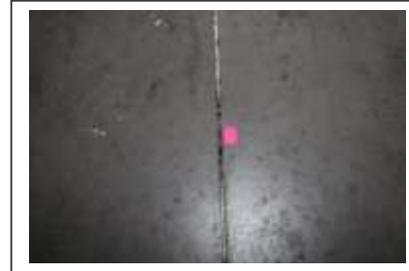
Floor tiles grouting found incomplete

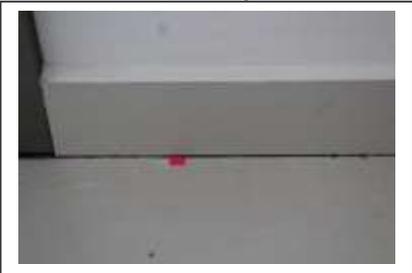
Gap sighted at the bottom of skirting tiles

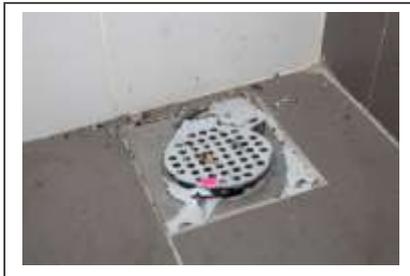
Floor trap cover found dented (unable to close)

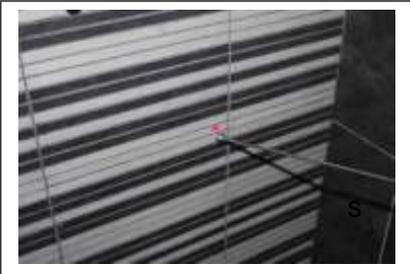
Hollowness found on wall tile

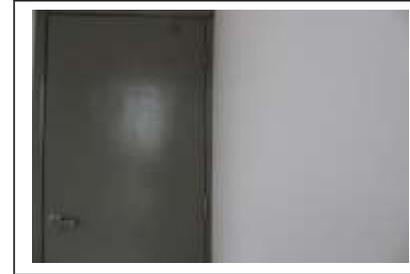
Size of door frame found inconsistent

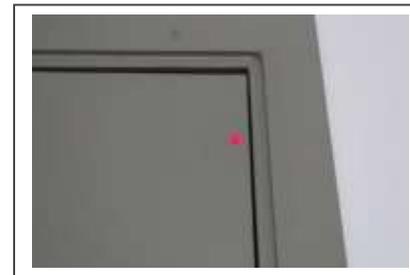
Door panel found misaligned

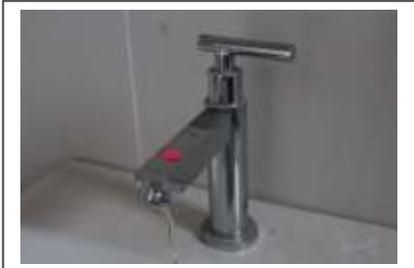
Lower water pressure sighted at wash basin water tap

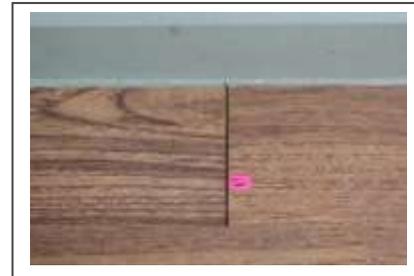
Gap sighted between timber flooring panel

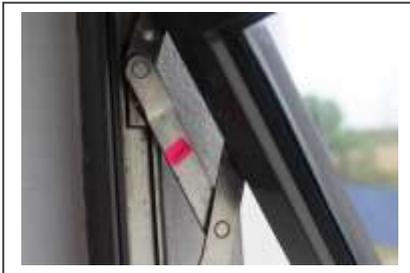
Squeaky sound heard in operating the window

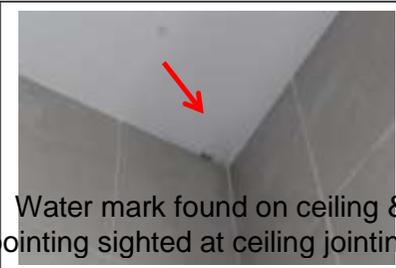
Water mark found on ceiling & pointing sighted at ceiling jointing

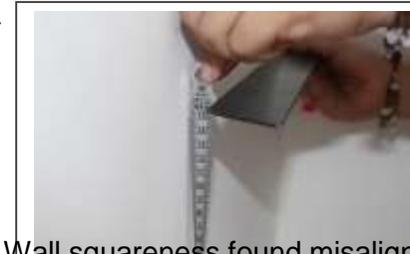
Wall squareness found misaligned and exceeded the tolerance of 4mm over 300mm (more than 15.0mm)

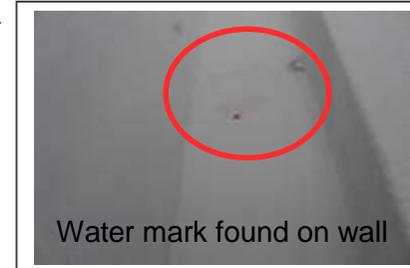
Water mark found on wall

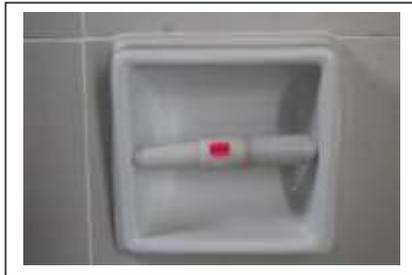
Toilet paper holder found misaligned

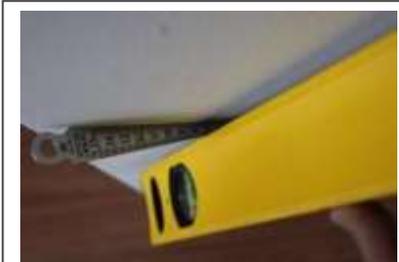
Wall found uneven and exceeded tolerance of 3mm over 1.2m (approximately 7.7mm)

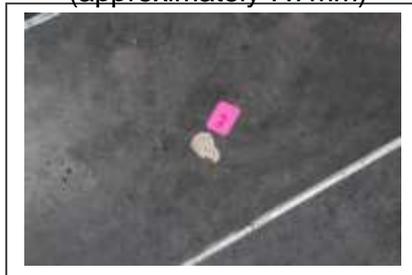
Chipping sighted on floor tile

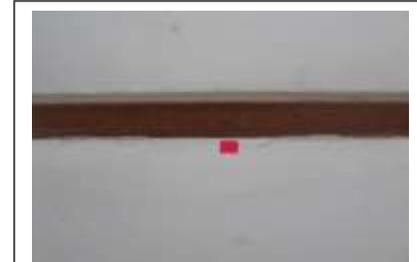
Skim coat at staircase edges found peeled off

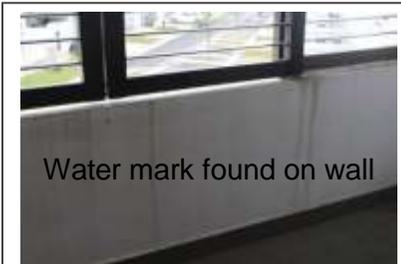
Water mark found on wall

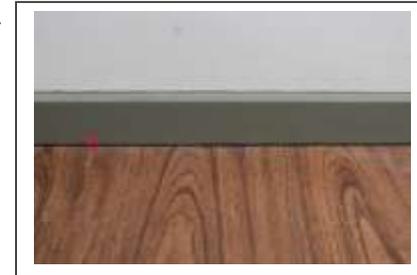
Gap sighted at the bottom of timber skirting

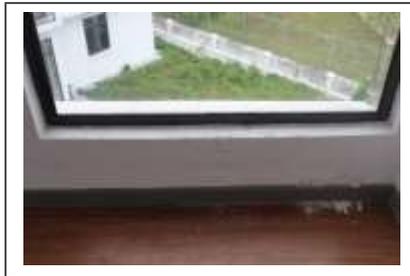
Blistering and paint peeling off sighted on wall

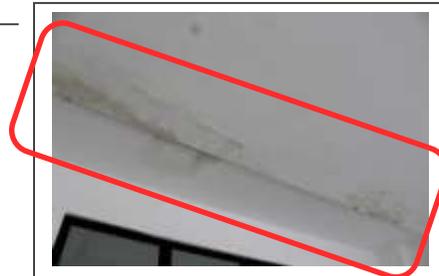
Water dampness detected on ceiling

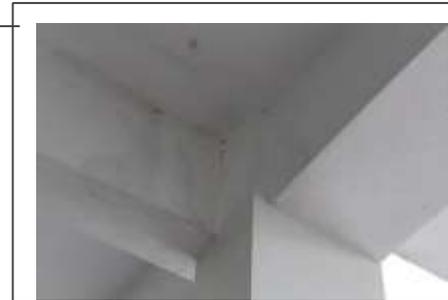
Water dampness detected on beam

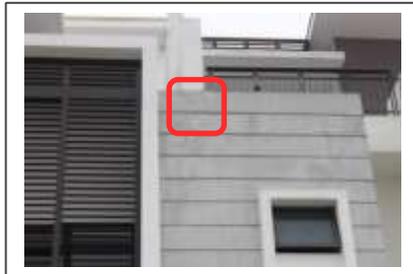
Diagonal crack sighted on external wall

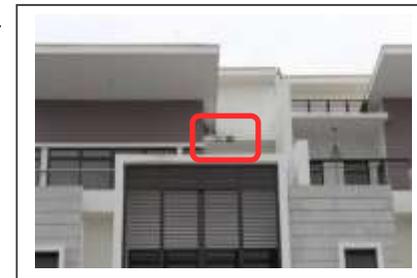
Water mark sighted on coping

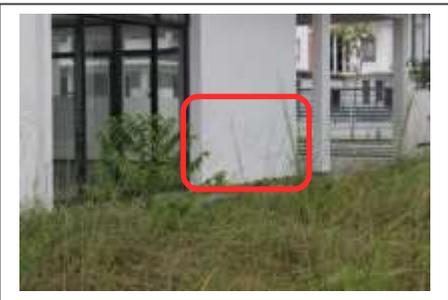
Patchiness sighted on external wall
